AC Recondition As Found

Lexicon (10257)
8900 Fouche Dam Pike
Little Rock, AR

AC Recondition - Rev. 2

Description: 4HP REULAND 1800/53RPM WEO-215/H400

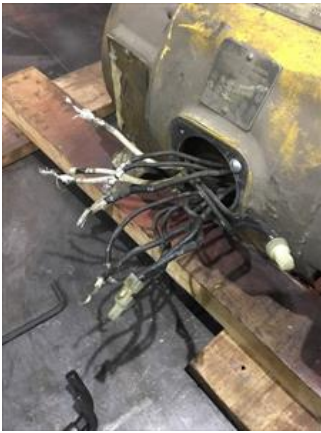
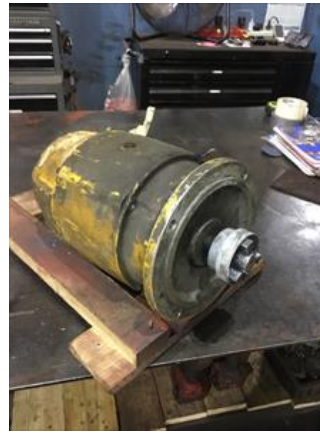
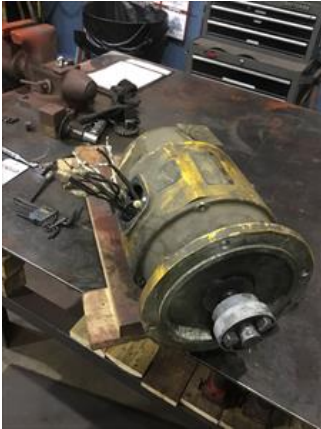
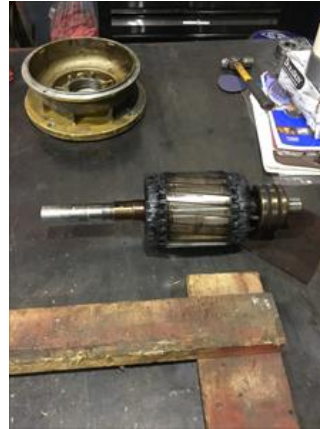
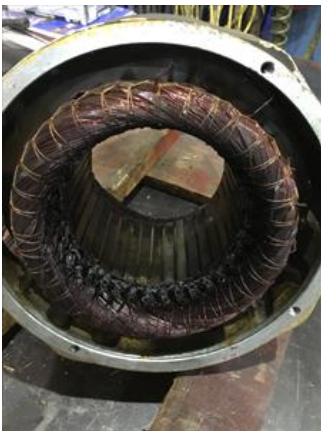
3. Photos of all six sides of the machine.
4. Describe the Overall Condition of the Equipment as Received

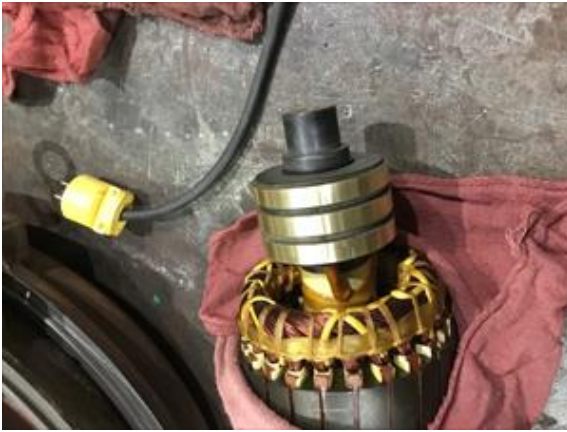
Turned rings

56.	List Machine Work Needed Below <i>Turn rings on rotor.</i>		
57.	Technician		Terrence. Holland
