## AC Recondition As Found

**Twin Rivers (12049)**  
3501 Jefferson Parkway  
Pine Bluff, AR 71602

### AC Recondition - Rev. 2

**Location:** Shop  
**Serial Number:** YZH714B713001  
**Description:** 75HP TECO 1800RPM 365T

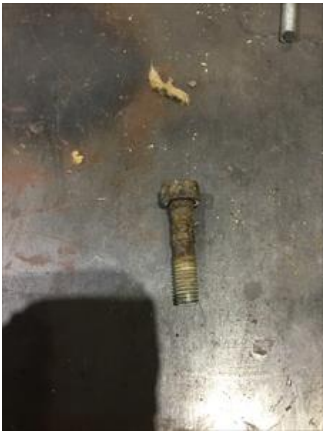
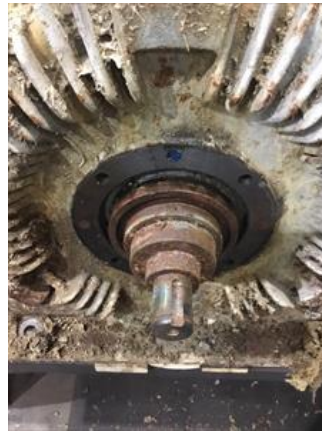
*Mount bolts corroded and need replacing.*

*Replace sheave hub 2 3/8" and repair broken motor mount base brackets. Replace worn and corroded hardware mount bolts.*

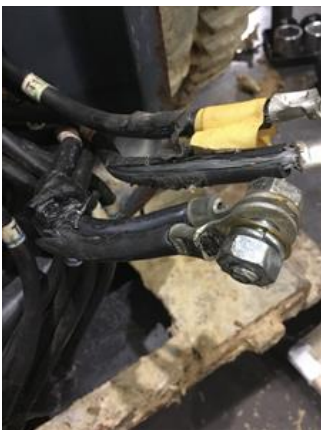
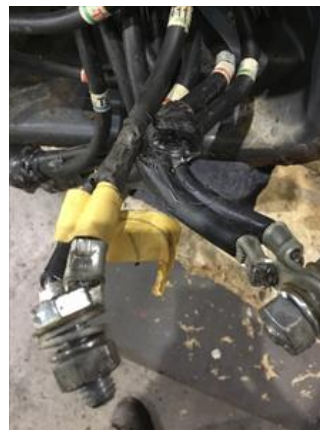
P54

11. Lead Condition **(F) Fail**

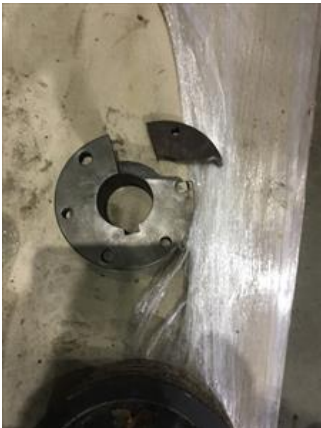
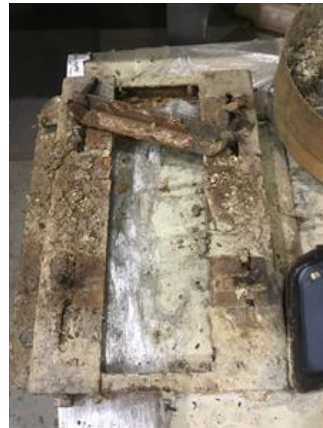
17. Heater Quantity, Ratings			
Quantity		Volts/Watts	Pass/Fail
18. Broken or Missing Components			sheave hub & motor mount base brackets

*Both housing fits bad. Motor mount base brackets need replacement.*

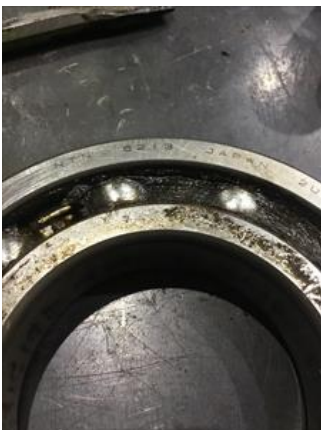
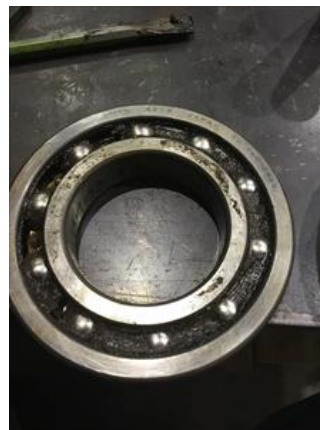
P87

24. Drive End Bearing Qty.	1
25. Drive End Bearing Type	(Ball) Ball Bearing
26. Drive End Lubrication Type	(Grease) Grease Lubricated
27. Drive End Bearing Insulation or Grounding Device?	none
28. Drive End Wavy Washer/Snap-Ring Other Retention Device?	none
29. Drive End Bearing Condition	grease dirty and contaminated

34.	Opposite Drive End Bearing Insulation or Grounding Device?	none	
35.	Opposite Drive End Wavy Washer/Snap-Ring Other Retention Device?	none	
36.	Opposite Drive End Bearing Condition	grease dirty and contaminated

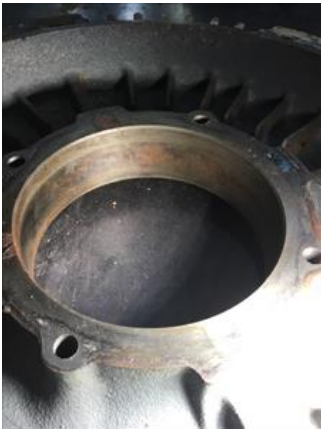
62.	Drive End - Endbell Bearing Fit			
	0 Degrees	60 Degrees	120 Degrees	
	5.5133	5.5134	5.5134	
63.	Drive End - Endbell Bearing Fit Condition			(F) Fail P16
	Lip groove worn in fit

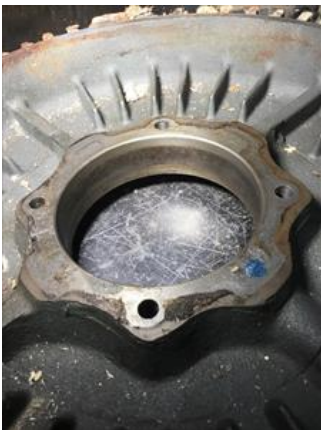
64.	Opposite Drive End - Endbell Bearing Fit			
	0 Degrees	60 Degrees	120 Degrees	
	4.7258	4.7257	4.7257	
65.	Opposite Drive End - Endbell Bearing Fit Condition			(F) Fail P42
	Lip groove worn in fit
