AC Recondition As Found
Baldor Warranty Division
685 Mid America Blvd
Hot Springs, AR 71913

AC Recondition - Rev. 2

Description: 20HP BALDOR 1800RPM 256TC

Repair Stage: Teardown Inspection

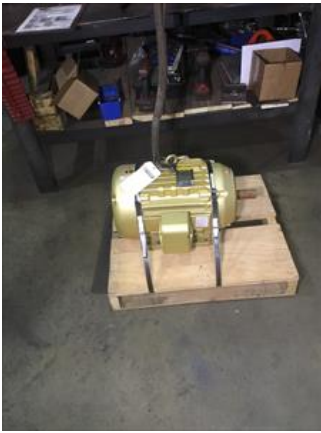
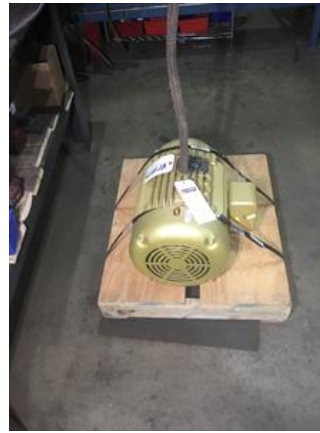
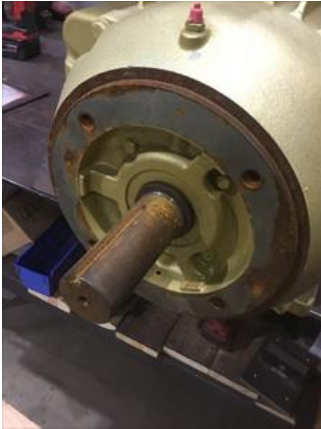
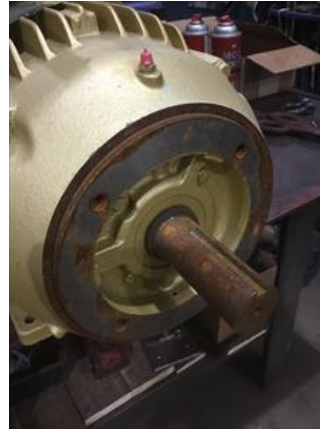
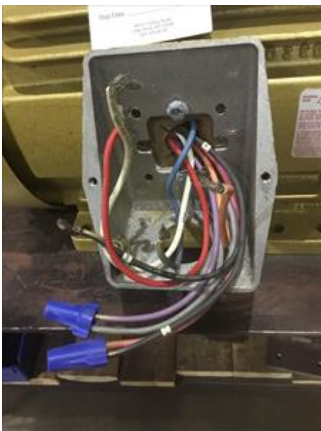
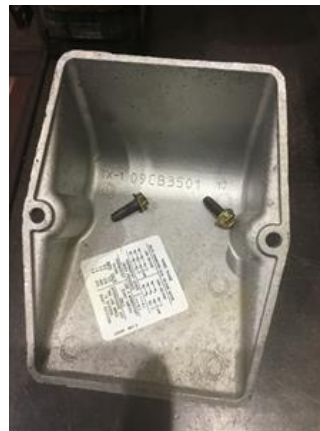
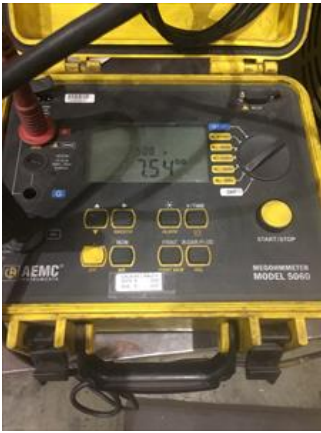
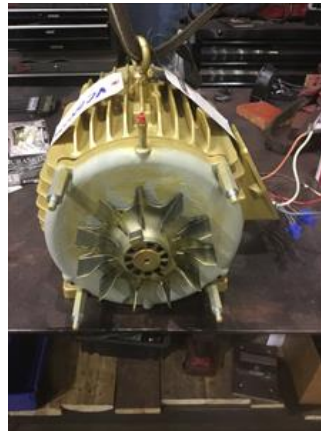
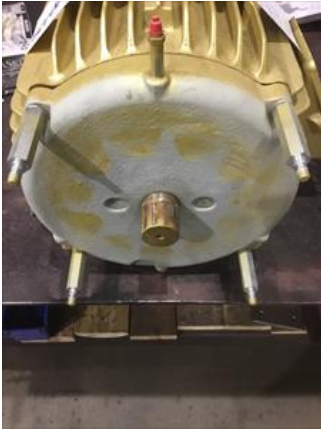
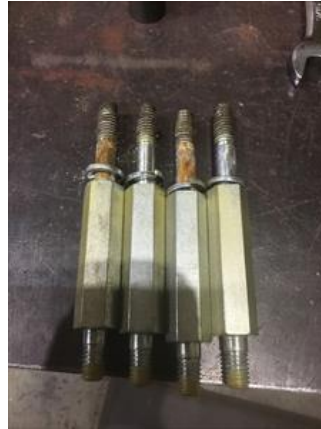
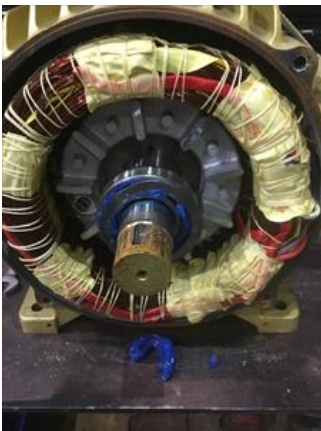
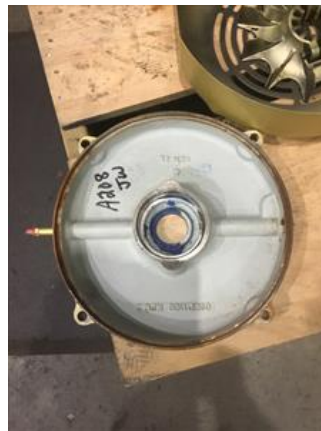
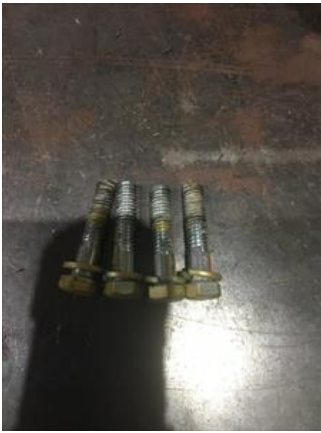
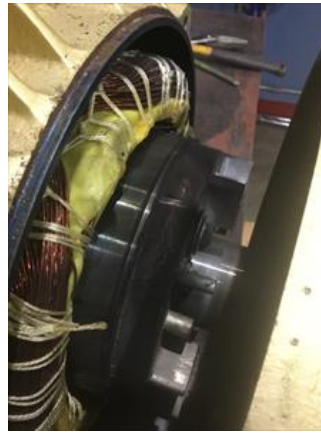
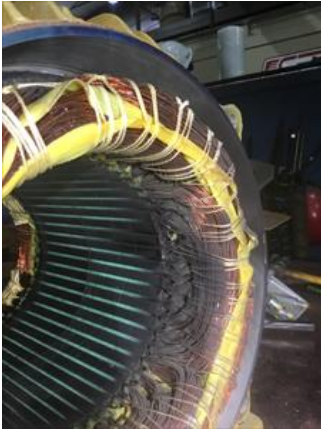
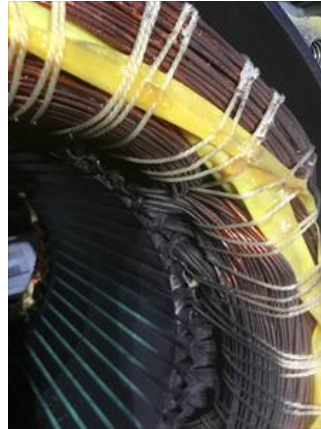
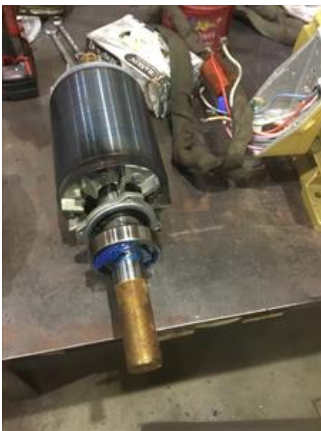
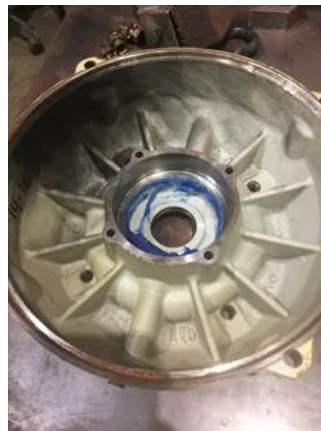
3. Photos of all six sides of the machine.
4. Describe the Overall Condition of the Equipment as Received

2 - Good

Overall Condition
