## AC Recondition As Found

Hiland Dairy (10126)

### AC Recondition - Rev. 2

Description: 7.2HP THERMO KING 1800RPM  
184T

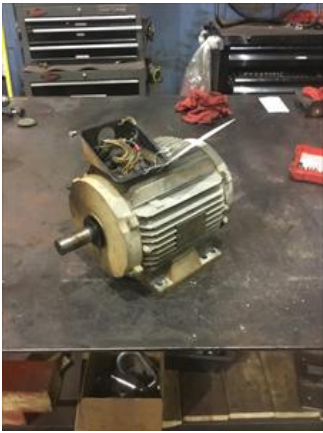
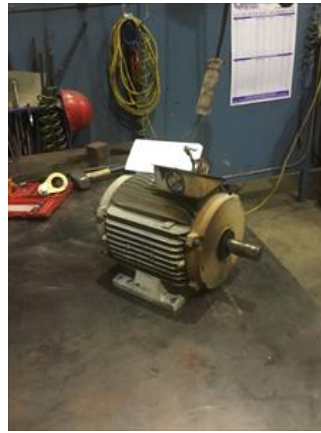
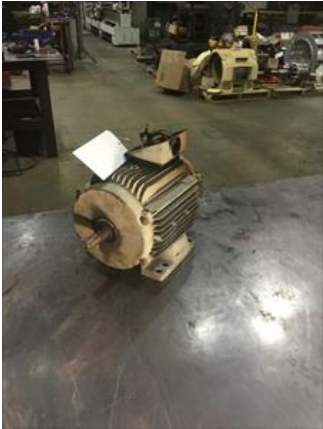
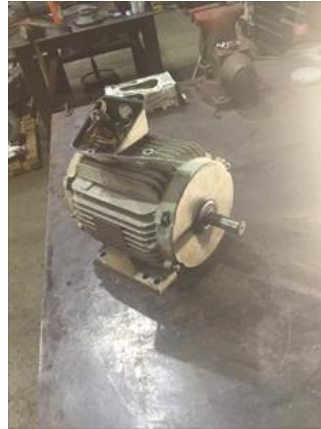
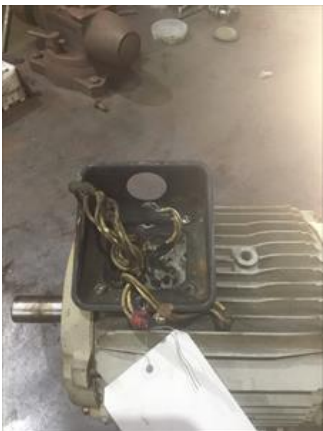
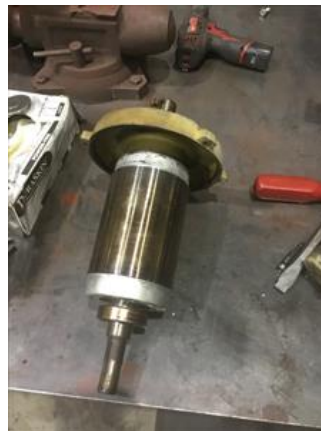
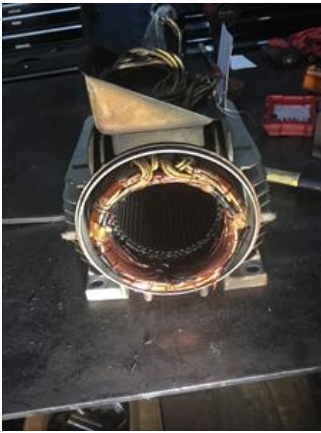
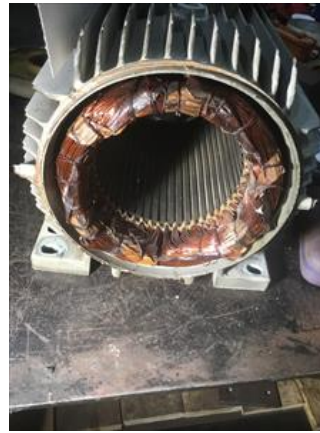
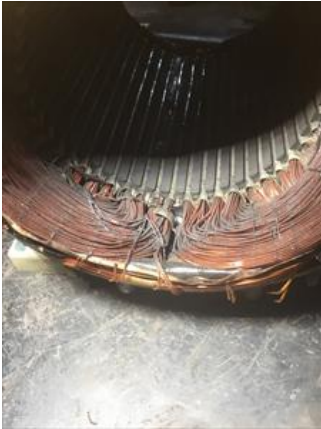
3. Photos of all six sides of the machine.

*Bearing fragments imbedded in windings.*

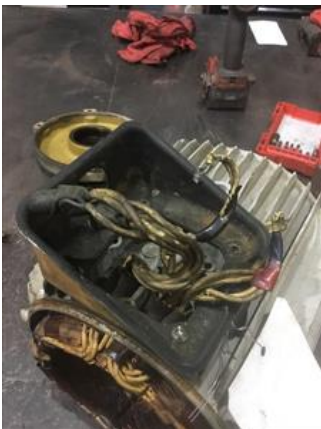
<i>Both bearings locked up.</i>		
6. Does Shaft Have Visible Damage?		<b>(No) No</b>
7. Assembled Shaft Runout		<b>Inches</b>
8. Assembled Shaft End Play		
9. Air Gap Variation <10%		
10. Lead Condition		P32

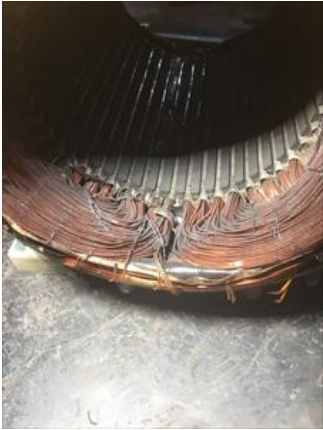
15.	Insulation Resistance/Megger		
16.	Winding Resistance		
	1-2	1-3	2-3
17.	Perform Surge Test	(NA) Not Applicable	
18.	Stator Condition	windings shorted by bearing cage failure	P39

*Windings shorted*

*Poor bearing lubrication causing bearing cage failure.*

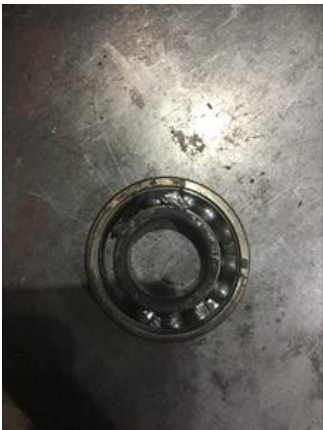
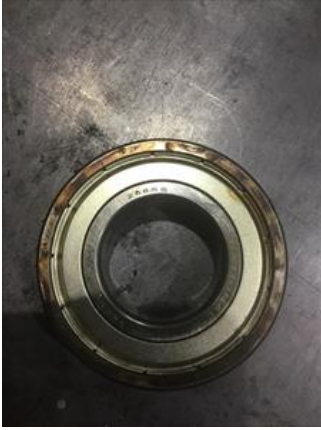
19.	Drive End Bearing Number-	6206	
20.	Drive End Bearing Qty.	1	
21.	Drive End Bearing Type	(Ball) Ball Bearing	
22.	Drive End Lubrication Type	(Grease) Grease Lubricated	
23.	Drive End Bearing Insulation or Grounding Device?	none	
24.	Drive End Wavy Washer/Snap-Ring Other Retention Device?	none	
25.	Drive End Bearing Condition	cage failed	P42

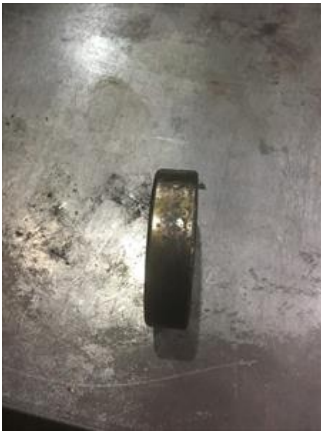
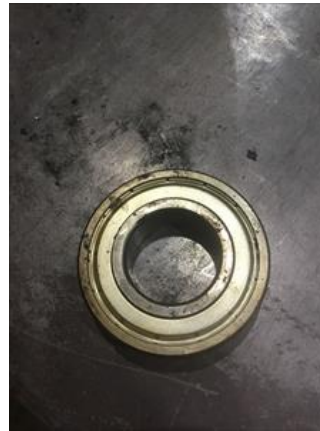
32. Opposite Drive End Bearing Condition

**worn**

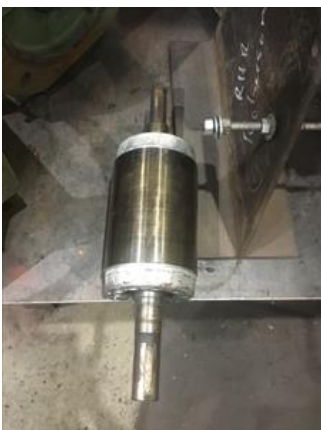
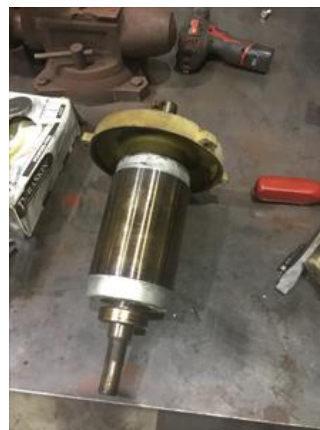
36.	Growler Test	(Pass) Pass
37.	Number of Rotor Bars	
38.	Rotor Condition	good
39.	List the Parts needed for the Repair Below <i>ODE housing fit pitted and lip worn in.</i>	P29
<div style="display: flex; justify-content: space-around;">     </div>

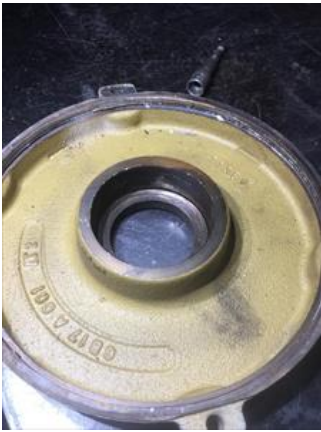
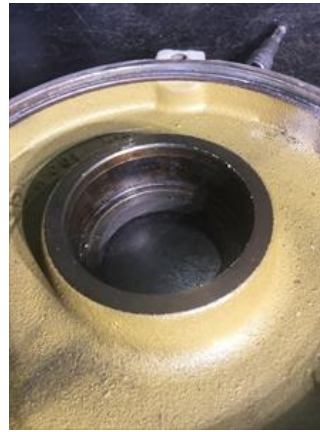
Failed. Lip worn in

53. Opposite Drive End - Endbell Bearing Fit Condition **(F) Fail**

56. List Machine Work Needed Below

#1 end bell fit.
