AC Recondition As Found

AC Recondition - Rev. 2

Description: 125HP SIEMENS 1800RPM 444T

Repair Stage: Teardown Inspection

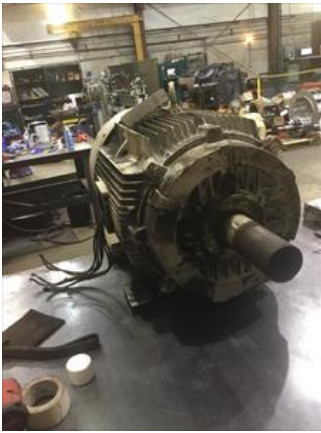
4. Describe the Overall Condition of the Equipment as Received
Good but dirty

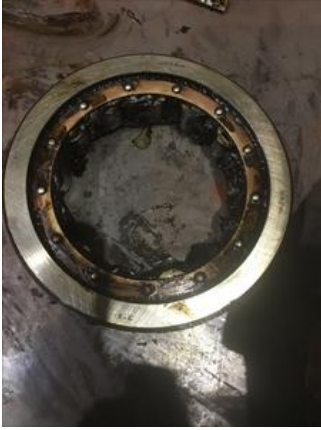
20. Drive End Bearing Qty.	1
21. Drive End Bearing Type	
22. Drive End Lubrication Type	(Grease) Grease Lubricated
23. Drive End Bearing Insulation or Grounding Device?	none
24. Drive End Wavy Washer/Snap-Ring Other Retention Device?	none
25. Drive End Bearing Condition	grease dirty and contaminated

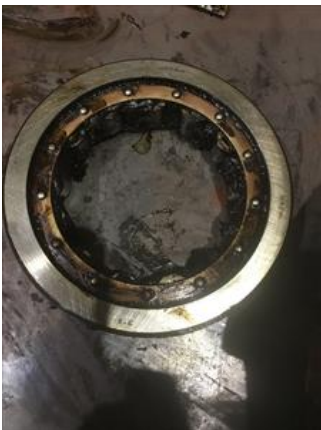
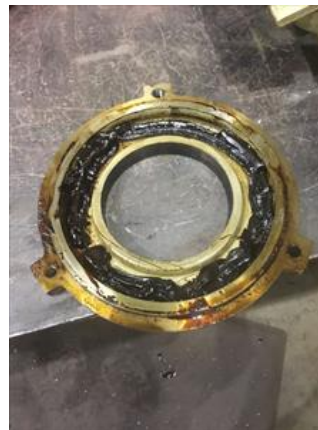
26. Opposite Drive End Bearing Number-	6316
27. Opposite Drive End Bearing Qty.	
28. Opposite Drive End Bearing Type	
29. Opposite Drive End Lubrication Type	
30. Opposite Drive End Bearing Insulation or Grounding Device?	
31. Opposite Drive End Wavy Washer/Snap-Ring Other Retention Device?	
32. Opposite Drive End Bearing Condition	grease contaminated
33. Drive End Seal	
34. Opposite Drive End Seal

*Housing fit pitted and require repair.*

53. Opposite Drive End - Endbell Bearing Fit Condition **(F) Fail**

Ode housing fit pitted.

316 sleeve for ode housing fit and 6316 2Z bearing as well as NU 318 c3 bearing. Also customer request new connection box.
