## AC Recondition As Found

Kimberly Clark (10176-KCM)

### AC Recondition - Rev. 2

Description: 40HP RELIANCE 1800RPM 324T

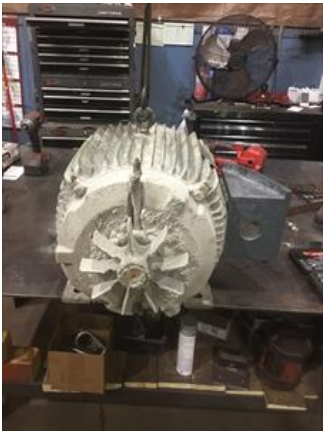
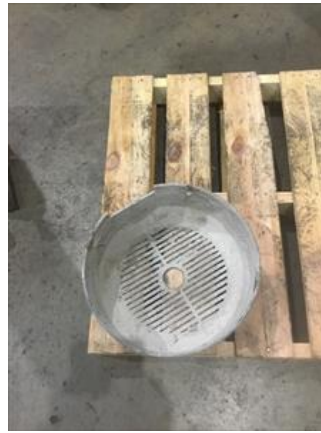
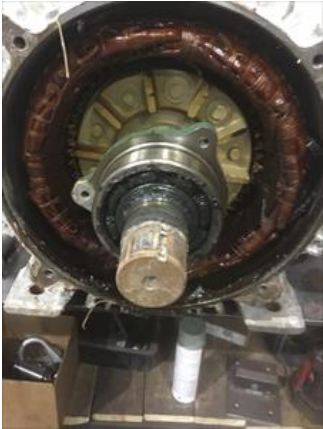
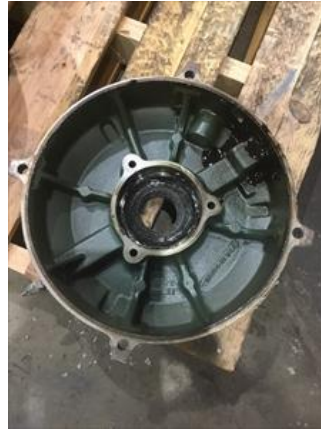
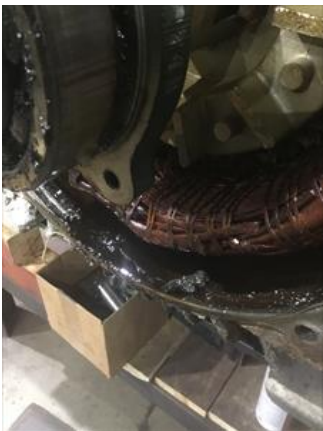
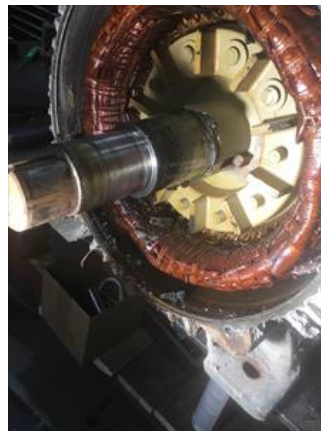
4. Describe the Overall Condition of the Equipment as Received  
*Serviceable*

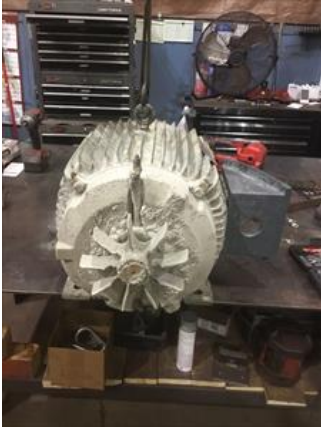
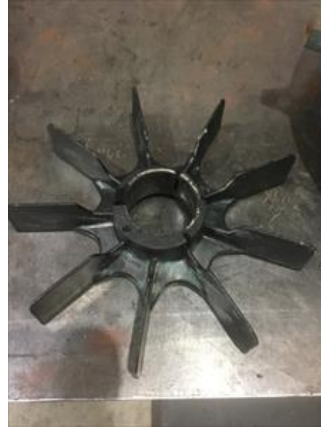
14. Broken or Missing Components

fan cover bolt broken off.  
requires drill and tap

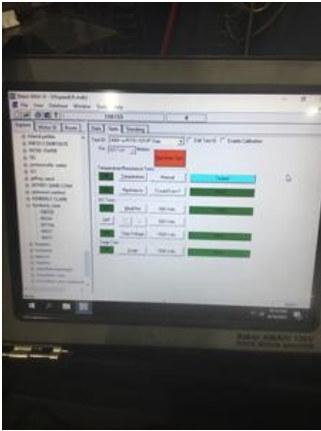
17. Perform Surge Test

(P) Pass

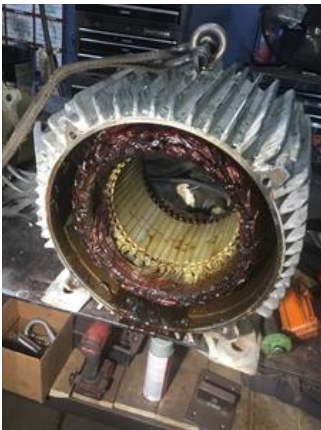
18. Stator Condition

saturated with oil
