## AC Recondition As Found

### 3M-Main Plant (10001)

#### AC Recondition - Rev. 2

Description: 125HP TOSHIBA 1800RPM 444T

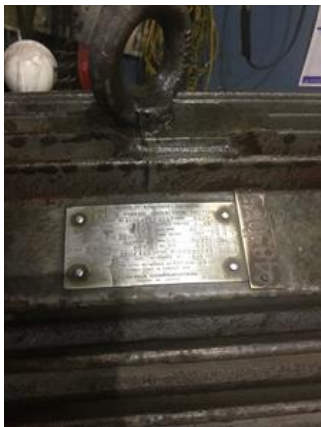
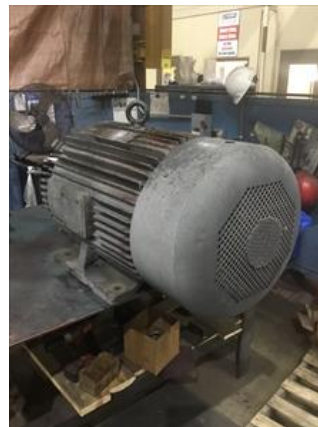
1. Report Date
2. Nameplate Picture

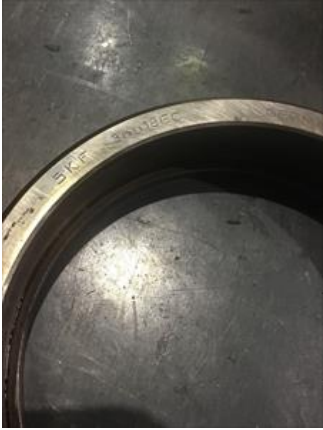
12.	Lead Length	9 Inches	
13.	Frame Condition	pass	
14.	Fan Condition	(P) Pass	
15.	Broken or Missing Components	end cap mount bolts	
<b>Initial Electrical Inspection</b>			
16.	Insulation Resistance/Megger	Megohms	
	<i>Grounded</i>		
17.	Winding Resistance		
	1-2	1-3	2-3
18.	Perform Surge Test	(NA) Not Applicable	
19.	Stator Condition	rewind stator	
<b>Mechanical Inspection</b>			
20.	Drive End Bearing Number-	SKF 3nu18EC	P8

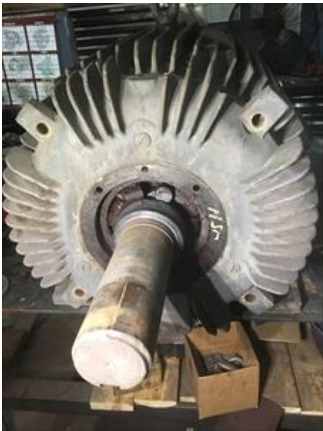
21.	Drive End Bearing Qty.	1	
22.	Drive End Bearing Type	(Roller) Roller Bearing	
23.	Drive End Lubrication Type	(Grease) Grease Lubricated	
24.	Drive End Bearing Insulation or Grounding Device?	none	
25.	Drive End Wavy Washer/Snap-Ring Other Retention Device?		
26.	Drive End Bearing Condition	destroyed	P43

59.	Failure locations		
60.	Root cause of failure		
	<i>D.E bearing shattered due to contaminated hard grease. Also found multiple large pieces of hardened varnish in stator.</i>

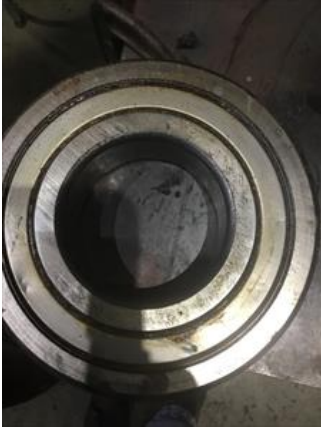
28. Opposite Drive End Bearing Qty.	1
29. Opposite Drive End Bearing Type	(Ball) Ball Bearing
30. Opposite Drive End Lubrication Type	(Grease) Grease Lubricated
31. Opposite Drive End Bearing Insulation or Grounding Device?	none
32. Opposite Drive End Wavy Washer/Snap-Ring Other Retention Device?	none
33. Opposite Drive End Bearing Condition	worn/contaminated grease
34. Drive End Seal	
35. Opposite Drive End Seal

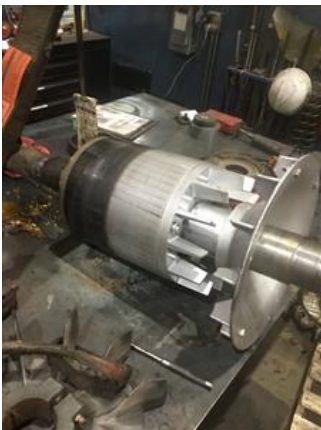
36. Rotor Type/Material	(Squirrel Aluminum) Squirrel Cage Aluminum Die Cast
37. Growler Test	(Pass) Pass
38. Number of Rotor Bars	
39. Rotor Condition	rotor dragged iron

40. List the Parts needed for the Repair Below  
*New shaft, rewind stator, sleeve housing fits*
41. Signature of Technician that Disassembled Motor
