AC Recondition As Found

AC Recondition - Rev. 2

Location: Shop
Serial Number: 1027909941
Description: 25HP WEG 1800RPM 284/6T

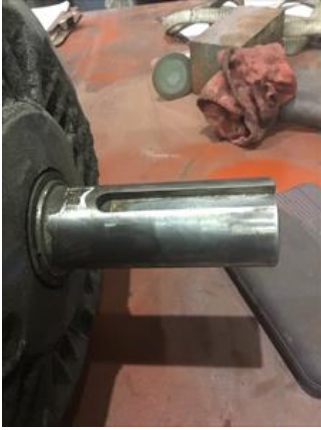
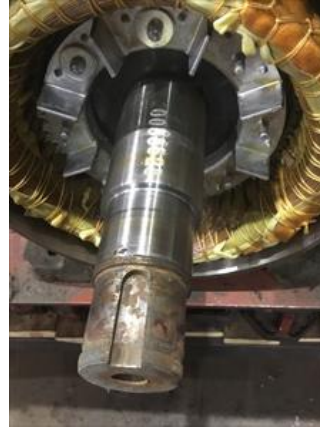
P12

5. Does Shaft Turn Freely?

(Yes) Yes

6. Does Shaft Have Visible Damage?

(No) No

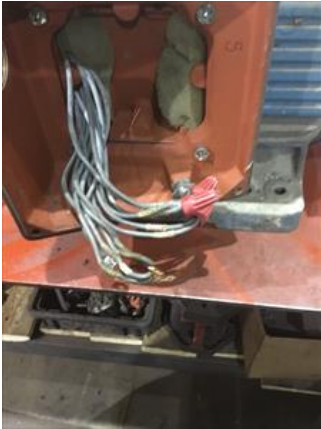
P32

10. Lead Condition **(P) Pass**

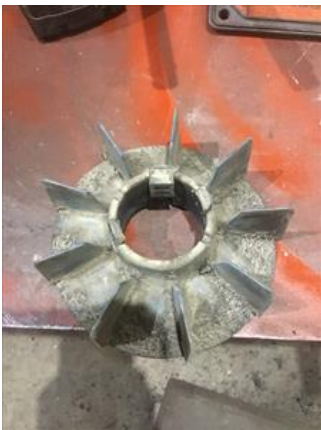
P53

13. Fan Condition **(P) Pass**

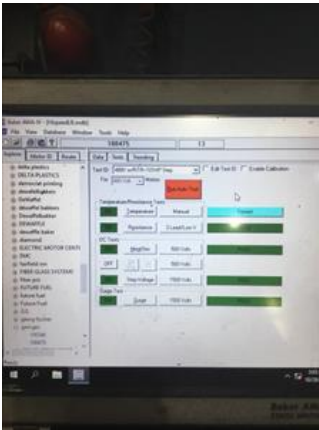
P35

17. Perform Surge Test

(P) Pass

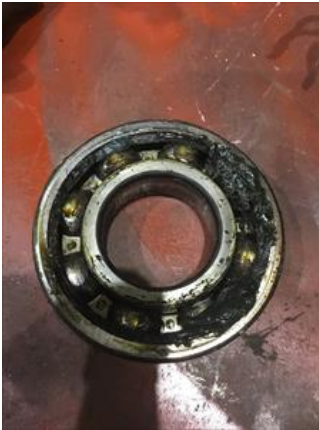
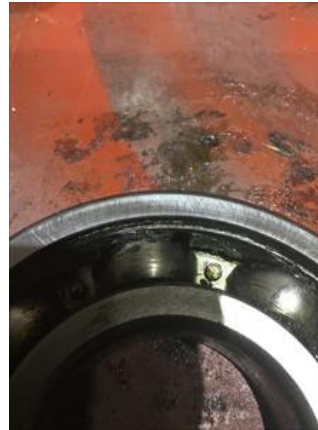
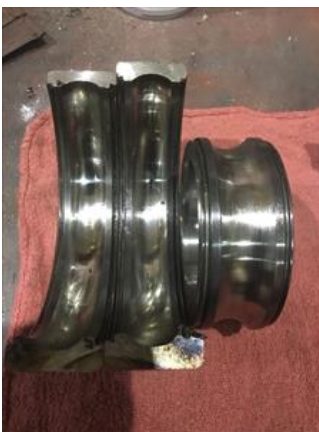
P8

24.	Drive End Wavy Washer/Snap-Ring Other Retention Device?	none	
25.	Drive End Bearing Condition	replace	
26.	Opposite Drive End Bearing Number-	6211 C3	P46
<div>     </div>			
<div>   </div>			
27.	Opposite Drive End Bearing Qty.	1	
28.	Opposite Drive End Bearing Type	(Ball) Ball Bearing	
29.	Opposite Drive End Lubrication Type	(Grease) Grease Lubricated	
30.	Opposite Drive End Bearing Insulation or Grounding Device?	none	
31.	Opposite Drive End Wavy Washer/Snap-Ring Other Retention Device?	none	
32.	Opposite Drive End Bearing Condition	replace	
33.	Drive End Seal		
34.	Opposite Drive End Seal	dust seal	P59
<div>   </div>

58. Failure locations
Bearings.

59. Root cause of failure
Bearing grease contaminated/bearings worn, and o.d.e housing fit pitted.

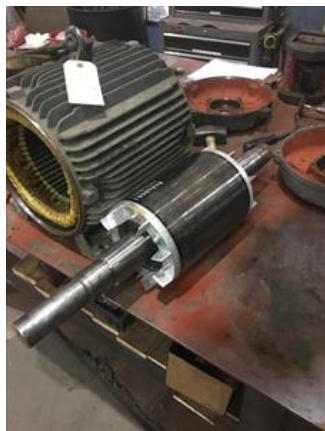
35. Rotor Type/Material	(Squirrel Aluminum) Squirrel Cage Aluminum Die Cast	
36. Growler Test	(Pass) Pass	
37. Number of Rotor Bars	40	
38. Rotor Condition	pass	P23

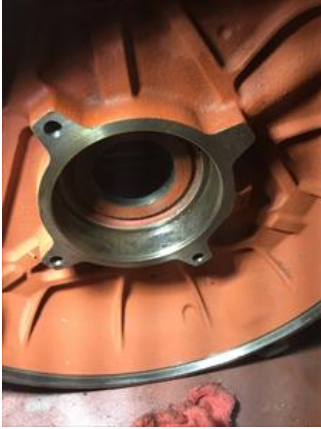
P18

● 51. Drive End - Endbell Bearing Fit Condition

(P) Pass

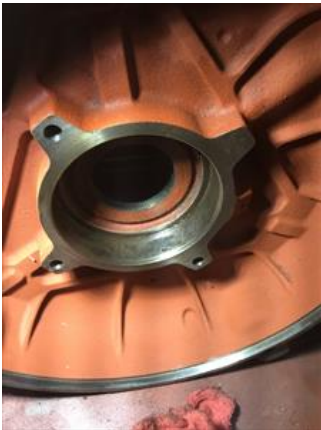
P22

● 53. Opposite Drive End - Endbell Bearing Fit Condition

(F) Fail

56. List Machine Work Needed Below
Machine O.D.E end bell housing fit

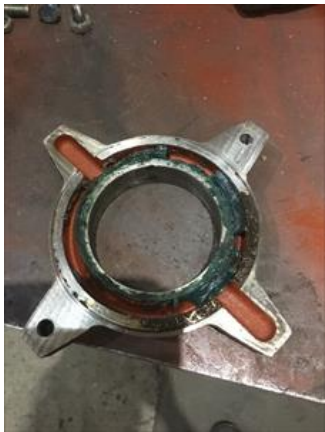
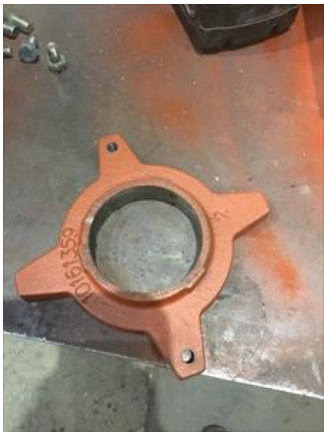
54. Bearing Cap Condition

pass
