## AC Recondition As Found

**Twin Rivers (12049)**  
3501 Jefferson Parkway  
Pine Bluff, AR 71602

### AC Recondition - Rev. 2

Description: 25HP US MOTORS AERATOR  
1200RPM 324LPHZ

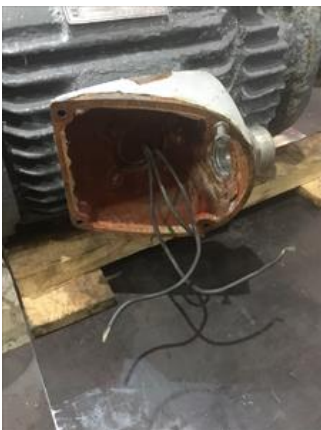
5.	Does Shaft Turn Freely?	(Yes) Yes	
6.	Does Shaft Have Visible Damage?	(No) No	
7.	Assembled Shaft Runout	0.001 Inches	
8.	Assembled Shaft End Play		
9.	Air Gap Variation <10%		
10.	Lead Condition	(P) Pass	P32

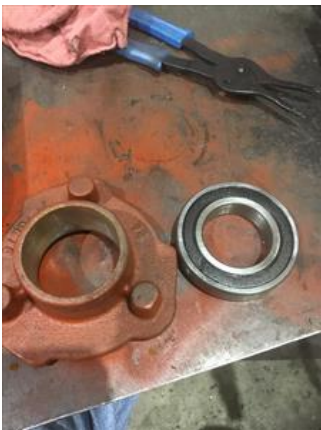
20. Drive End Bearing Qty.	1
21. Drive End Bearing Type	<b>(Ball) Ball Bearing</b>
22. Drive End Lubrication Type	<b>(Grease) Grease Lubricated</b>
23. Drive End Bearing Insulation or Grounding Device?	<b>none</b>
24. Drive End Wavy Washer/Snap-Ring Other Retention Device?	<b>none</b>
25. Drive End Bearing Condition	<b>replace</b>
26. Opposite Drive End Bearing Number-	<b>6210</b>

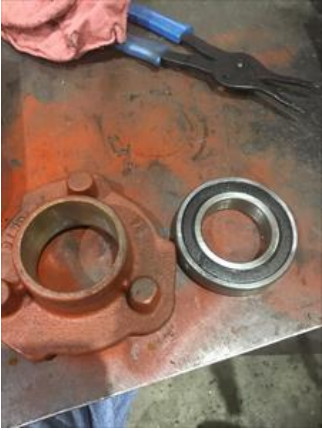
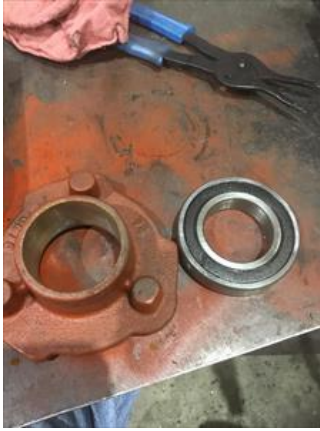
54.	Bearing Cap Condition		
	Drive End Bearing Cap	Opposite Drive End Bearing Cap	
	pass	pass	
<div style="display: flex; justify-content: space-around;">

55.	End Bell Air Seal Fits		
	Drive End Air Seal	Opposite Drive End Air Seal	
56.	List Machine Work Needed Below		
	<i>Seal surface worn</i>		
57.	Technician		Terrence. Holland

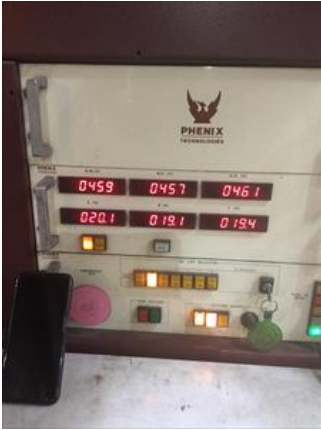
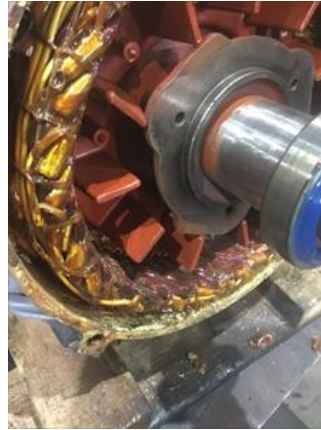
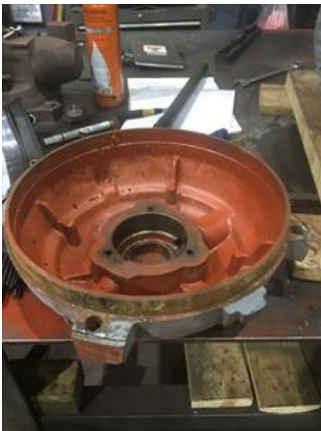
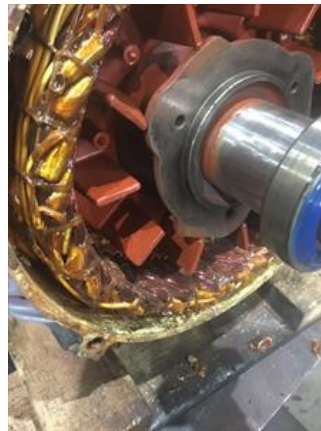
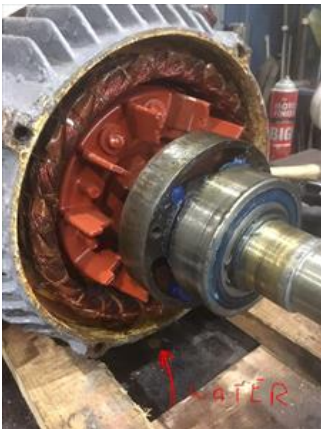
59. Root cause of failure

*Motor pulls high amps with no load. Possibly wound with wrong data. Both housing fits in stator and on end bells not clean. Also found water inside stator.*
