AC Recondition As Found
Baptist Health Medical Center
P.O. Box 8516
Little Rock, AR 72215

AC Recondition - Rev. 2

Location: MOTOR SHOP LR
Serial Number: Z1103011381
Description: 20HP BALDOR 3600RPM 256T

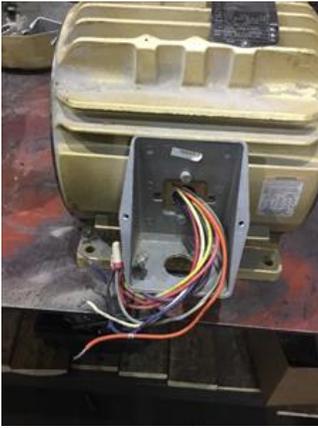
10. Lead Condition

(P) Pass

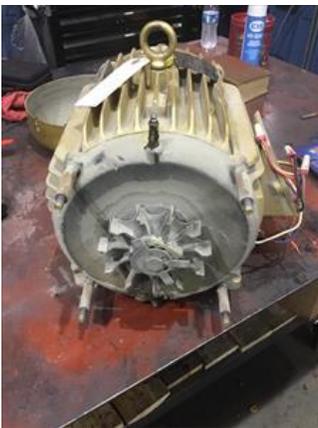
13. Fan Condition

(P) Pass

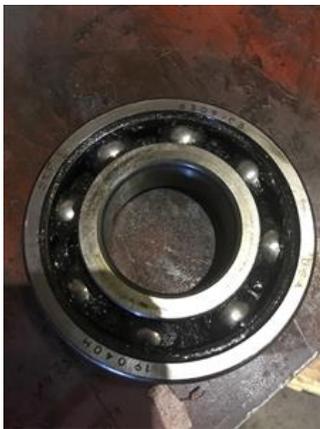
19. Drive End Bearing Number-

6309

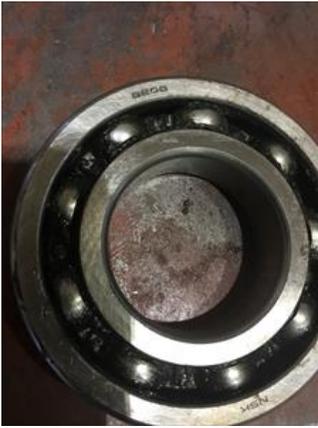
25. Drive End Bearing Condition

replace

Both endbell housings bad. Replace both bearings

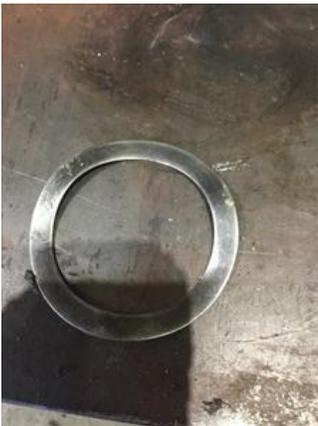
32. Opposite Drive End Bearing Condition	replace
33. Drive End Seal	
34. Opposite Drive End Seal

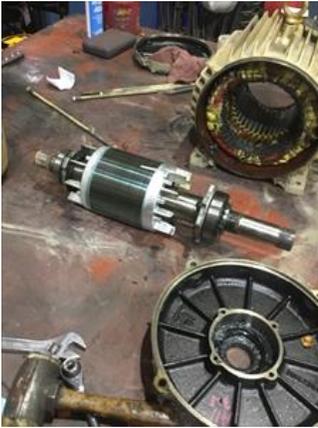
36. Growler Test (Pass) Pass

38. Rotor Condition good
