AC Recondition As Found

PECO FOODS NEWARK
318 SOUTH LOCUST STREET
NEWARK, AR 72562

AC Recondition - Rev. 2

Description: 50HP BALDOR 3600RPM 326TS

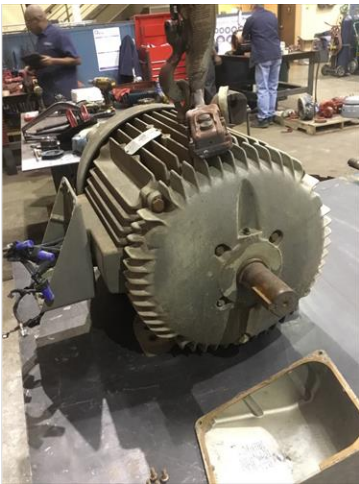
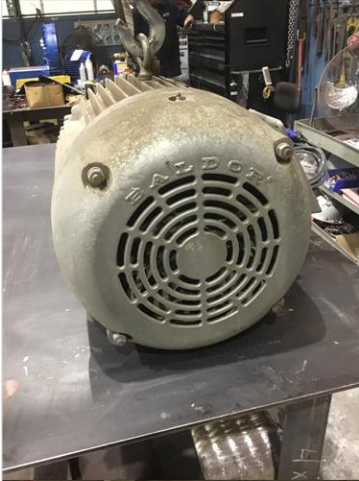
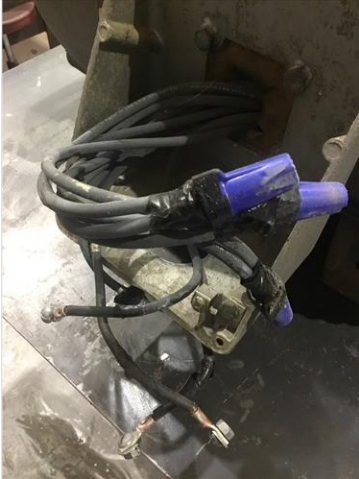
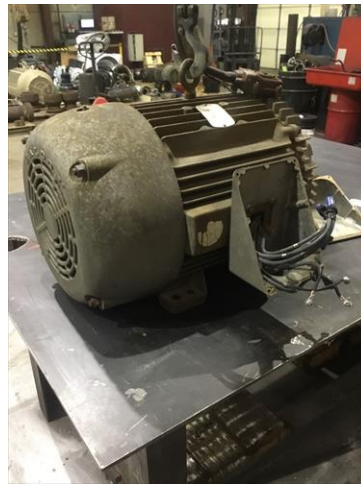
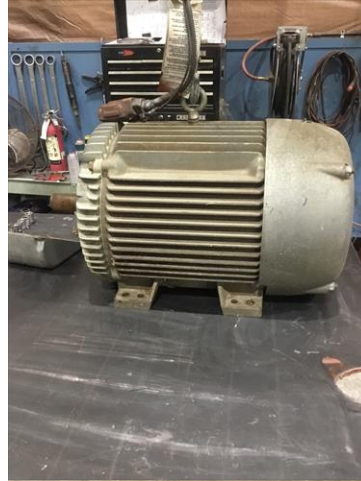
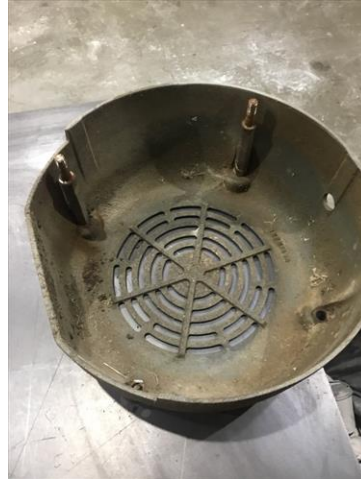
3. Photos of all six sides of the machine.

Dirty

5.	Does Shaft Turn Freely?	(Yes) Yes
6.	Does Shaft Have Visible Damage?	(No) No
7.	Assembled Shaft Runout	
8.	Assembled Shaft End Play	
9.	Air Gap Variation <10%	
10.	Lead Condition	(P) Pass
11.	Lead Length	8 Inches
12.	Frame Condition	pass
13.	Fan Condition	(F) Fail
	<i>Fan is dry rotten</i>	
14.	Broken or Missing Components	fan is cracked

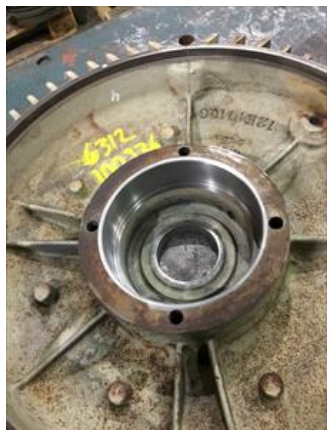
81. Drive End - Endbell Bearing Fit Post Repair

51.	Drive End - Endbell Bearing Fit	
	0 Degrees 60 Degrees 120 Degrees	
	<div> <div></div> <div>5.1197 5.1195 5.1189</div> </div>	
52.	Drive End - Endbell Bearing Fit Condition	(F) Fail

53.	Opposite Drive End - Endbell Bearing Fit	
	0 Degrees 60 Degrees 120 Degrees	
	<div> <div></div> <div>4.7257 4.7253 4.7254</div> </div>	
54.	Opposite Drive End - Endbell Bearing Fit Condition	(F) Fail

68.	Post Rewind Surge Test		
69.	Post Rewind Hi-Pot		
70.	Technician		
Root Cause of Failure			
71.	Failure locations <i>Bearings and end bell bearing fits</i>

72.	Root cause of failure <i>Contamination and wear</i>		
Mechanical Fits- Rotor - Post Repair			
73.	Shaft Runout Post Repair		
74.	Rotor Runout Post Repair		
	Drive End Bearing Fit	Rotor Body	Opposite Drive End Bearing

57.	List Machine Work Needed Below <i>Both end bell bearing fits</i>	
58.	Technician	Cw
