AC Recondition As Found

Remington (10243)

AC Recondition - Rev. 2

Description: 15HP LINCOLN 1800RPM 254T

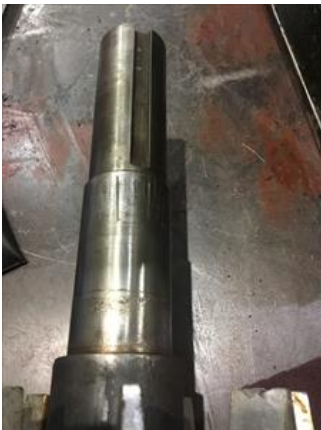
| 6. Does Shaft Have Visible Damage? | (Yes) Yes | P12 |

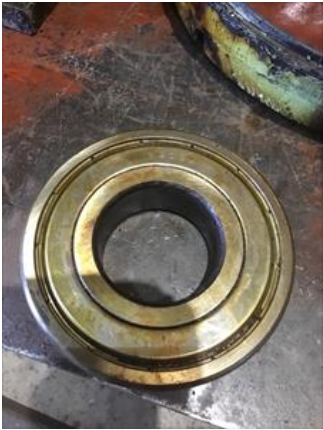
19. Drive End Bearing Number-	6309Z	P8
-------------------------------	-------	----

20. Drive End Bearing Qty.	1
21. Drive End Bearing Type	(Ball) Ball Bearing
22. Drive End Lubrication Type	(Grease) Grease Lubricated
23. Drive End Bearing Insulation or Grounding Device?	none
24. Drive End Wavy Washer/Snap-Ring Other Retention Device?	none
25. Drive End Bearing Condition	worn

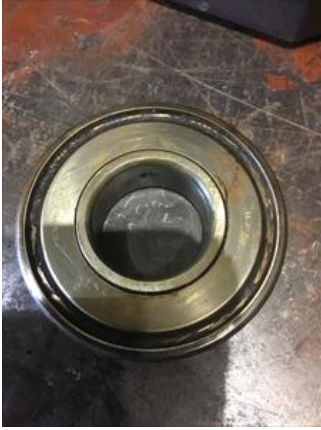
27. Opposite Drive End Bearing Qty.	1	
28. Opposite Drive End Bearing Type	(Ball) Ball Bearing	
29. Opposite Drive End Lubrication Type	(Grease) Grease Lubricated	
30. Opposite Drive End Bearing Insulation or Grounding Device?	none	
31. Opposite Drive End Wavy Washer/Snap-Ring Other Retention Device?		
32. Opposite Drive End Bearing Condition	worn	
33. Drive End Seal	none	
34. Opposite Drive End Seal	replace	P59

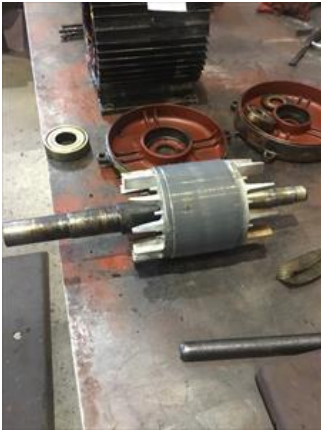
**Rotor Inspection**

36. Growler Test (Pass) Pass

38. Rotor Condition serviceable
