AC Recondition As Found
ARKANSAS INDUSTRIAL MACHINERY
3804 N. NONA ST
NORTH LITTLE ROCK, AR 72118

AC Recondition - Rev. 2

Description: 75KW ABB

Repair Stage: Teardown Inspection

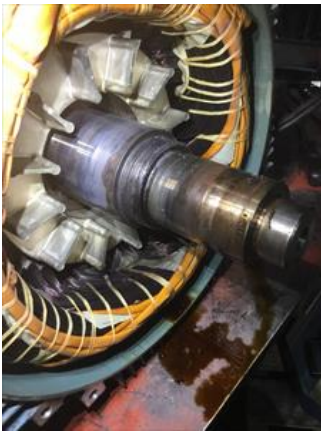
P12

7. Does Shaft Have Visible Damage? **(Yes) Yes**

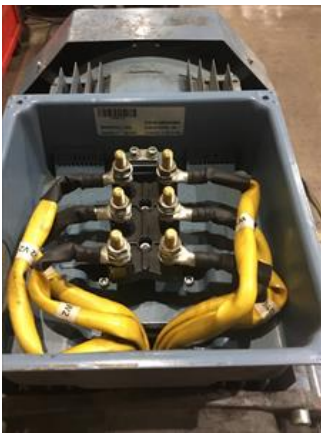
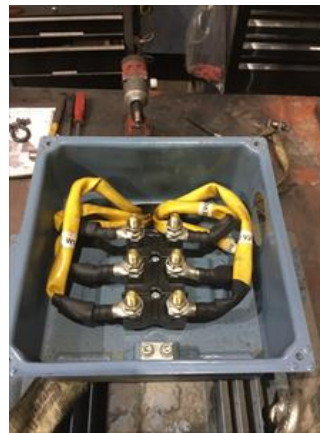
P32

11. Lead Condition **(P) Pass**

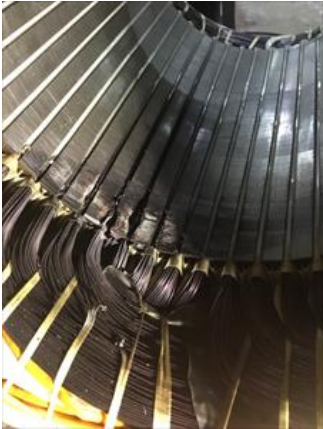
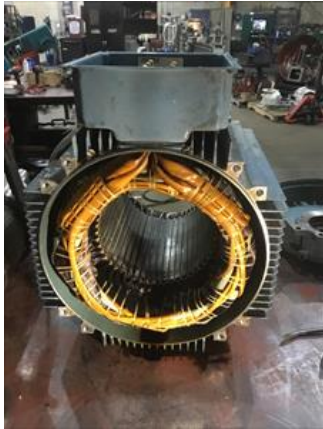
16.	Insulation Resistance/Megger			0 Megohms
17.	Winding Resistance			
	1-2	1-3	2-3	
● 18.	Perform Surge Test			(NA) Not Applicable
19.	Stator Condition			core damaged and coils require rewind. P39

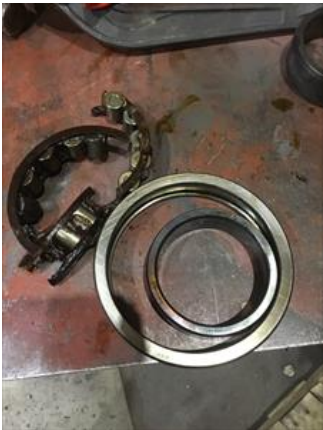
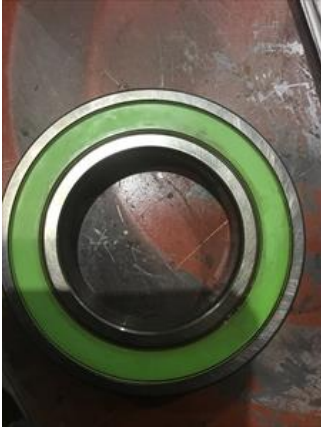
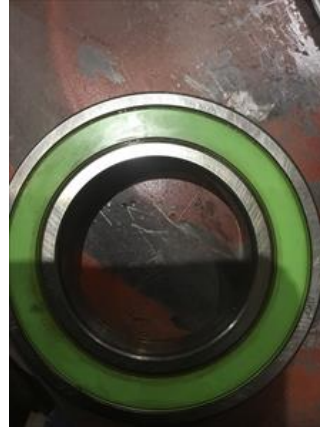
20.	Drive End Bearing Number-			NU 213
21.	Drive End Bearing Qty.			1
22.	Drive End Bearing Type			(Roller) Roller Bearing
23.	Drive End Lubrication Type			(Oil) Oil Lubricated
24.	Drive End Bearing Insulation or Grounding Device?			none
25.	Drive End Wavy Washer/Snap-Ring Other Retention Device?			none
26.	Drive End Bearing Condition			complete bearing failure. P43

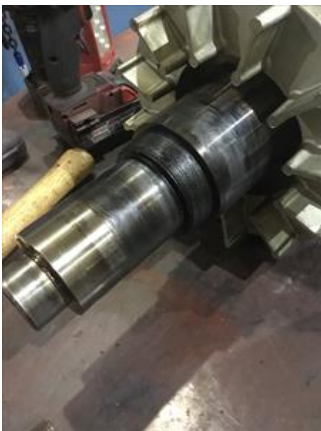
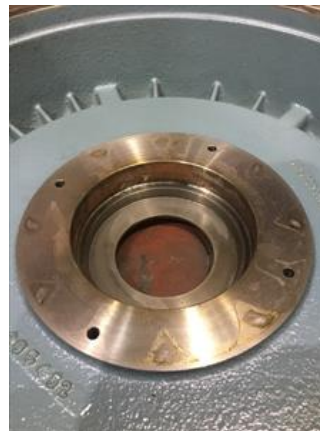
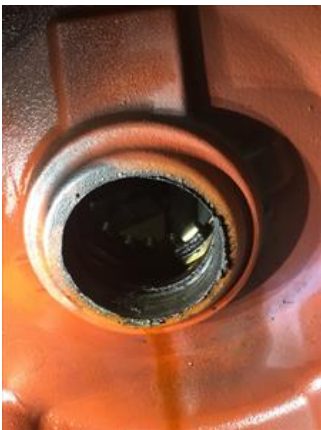
P37

D.e. Shaft has excessive wear on seal surface spacer.D.e. Housing require sleeve for air seal fit.

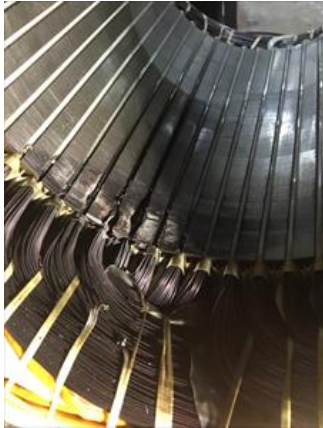
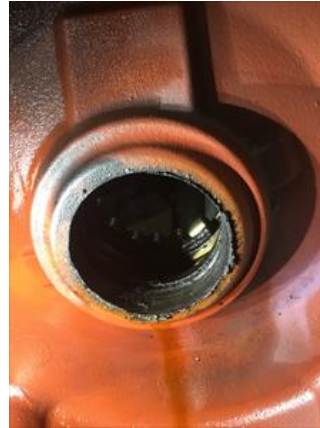
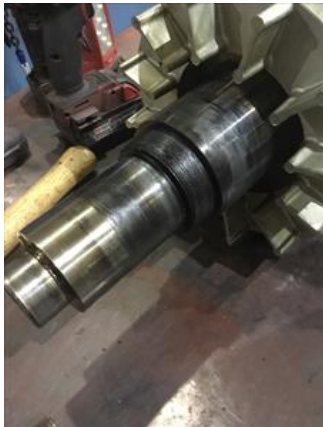
P6

D.e. Bottom center stator core damaged. D.e shoulder for seal surface spacer damaged. Sleeve needed on D.e housing.

D.e. Bearing race heated up and expanded. This caused a loose fit on the shaft allowing the race to move causing the rotor to drop onto the stator core which took out the windings. Recommend snap ring groove and retainer if repaired.
