AC Recondition As Found

Arauco-Malvern MDF (10298)

Description: 75HP SIEMENS 1800RPM 365T

Repair Stage: Teardown Inspection

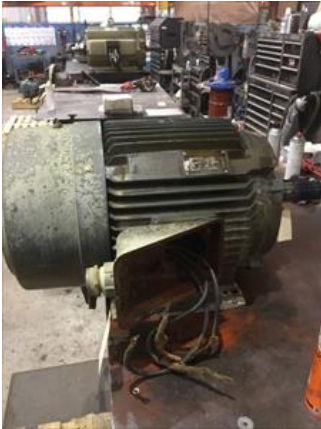
P32

● 10. Lead Condition

(P) Pass

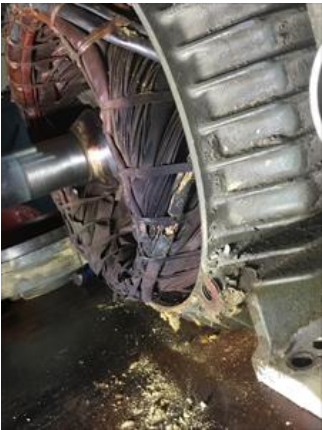
16. Winding Resistance		
1-2	1-3	2-3
17. Perform Surge Test	(F) Fail	P35

18. Stator Condition	rewind stator	
Mechanical Inspection

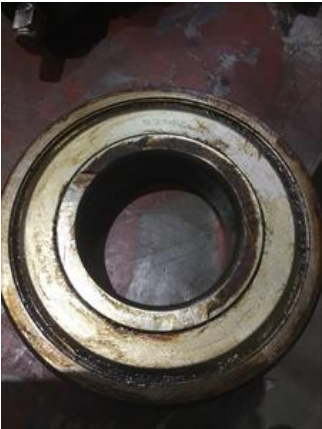
19. Drive End Bearing Number-	6314 Z	P8

20. Drive End Bearing Qty.	1	
21. Drive End Bearing Type	(Ball) Ball Bearing	
22. Drive End Lubrication Type	(Grease) Grease Lubricated	
23. Drive End Bearing Insulation or Grounding Device?	none	
24. Drive End Wavy Washer/Snap-Ring Other Retention Device?	none	
25. Drive End Bearing Condition	replace	
26. Opposite Drive End Bearing Number-	6210 NSE C3	
27. Opposite Drive End Bearing Qty.	1

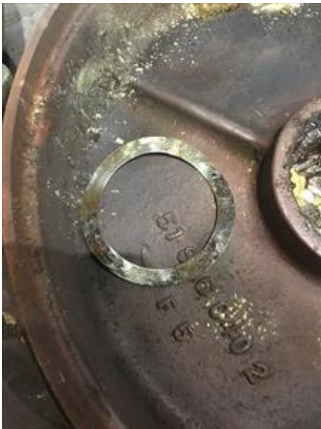
P55

32. Opposite Drive End Bearing Condition

replace

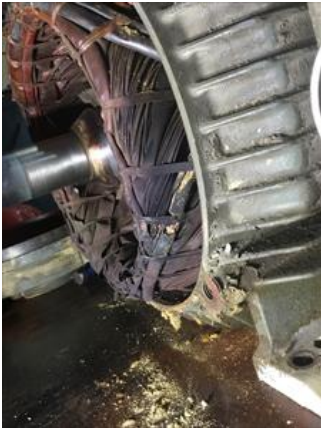
P6

58. Failure locations

Windings have blow hole on ode end of coil head
