## AC Recondition As Found

Remington (10243)

### AC Recondition - Rev. 2

Description: 1/4HP DELCO 3600RPM

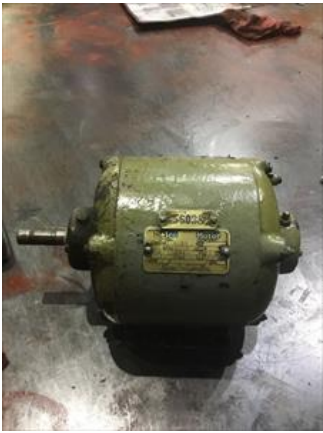
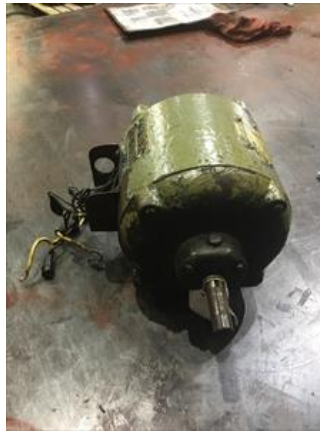
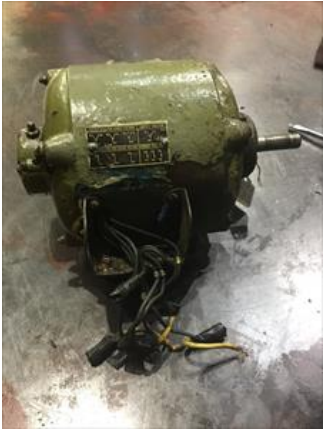
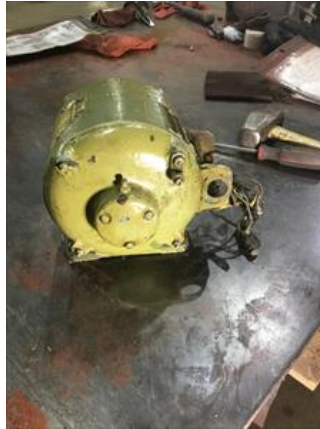
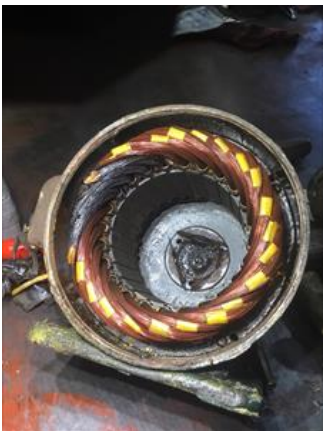
P27

4. Describe the Overall Condition of the Equipment as Received  
*Serviceable*

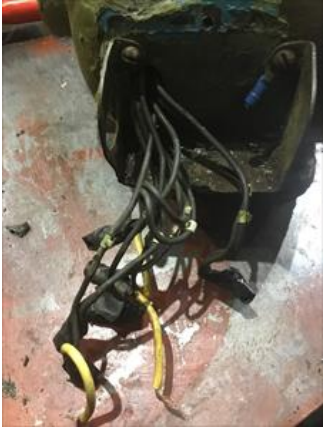
10.	Lead Condition	(P) Pass	P32

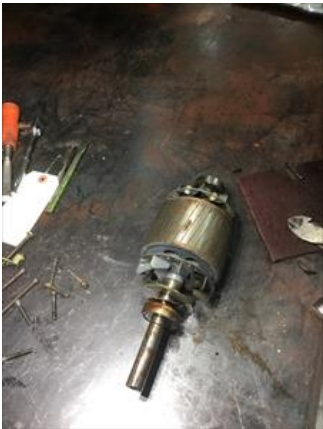
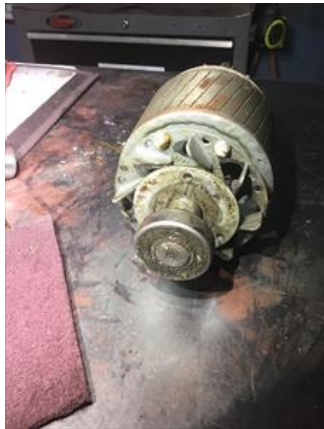
11.	Lead Length	6 Inches	
12.	Frame Condition	good	
13.	Fan Condition	(P) Pass	P53

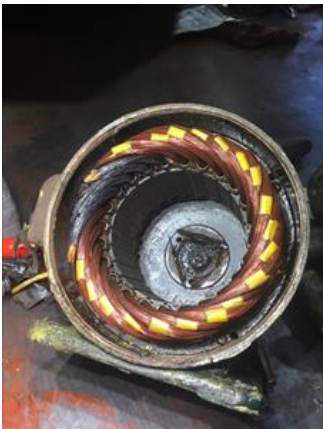
17.	Perform Surge Test	(NA) Not Applicable	P35
-----	--------------------	---------------------	-----

18. Stator Condition	rewind	
<b>Mechanical Inspection</b>		
19. Drive End Bearing Number-	6203	P8

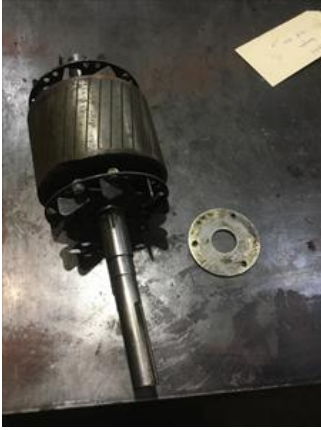
27. Opposite Drive End Bearing Qty.	1	
28. Opposite Drive End Bearing Type	(Ball) Ball Bearing	
29. Opposite Drive End Lubrication Type	(Grease) Grease Lubricated	
30. Opposite Drive End Bearing Insulation or Grounding Device?	none	
31. Opposite Drive End Wavy Washer/Snap-Ring Other Retention Device?	none	
32. Opposite Drive End Bearing Condition	replace	
33. Drive End Seal		
34. Opposite Drive End Seal		
<b>Rotor Inspection</b>

*Rewind/machine D.E. Housing fit. Replace 2 ea. 6203 bearings.*

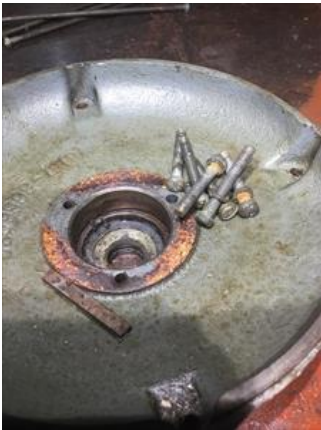
P2

50. Drive End - Endbell Bearing Fit

**Pitted**

*D.E. Housing fit pitted*

*Windings single phased. D.e housing fit needs repair.*

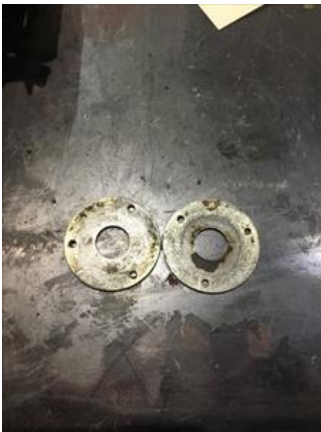
P30

54. Bearing Cap Condition

**pass**
