## AC Recondition As Found

Remington (10243)

### AC Recondition - Rev. 2

Description: 1/4HP DELCO 3600RPM

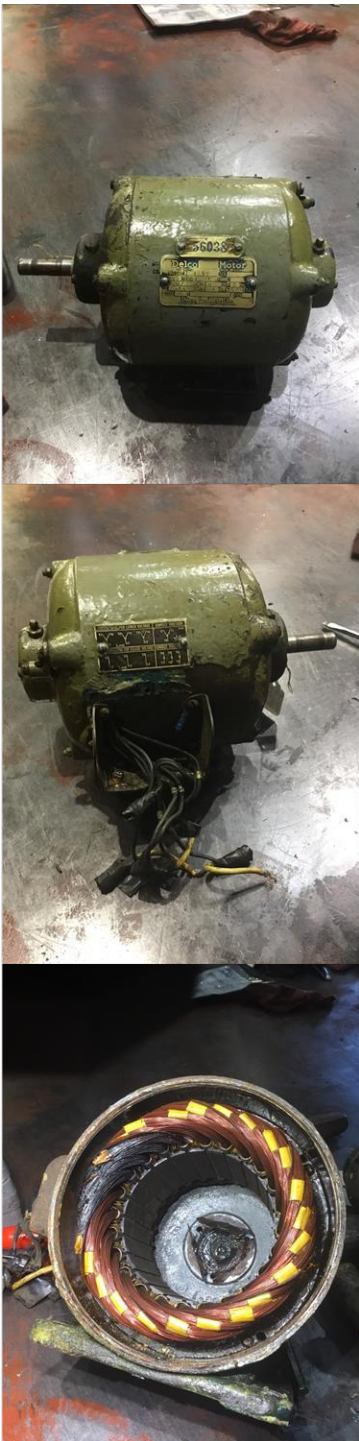
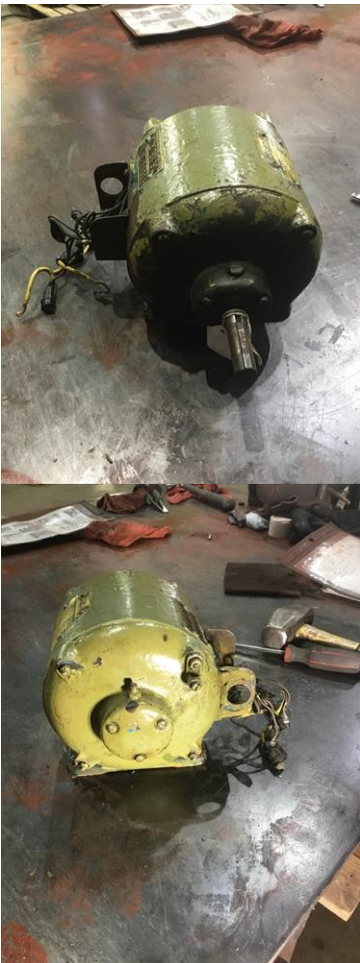
3. Photos of all six sides of the machine.

4. Describe the Overall Condition of the Equipment as Received		
Serviceable		
Initial Mechanical/Electrical		<input type="checkbox"/>
● 5. Does Shaft Turn Freely?		(Yes) Yes
6. Does Shaft Have Visible Damage?		(No) No
7. Assembled Shaft Runout		Inches
8. Assembled Shaft End Play		
9. Air Gap Variation <10%

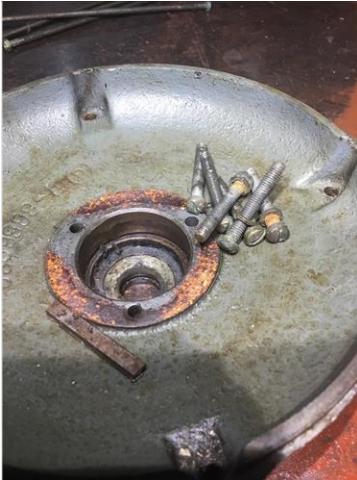
## 50. Drive End - Endbell Bearing Fit

**Pitted**

***D.E. Housing fit pitted***

*Windings single phased. D.e housing fit needs repair.*

*Rewind/machine D.E. Housing fit. Replace 2 ea. 6203 bearings.*

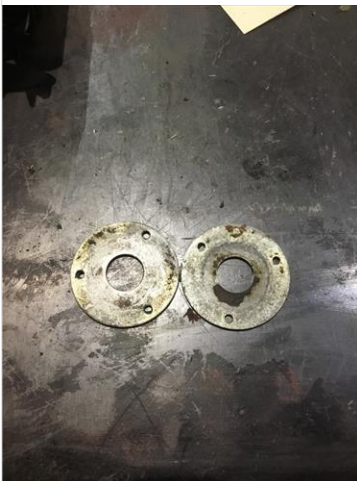
## 54. Bearing Cap Condition

**pass****pass**
