AC Recondition As Found

Union Pacific-Vine St 10945

Description: 50HP SIEMENS 3600RPM 326TS

Hi-Speed Job Number: 100431

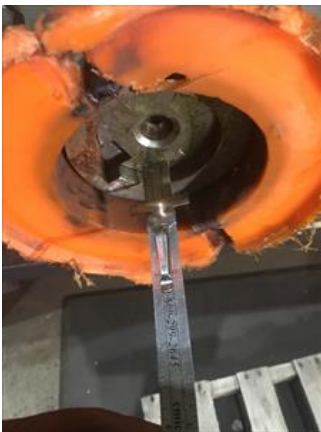
P40

5. Distance from the end of the shaft to the Coupling/Sheave **0.375 inches**

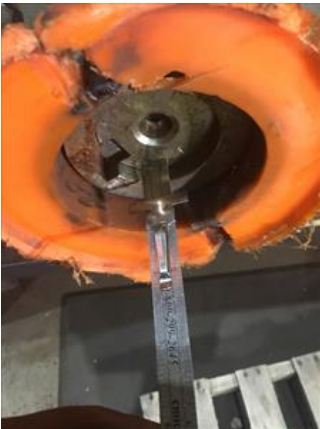
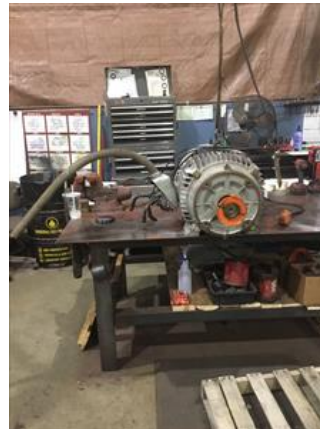
P58

15. Broken or Missing Components

D.E. coupling

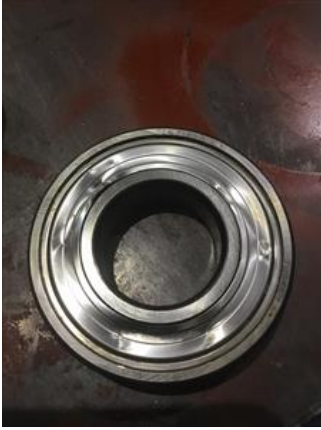
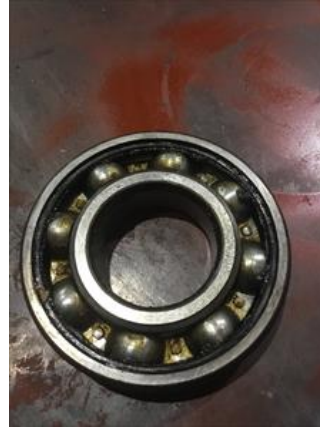
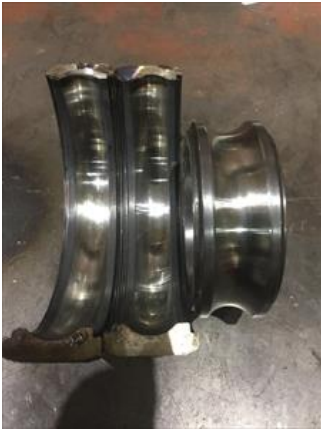
P8

20. Drive End Bearing Number-

6312

26. Drive End Bearing Condition

replace

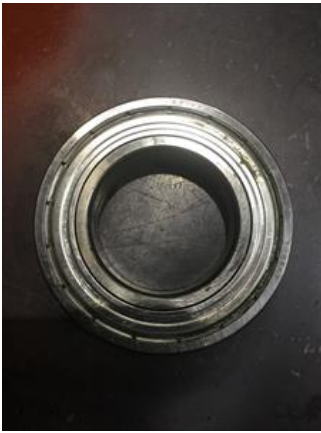
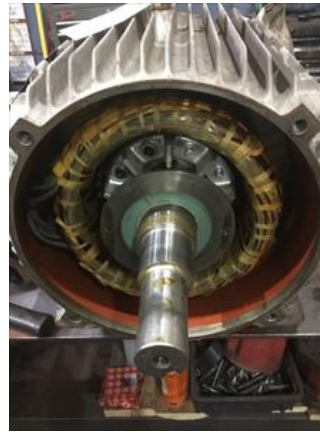
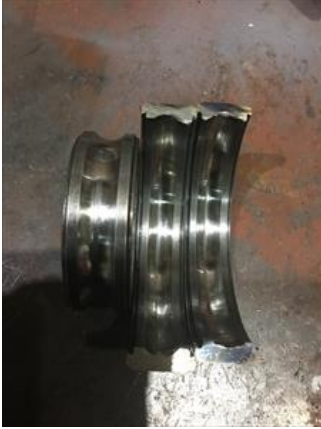
P47

27. Opposite Drive End Bearing Number-

6210

33.	Opposite Drive End Bearing Condition	replace	
34.	Drive End Seal	lip seal	
35.	Opposite Drive End Seal	none	
Rotor Inspection

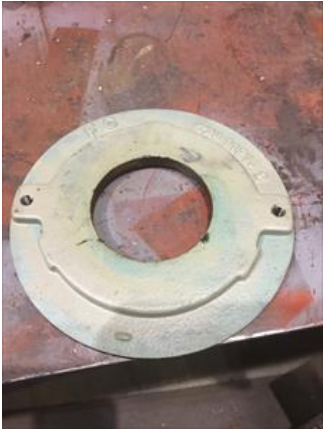
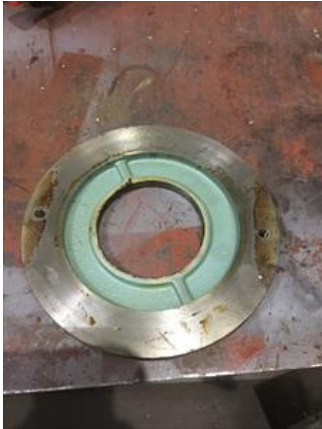
51.	Drive End - Endbell Bearing Fit		
	0 Degrees	60 Degrees	120 Degrees
	5.1194	5.1196	
	Max allowed is 5.1191		
52.	Drive End - Endbell Bearing Fit Condition		(F) Fail
53.	Opposite Drive End - Endbell Bearing Fit		
	0 Degrees	60 Degrees	120 Degrees
	3.5445	3.5444	3.5444
	Max allowed is 3.5442		
54.	Opposite Drive End - Endbell Bearing Fit Condition		(F) Fail
55.	Bearing Cap Condition		P30
	Drive End Bearing Cap	Opposite Drive End Bearing Cap	
	pass		
<div style="display: flex; justify-content: space-around;">

Root Cause of Failure			
59.	Failure locations		
	Housing fits		
60.	Root cause of failure		
	Excessive wear

</div>			
56.	End Bell Air Seal Fits		
	Drive End Air Seal	Opposite Drive End Air Seal	
57.	List Machine Work Needed Below		
	Re-sleeve both end bell housing fits.		
58.	Technician		Terrence Holland
