AC Recondition As Found

Union Pacific-Vine St 10945

AC Recondition - Rev. 2

Description: 50HP SIEMENS 3600RPM 326TS

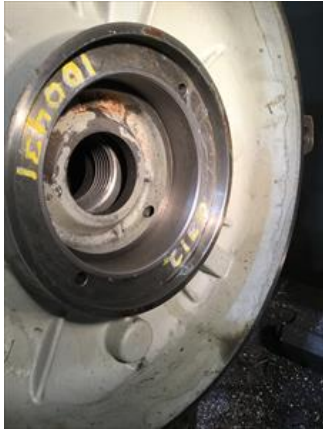
51.	Drive End - Endbell Bearing Fit		
	0 Degrees	60 Degrees	120 Degrees
	5.1194	5.1196	
	Max allowed is 5.1191		
52.	Drive End - Endbell Bearing Fit Condition		(F) Fail
53.	Opposite Drive End - Endbell Bearing Fit		
	0 Degrees	60 Degrees	120 Degrees
	3.5445	3.5444	3.5444
	Max allowed is 3.5442		
54.	Opposite Drive End - Endbell Bearing Fit Condition		(F) Fail
55.	Bearing Cap Condition		
	Drive End Bearing Cap	Opposite Drive End Bearing Cap	
	pass		
<div style="display: flex; justify-content: space-around;">     </div>			
56.	End Bell Air Seal Fits		
	Drive End Air Seal	Opposite Drive End Air Seal	
57.	List Machine Work Needed Below		
	Re-sleeve both end bell housing fits.		
58.	Technician		Terrence Holland

81.	Technician		
82.	Technician		
Root Cause of Failure			
83.	Failure locations		
	<i>Housing fits</i>		
84.	Root cause of failure		
	<i>Excessive wear</i>		
Mechanical Fits- Rotor - Post Repair

101.	Drive End - Endbell Bearing Fit Post Repair			P0
	0 Degrees	60 Degrees	120 Degrees	
	5.1185	5.1186	5.1186
