## AC Recondition As Found

Arkansas Electric Coop. (11681)

### AC Recondition - Rev. 2

Description: 7.5HP AMETEK BLOWER 3600RPM  
215TCZ  
AMETEK PART 511570

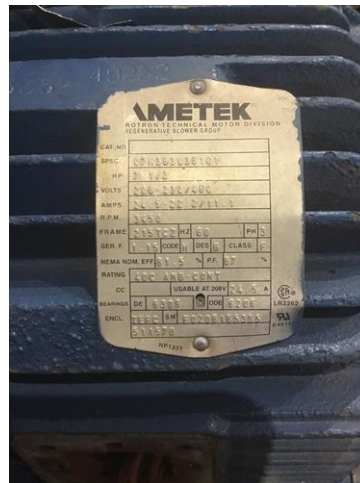
1. Report Date
2. Nameplate Picture

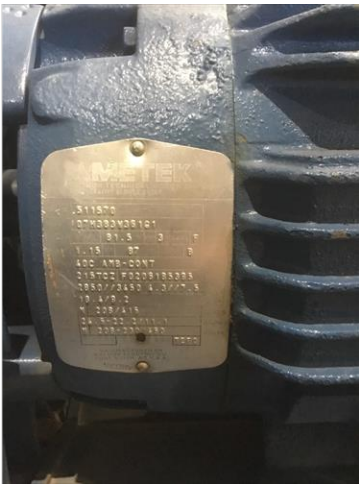
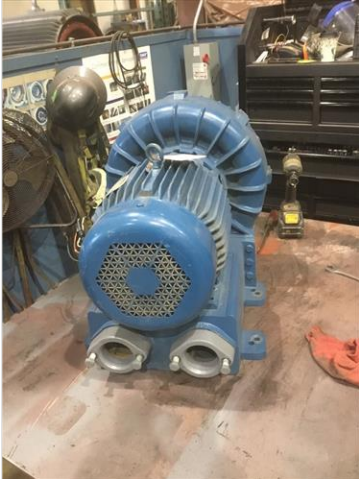
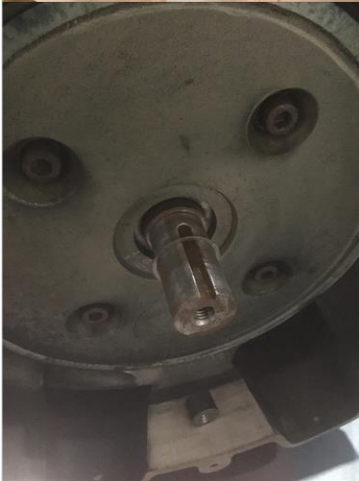
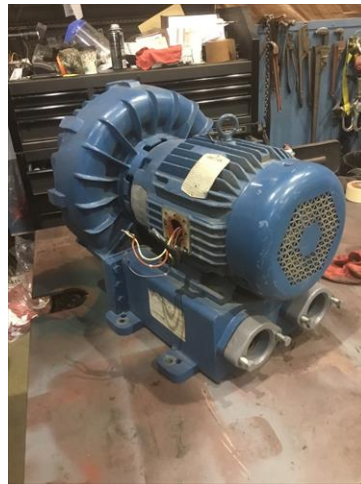
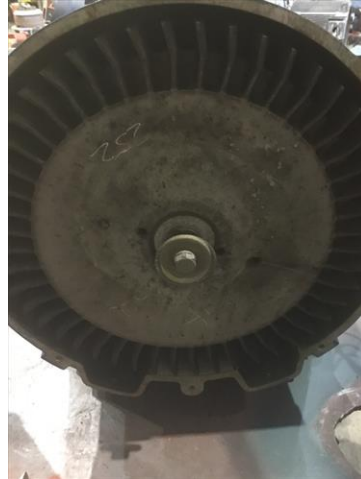
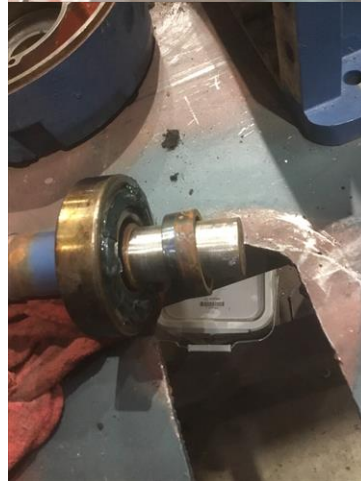
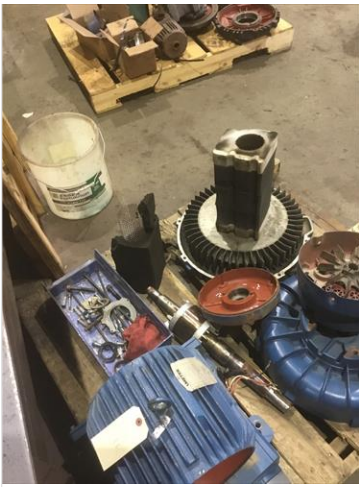
3.	Photos of all six sides of the machine.		
4.	Describe the Overall Condition of the Equipment as Received		
5.	Distance from the end of the shaft to the Coupling/Sheave		
<b>Initial Mechanical/Electrical</b>

Needs 1 filter

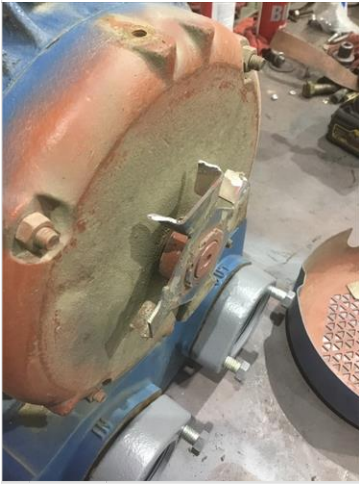
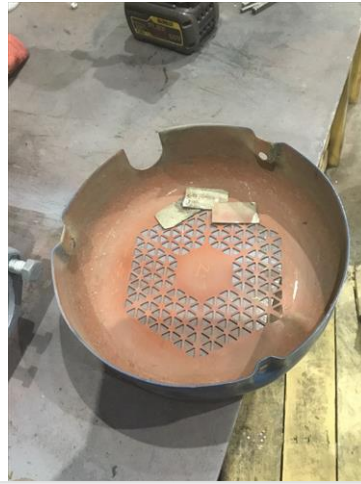
14. Fan Condition

(F) Fail

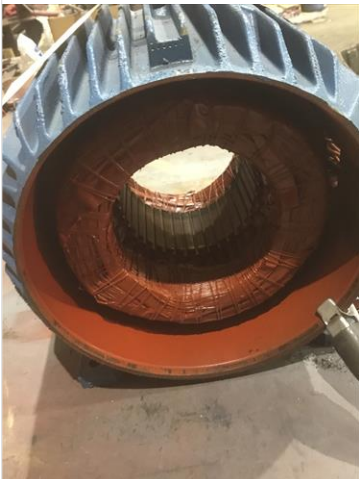
18. Perform Surge Test

(F) Fail

20. Stator Condition

Rewind

70.	Post Rewind Hi-Pot		
71.	Technician		
<b>Root Cause of Failure</b>			
72.	Failure locations		
73.	Root cause of failure		
	<i>Turn to turn short</i>		
<b>Mechanical Fits- Rotor - Post Repair</b>

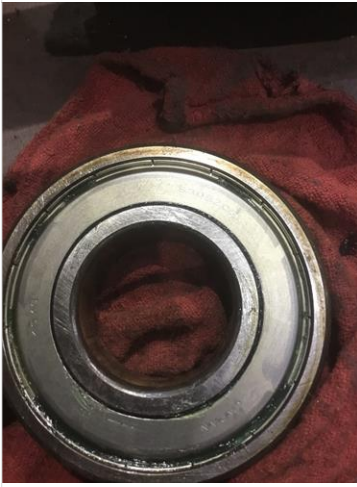
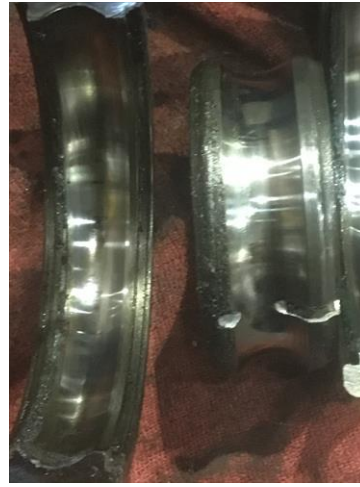
21. Drive End Bearing Number-

6309ZZ

Fatigue

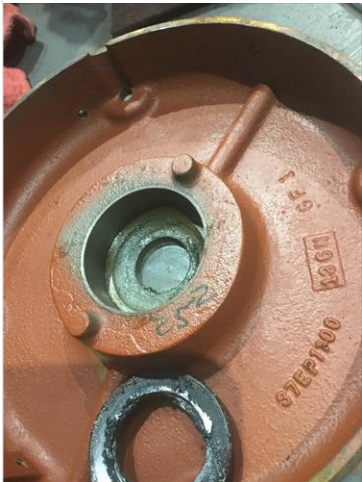
54. Opposite Drive End - Endbell Bearing Fit			P18
0 Degrees	60 Degrees	120 Degrees	
2.4404	2.4404	2.4404	
<div> <div></div> <div>.0005 undersized</div> </div>

55. Opposite Drive End - Endbell Bearing Fit Condition			(F) Fail
<div> <div></div> <div>.0005 undersized</div> </div>			
56. Bearing Cap Condition			P30
Drive End Bearing Cap	Opposite Drive End Bearing Cap		
pass	na

57. End Bell Air Seal Fits			
Drive End Air Seal	Opposite Drive End Air Seal		
58. List Machine Work Needed Below			
Ode end bell housing fit undersized			
59. Technician			RW
