**AC Recondition As Found**  
**Baptist Health Medical Center**  
P.O. Box 8516  
Little Rock, AR 72215

**AC Recondition - Rev. 2**

Description: 50HP BALDOR 1800RPM 326T

Repair Stage: Teardown Inspection

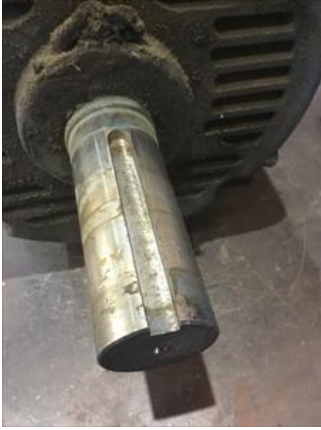
P12

6. Does Shaft Have Visible Damage?

(No) No

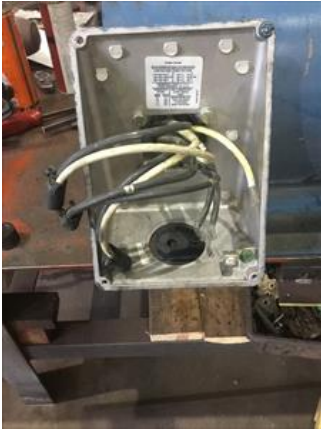
P32

10. Lead Condition

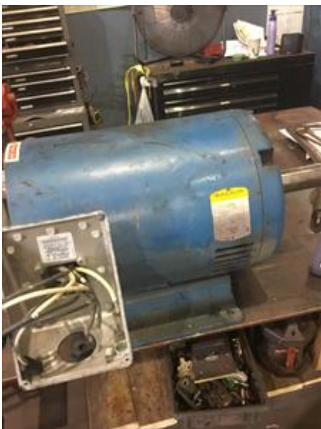
P51

12. Frame Condition

pass

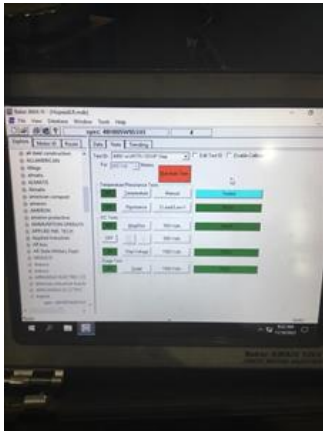
P35

## 17. Perform Surge Test

(P) Pass

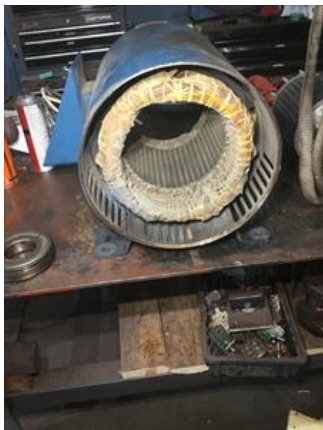
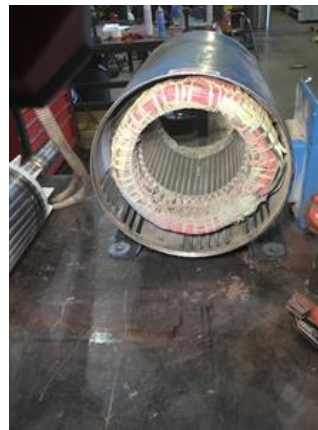
P39

## 18. Stator Condition

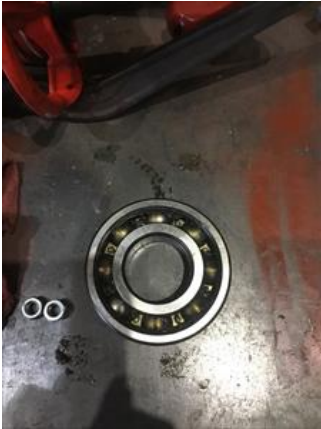
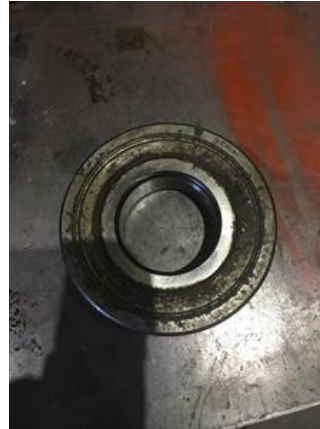
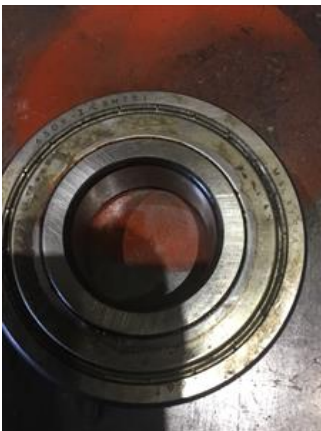
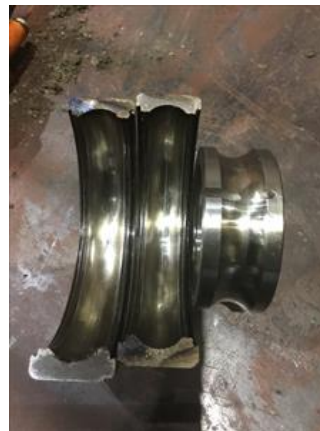
23.	Drive End Bearing Insulation or Grounding Device?	<b>none</b>	
24.	Drive End Wavy Washer/Snap-Ring Other Retention Device?	<b>none</b>	
25.	Drive End Bearing Condition	<b>replace</b>	
26.	Opposite Drive End Bearing Number-	<b>6309</b>	
27.	Opposite Drive End Bearing Qty.	<b>1</b>	<b>P47</b>

51.	Drive End - Endbell Bearing Fit Condition		<b>(F) Fail</b>
52.	Opposite Drive End - Endbell Bearing Fit		
	0 Degrees	60 Degrees	120 Degrees
	<b>3.9379</b>	<b>3.9378</b>	<b>3.9378</b>

58.	Failure locations <i>D.E. Housing fit out of tolerance. Replace both end bell baffles.</i>		
59.	Root cause of failure

36. Growler Test	(Pass) Pass
37. Number of Rotor Bars	
38. Rotor Condition	pass
39. List the Parts needed for the Repair Below	
Replace both bearings and both end bell baffles. D.E housing fit bad.	
40. Signature of Technician that Disassembled Motor	Terrence Holland

55.	End Bell Air Seal Fits		
	Drive End Air Seal	Opposite Drive End Air Seal	
56.	List Machine Work Needed Below <i>Sleeve D.E. Housing fit.</i>		
57.	Technician		<b>Terrence Holland</b>
