## AC Recondition As Found

### FUTURE FUEL CHEMICAL

#### AC Recondition - Rev. 2

**Location:** Shop  
**Serial Number:** 7291013-001 -AK T1  
**Description:** 15/7.5HP RELIANCE 1800/900RPM  
X0286TDZ

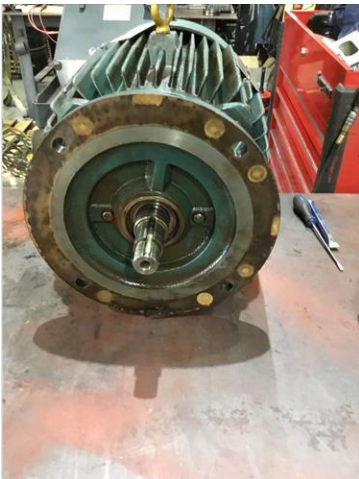
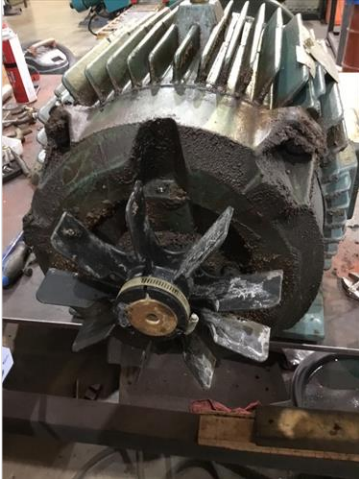
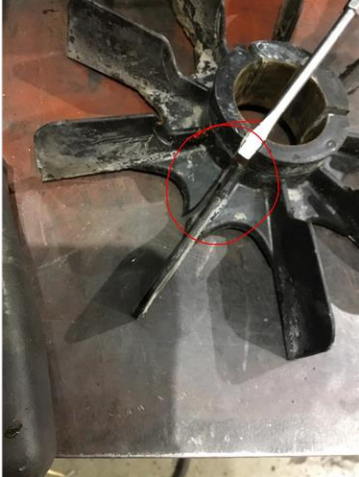
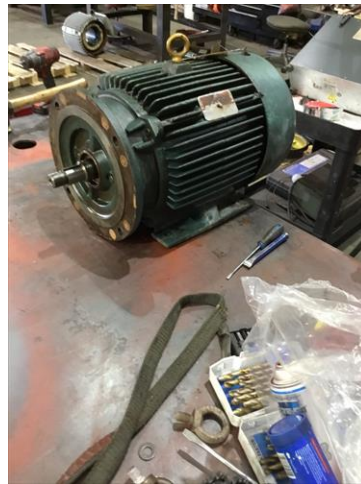
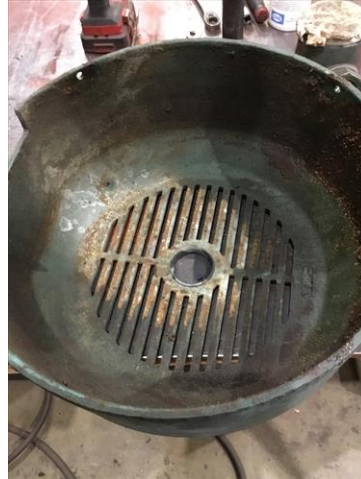
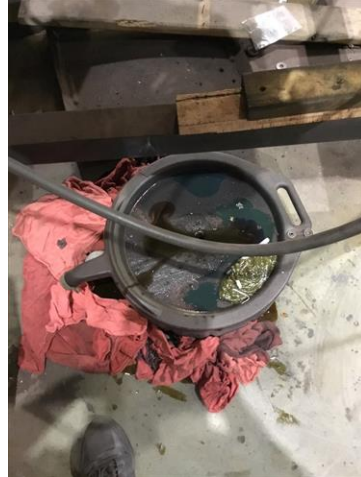
3. Photos of all six sides of the machine.
4. Describe the Overall Condition of the Equipment as Received

*Filthy*

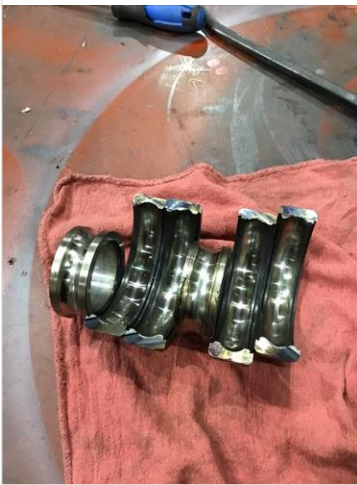
21. Drive End Bearing Qty.	1
22. Drive End Bearing Type	(Ball) Ball Bearing
23. Drive End Lubrication Type	(Grease) Grease Lubricated
24. Drive End Bearing Insulation or Grounding Device?	no
25. Drive End Wavy Washer/Snap-Ring Other Retention Device?	no
26. Drive End Bearing Condition	minor frosting and false brinelling
27. Opposite Drive End Bearing Number-	6310
28. Opposite Drive End Bearing Qty.	1
29. Opposite Drive End Bearing Type	(Ball) Ball Bearing
30. Opposite Drive End Lubrication Type	(Grease) Grease Lubricated
31. Opposite Drive End Bearing Insulation or Grounding Device?	no
32. Opposite Drive End Wavy Washer/Snap-Ring Other Retention Device?	wavy
33. Opposite Drive End Bearing Condition	good
34. Drive End Seal	none
35. Opposite Drive End Seal	none
