### AC Recondition As Found

Sage V Foods  
5901 SLOAN DRIVE  
LITTLE ROCK, AR 72206

#### AC Recondition - Rev. 2

Location: MOTOR SHOP LR  
Serial Number: NO NP  
Description: 2.5HP BALDOR 1200RPM 213Z SHAKER

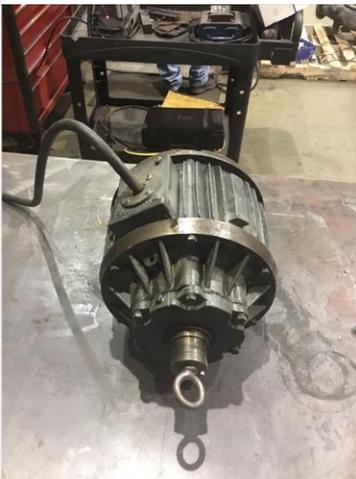
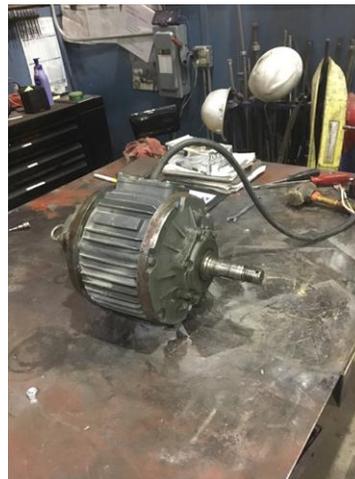
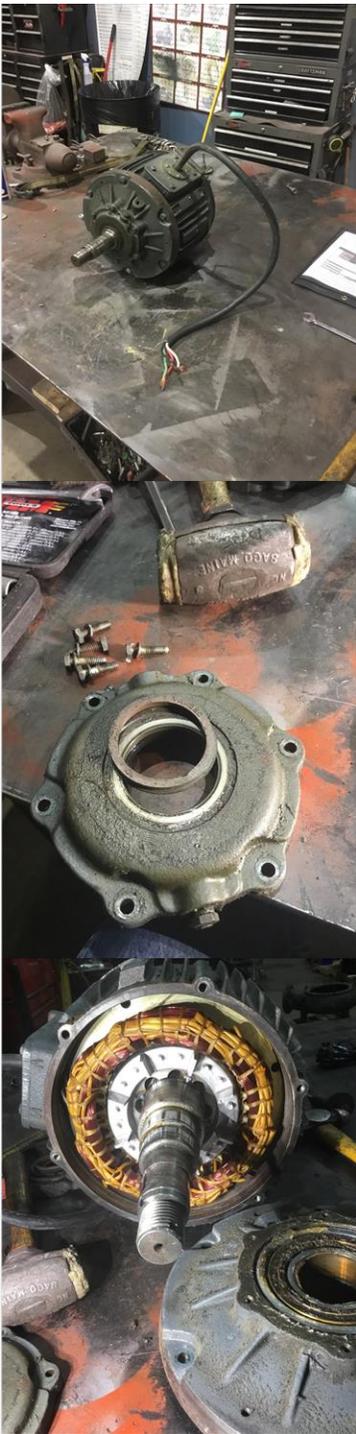
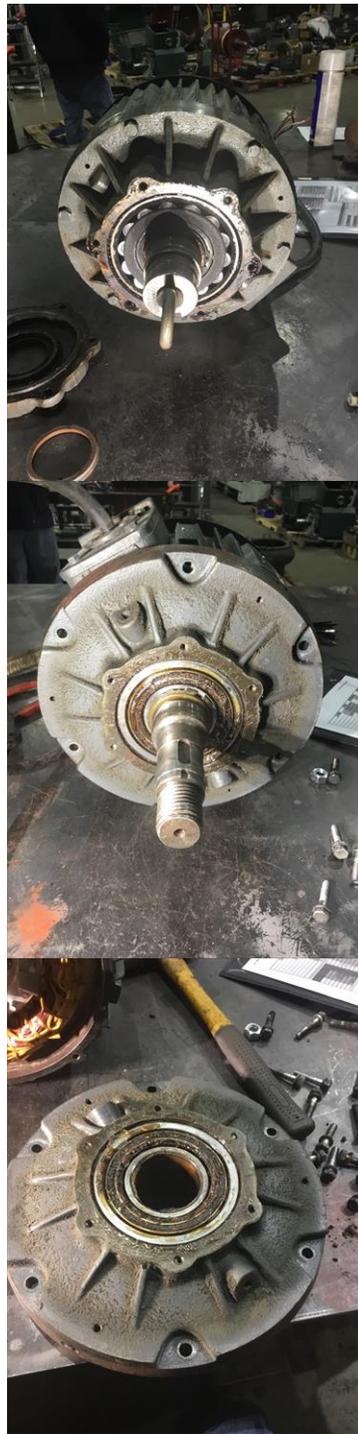
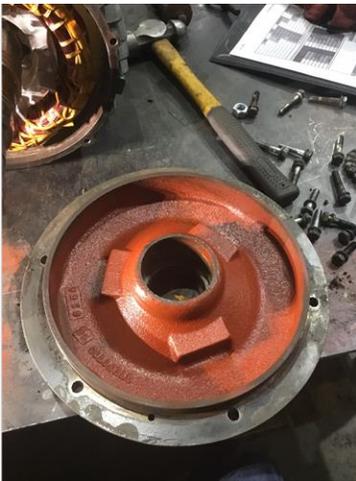
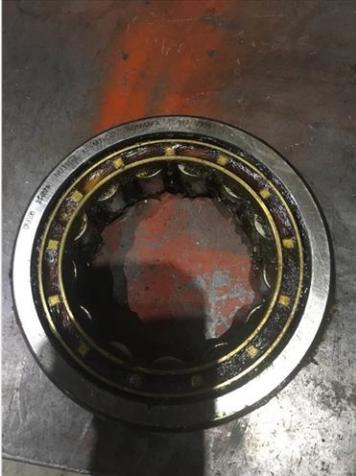
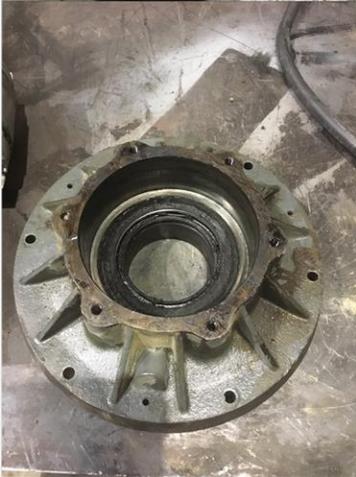
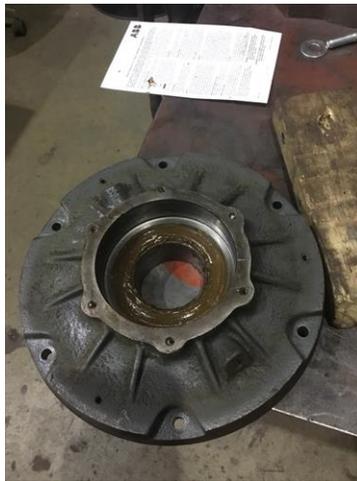
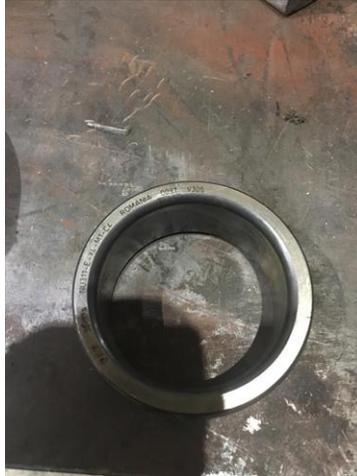
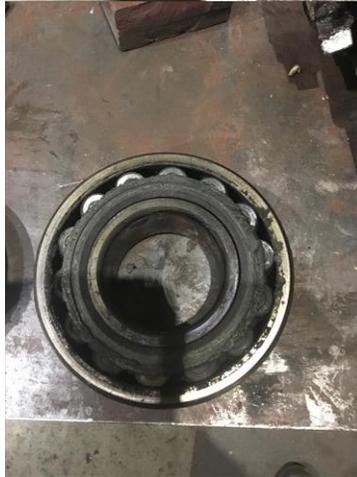
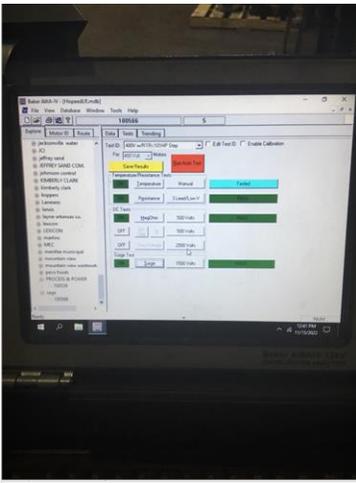
3. Photos of all six sides of the machine.

4. Describe the Overall Condition of the Equipment as Received  
*Serviceable*

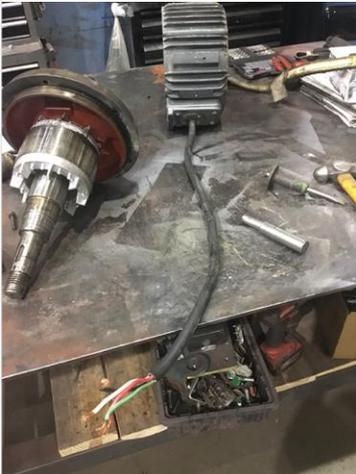
- 6. Does Shaft Turn Freely? **(Yes) Yes**
- 7. Does Shaft Have Visible Damage? **(No) No**
- 8. Assembled Shaft Runout
- 9. Assembled Shaft End Play
- 10. Air Gap Variation <10%
- 11. Lead Condition **(P) Pass** P32

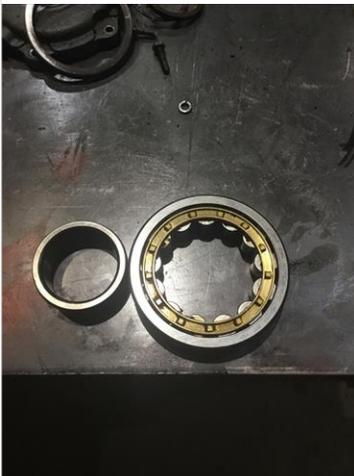
21. Drive End Bearing Number-

nu 311-E-XL-M1-C4

replace

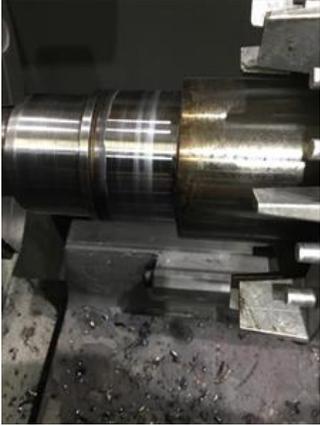
78. Drive End Bearing Shaft Fit Post Repair

0 Degrees	60 Degrees	120 Degrees
2.165	2.165	2.165

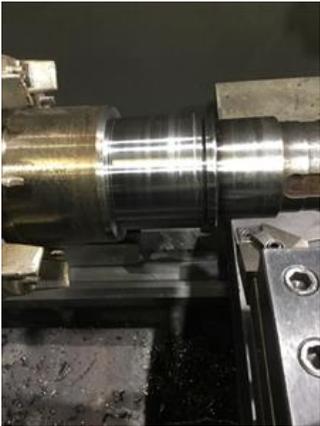
79. Opposite Drive End Bearing Shaft Fit Post Repair

0 Degrees	60 Degrees	120 Degrees
2.559	2.559	2.559

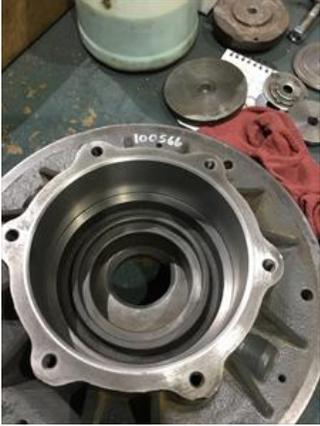
83. Opposite Drive End - Endbell Bearing Fit Post Repair

0 Degrees	60 Degrees	120 Degrees
5.5117	5.5117	5.5118
