AC Recondition As Found
US MOTORS WARRANTY REPAIR
8100 W. FLORISSENT
ST. LOUIS, MO 63136

AC Recondition - Rev. 2

Location: LR MOTOR SHOP
Serial Number: D 04 7796198-0009 R 0001
Description: 250HP US MOTORS VERTICAL
1800RPM H445TPA

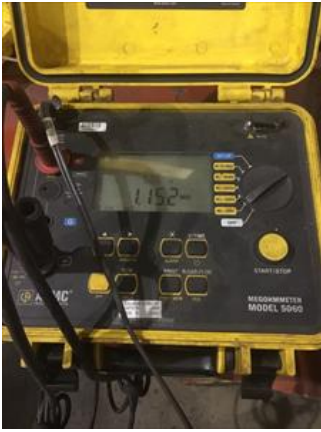
19. Stator Condition

stator windings blown

| <i>Replace rotor, and rewind stator with minor core repair.</i> |

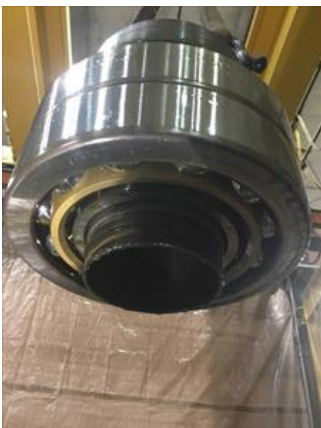
23.	Drive End Lubrication Type	(Oil) Oil Lubricated	
24.	Drive End Bearing Insulation or Grounding Device?	none	
25.	Drive End Wavy Washer/Snap-Ring Other Retention Device?	none	
26.	Drive End Bearing Condition	replace both	
27.	Opposite Drive End Bearing Number-	6215	P47

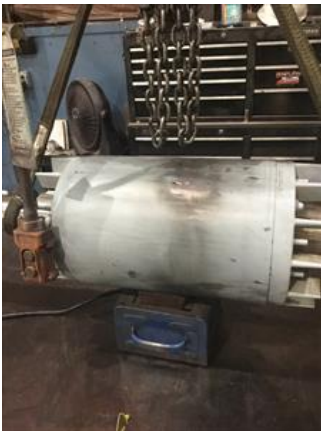
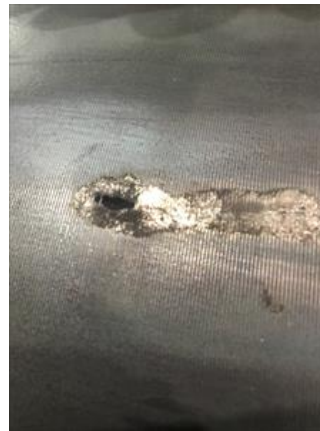
| 39. Rotor Condition | blow hole in laminations |

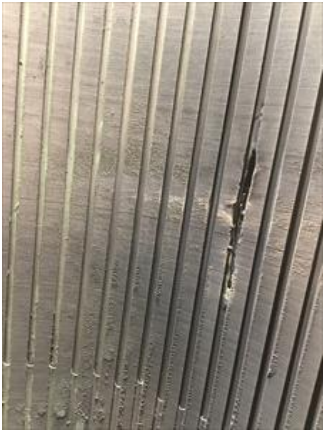
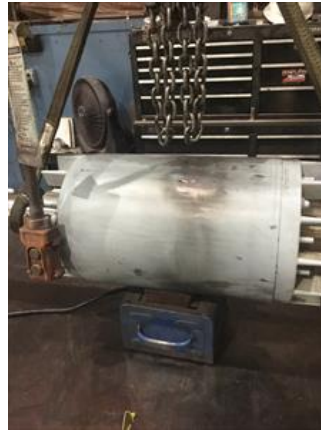
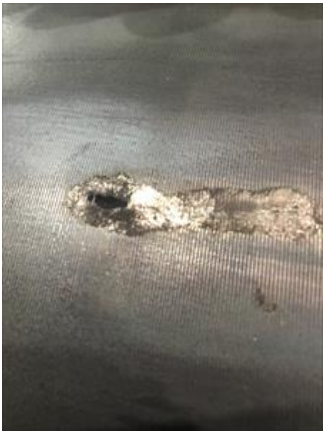
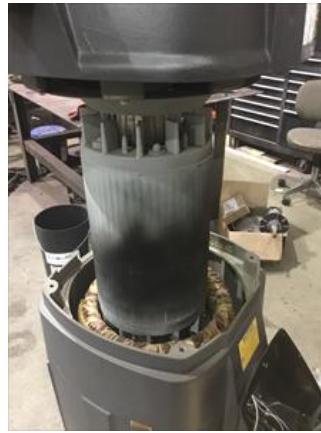
59. Failure locations

Stator core damaged. Rotor laminations have small blow hole.

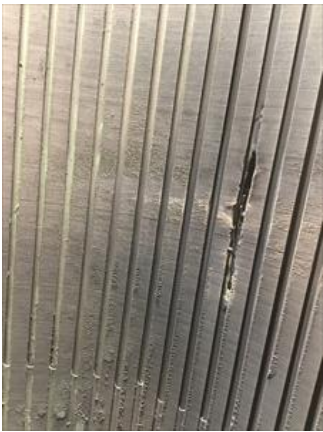
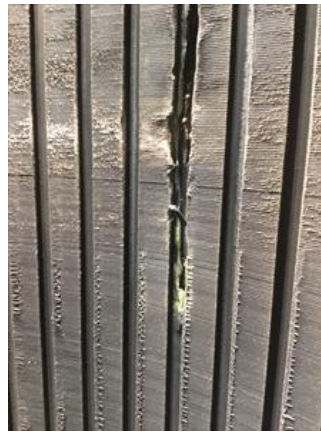
60. Root cause of failure

Windings shorted in slot.
