AC Recondition As Found
Ring Container Technologies (11634)
9000 Frazier Pike
Little Rock, AR 72206

AC Recondition - Rev. 2

Description: 10HP SAMA BLOWER 3600RPM
132S

Repair Stage: Teardown Inspection

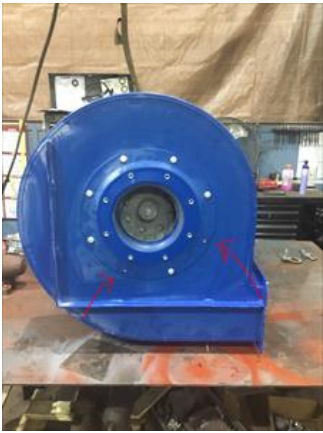
15. Broken or Missing Components

2 ea bolts missing

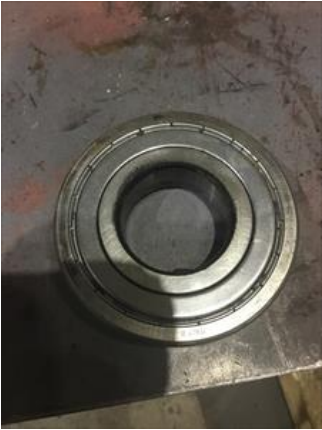
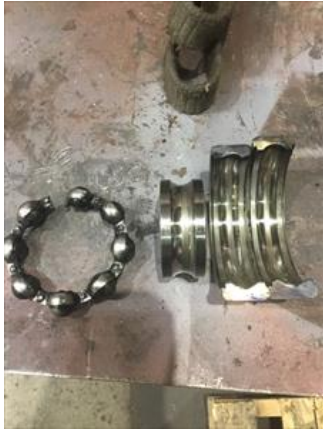
27.	Drive End Bearing Condition	replace	
28.	Opposite Drive End Bearing Number-	6308 2Z/C3	P48

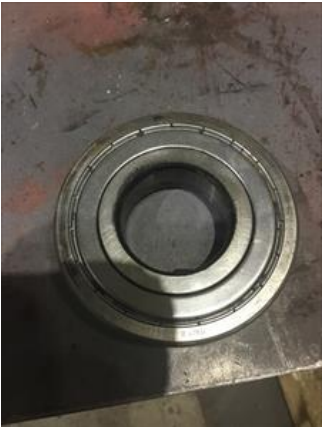
29.	Opposite Drive End Bearing Qty.	1	
30.	Opposite Drive End Bearing Type	(Ball) Ball Bearing	
31.	Opposite Drive End Lubrication Type	(Grease) Grease Lubricated	
32.	Opposite Drive End Bearing Insulation or Grounding Device?	none	
33.	Opposite Drive End Wavy Washer/Snap-Ring Other Retention Device?	none	
34.	Opposite Drive End Bearing Condition	replace	P58

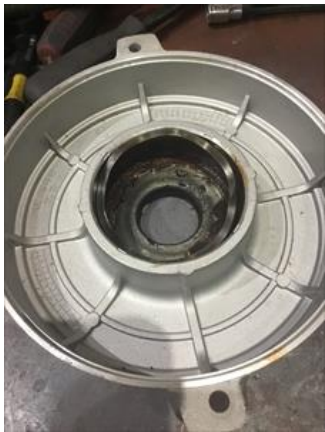
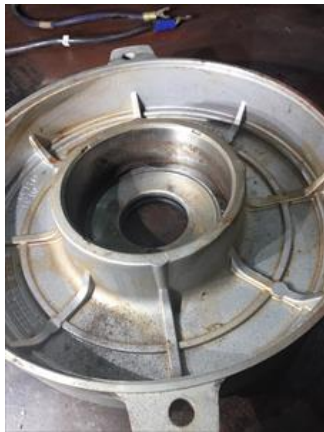
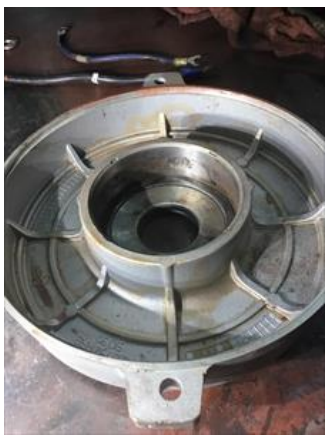
1.5747**1.5748****1.5747**● 50. Opposite Drive End Bearing Shaft Fit Condition **(F) Fail**

*308 sleeve for D.E. housing. Repair ODE shaft bearing journal. 2 ea lip seals for DE and ODE housings.
40*55*7*

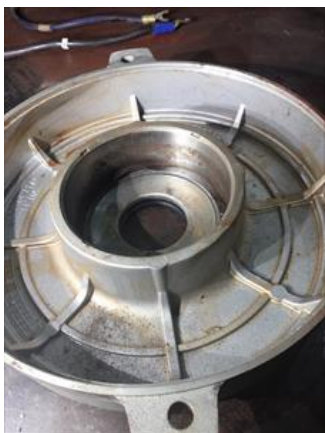
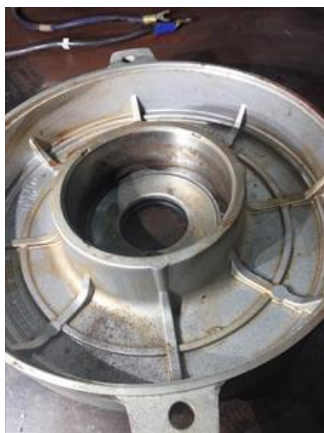
53. Drive End - Endbell Bearing Fit Condition

(F) Fail

Pitted

Root Cause of Failure		
60. Failure locations	<i>DE housing fit. ODE shaft bearing journal worn.</i>	
61. Root cause of failure

41. List the Parts needed for the Repair Below

56. Bearing Cap Condition	Drive End Bearing Cap	Opposite Drive End Bearing Cap
57. End Bell Air Seal Fits	Drive End Air Seal	Opposite Drive End Air Seal
58. List Machine Work Needed Below	<i>Sleeve D.E. housing fit. ODE shaft bearing journal worn.</i>	
59. Technician	<div style="text-align: right;">Terrence. Holland</div>
