AC Recondition As Found

3M-Main Plant (10001)

AC Recondition - Rev. 2

Description: 100HP GE 1800RPM 405T

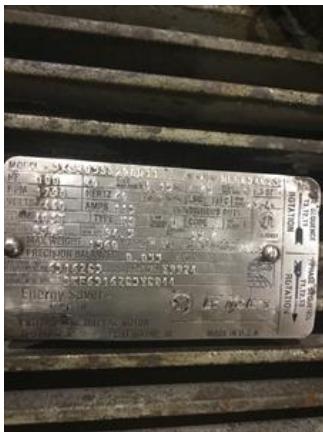
P20

2. Nameplate Picture

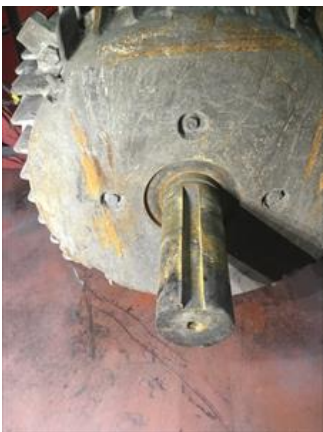
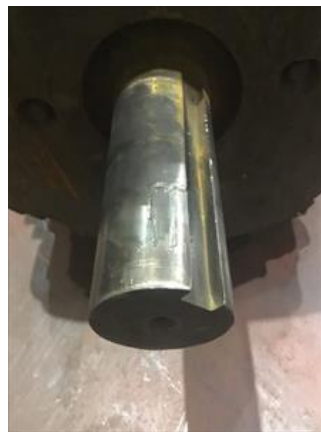
P11

5. Does Shaft Turn Freely? (No) No
6. Does Shaft Have Visible Damage? (Yes) Yes

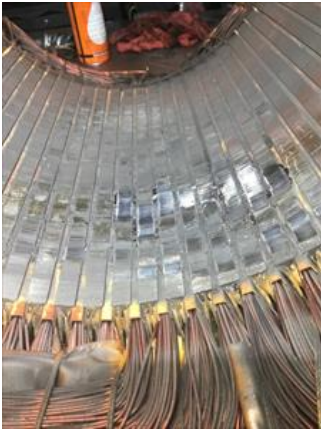
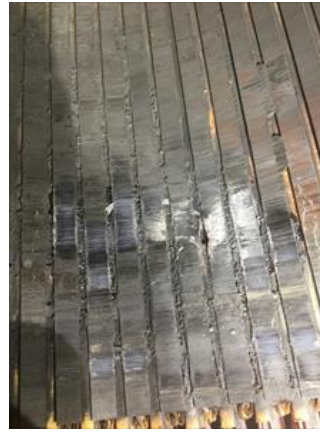
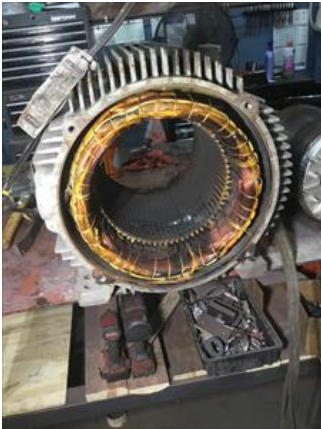
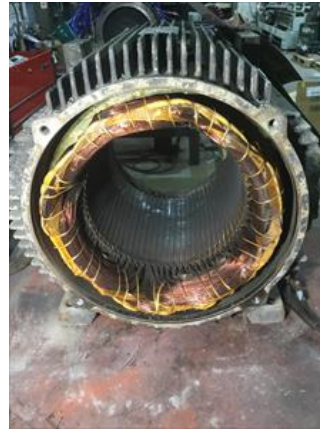
| 15. Insulation Resistance/Megger | 0.01 Megohms |
| 17. Perform Surge Test | (F) Fail |

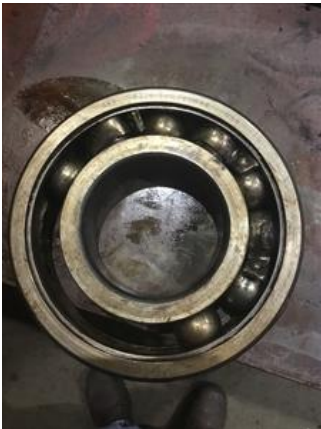
P8

20. Drive End Bearing Number-

6316

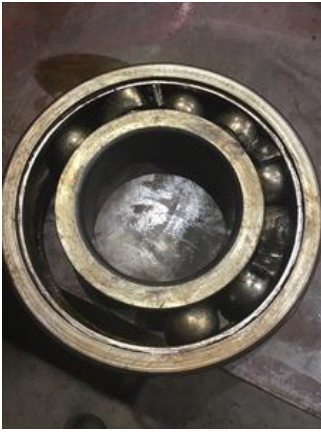
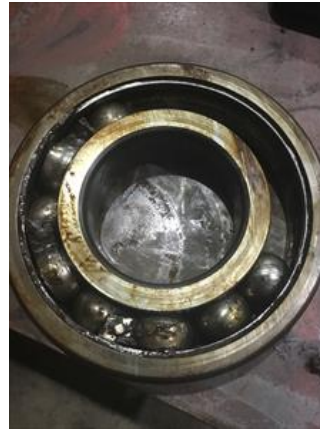
P42

26. Drive End Bearing Condition

cage destroyed

Coil to coil short between slots caused by D.E bearing cage failure. Bearing grease was hardened and contaminated.

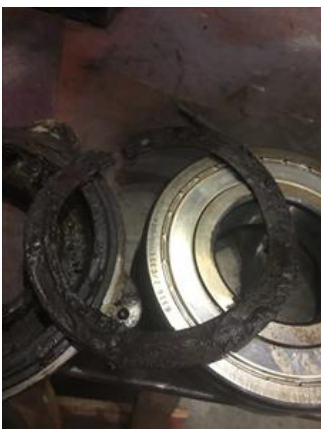
P56

33. Opposite Drive End Bearing Condition

replace

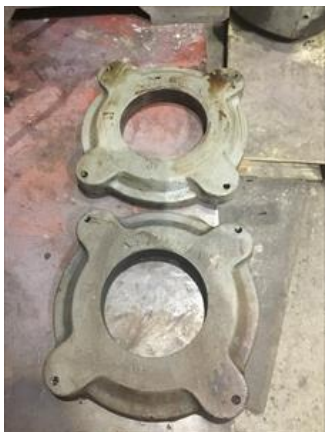
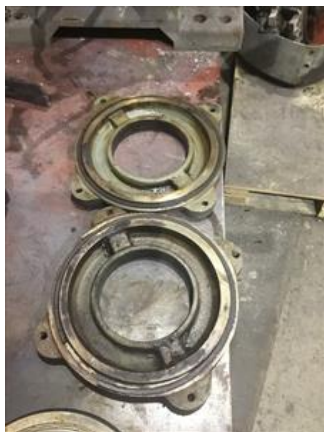
51.	Drive End - Endbell Bearing Fit		
	0 Degrees	60 Degrees	120 Degrees
	<div> <div></div> Pitted </div>		
52.	Drive End - Endbell Bearing Fit Condition		(F) Fail
53.	Opposite Drive End - Endbell Bearing Fit		
	0 Degrees	60 Degrees	120 Degrees
54.	Opposite Drive End - Endbell Bearing Fit Condition		(F) Fail
	<div> <div></div> Pitted </div>		
55.	Bearing Cap Condition		P30
	Drive End Bearing Cap	Opposite Drive End Bearing Cap	
	pass	pass	
<div>

</div>			
56.	End Bell Air Seal Fits		
	Drive End Air Seal	Opposite Drive End Air Seal	
57.	List Machine Work Needed Below		
	Re-sleeve both end bell housing fits.		
58.	Technician		Terrence Holland

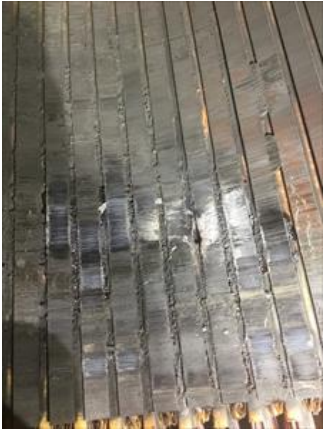
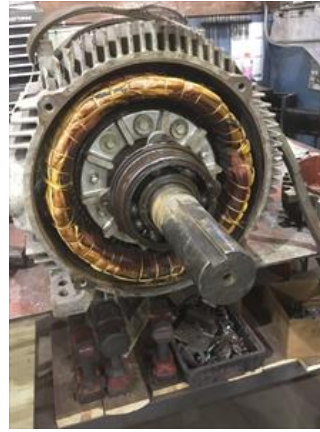
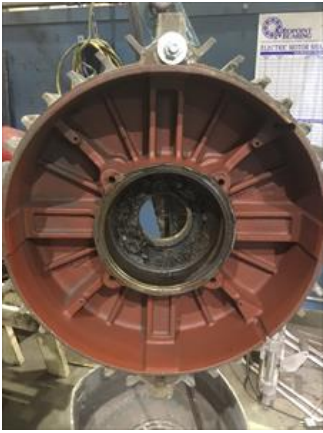
Root Cause of Failure			
59.	Failure locations		
	Bottom of stator iron between slots. Both housing fits.
