## AC Recondition As Found

Weaver-Bailey Contractors

### AC Recondition - Rev. 2

Location: MOTOR SHOP LR  
Serial Number: AUH708G705 007  
Description: 75HP TECO 1800RPM 365T

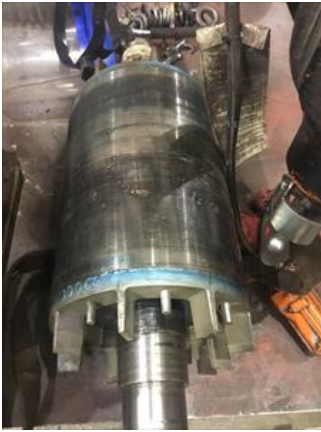
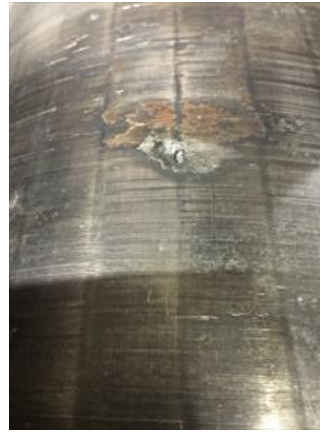
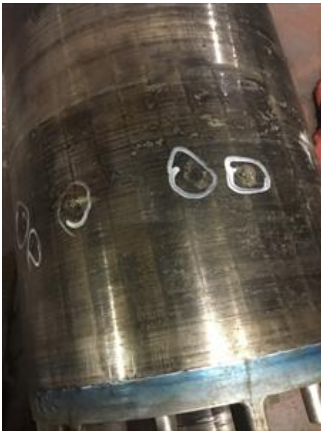
Blow hole in rotor.

**recommend replacing.**

<b>Root Cause of Failure</b>		
59.	Failure locations <i>Both housing fits bad. Rotor has multiple blow holes.</i>	
60.	Root cause of failure

*New rotor,*

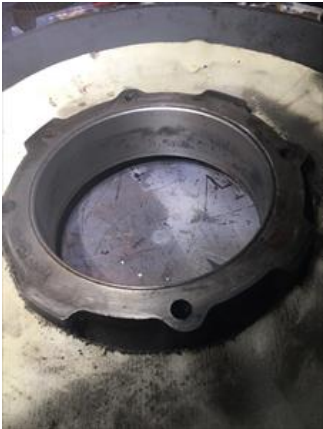
52.	Drive End - Endbell Bearing Fit Condition	<b>(F) Fail</b>	P10

<i>Pitted</i>

56.	End Bell Air Seal Fits	
	Drive End Air Seal	Opposite Drive End Air Seal
57.	List Machine Work Needed Below <i>Re-sleeve both housing fits.</i>	
58.	Technician	Terrence Holland

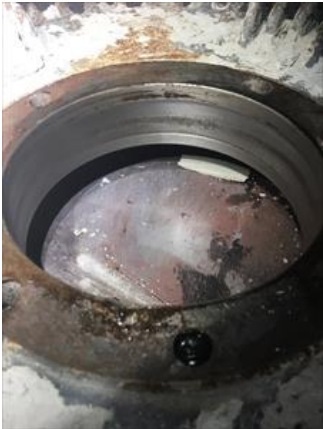
54.	Opposite Drive End - Endbell Bearing Fit Condition	<b>(F) Fail</b>	P22

<i>Groove worn in.</i>
