AC Recondition As Found

Weaver-Bailey Contractors

Location: MOTOR SHOP LR

Description: 75HP TECO 1800RPM 365T

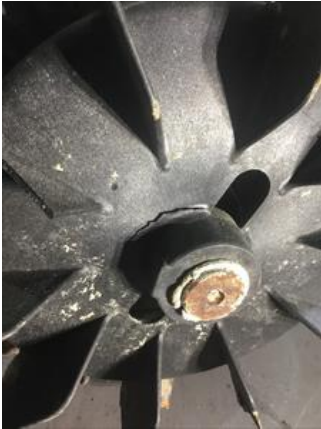
● 13. Fan Condition

(F) Fail

■ Replacement found

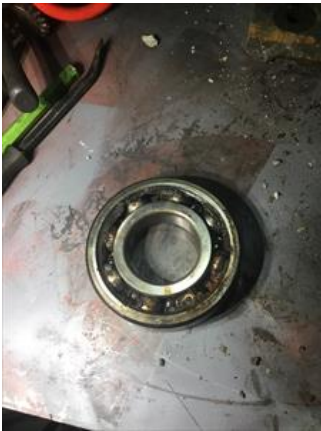
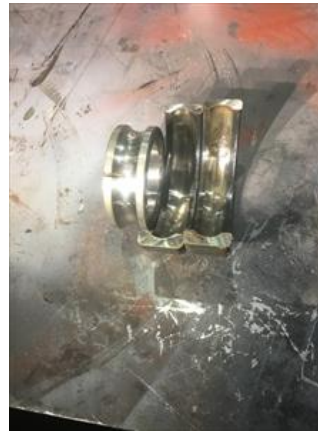
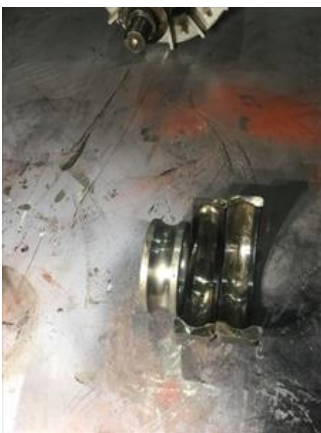
20. Drive End Bearing Number-

26. Drive End Bearing Condition

replace

Both housing fits bad. D.E. bearing has fatigue damage.
