### AC Recondition As Found

Remington (10243)

#### AC Recondition - Rev. 2

Location: MOTOR SHOP LR  
Serial Number: Z1507300199X  
Description: 15HP BALDOR 3600RPM 254TCZ

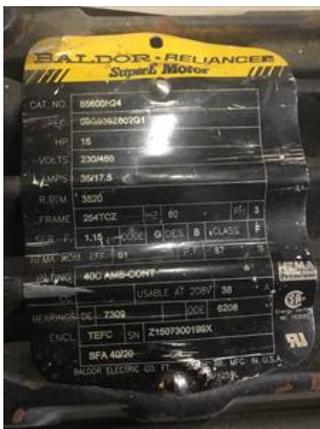
P20

1. Report Date
2. Nameplate Picture

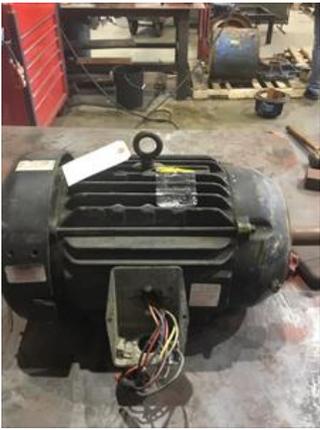
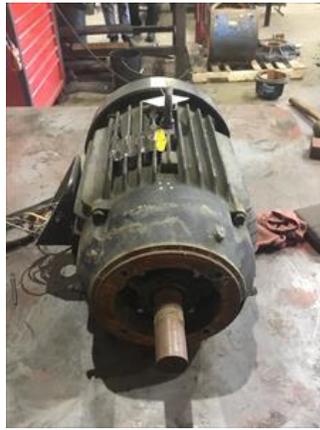
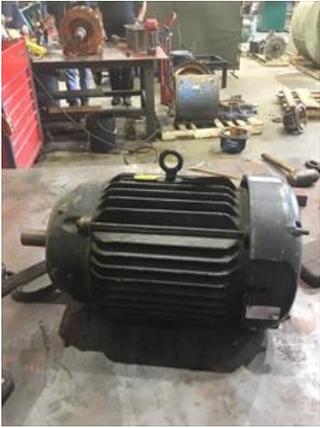
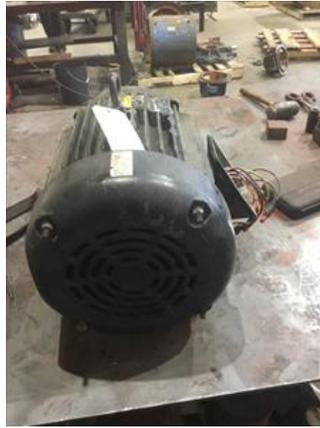
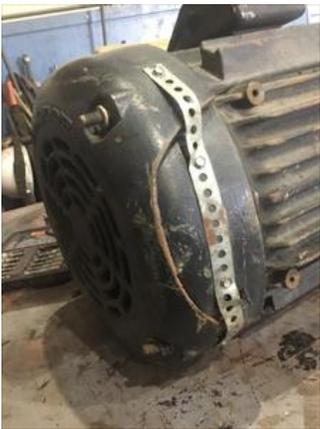
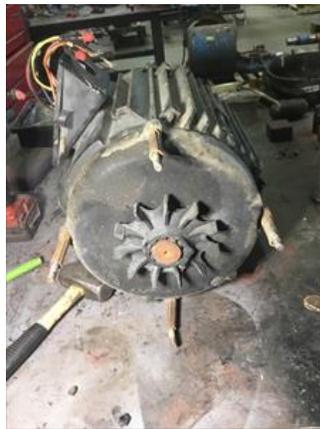
P27

3. Photos of all six sides of the machine.

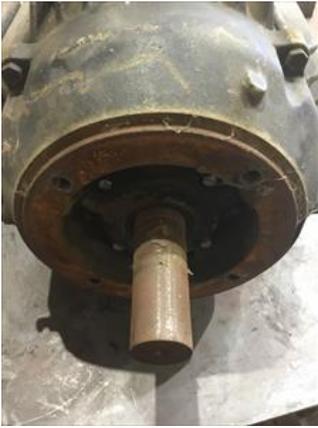
P11

6. Does Shaft Have Visible Damage?

(No) No

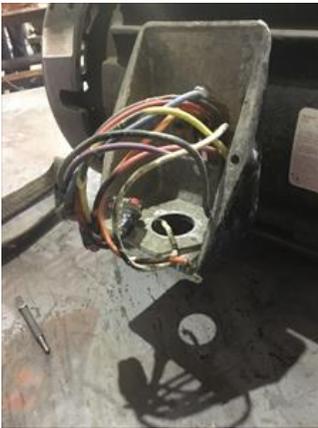
P32

● 10. Lead Condition

(P) Pass

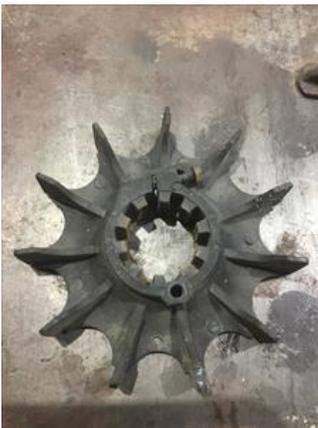
P54

● 13. Fan Condition

(P) Pass

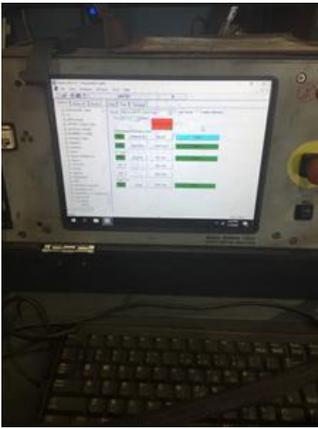
P35

17. Perform Surge Test

(P) Pass

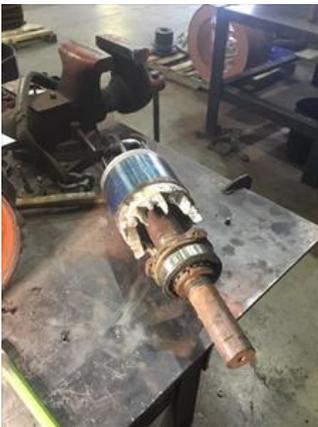
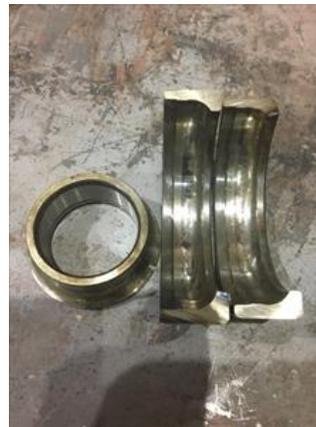
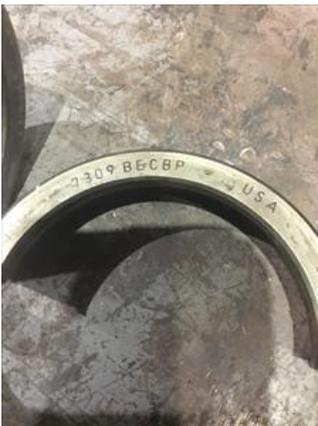
P8

20. Drive End Bearing Number-

7309

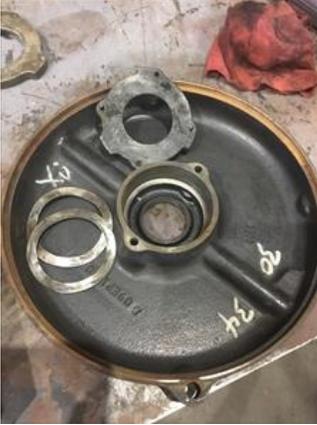
24. Drive End Bearing Insulation or Grounding Device?	none	
25. Drive End Wavy Washer/Snap-Ring Other Retention Device?	none	
26. Drive End Bearing Condition	replace.	
27. Opposite Drive End Bearing Number-	6208	
28. Opposite Drive End Bearing Qty.	1	
29. Opposite Drive End Bearing Type	(Ball) Ball Bearing	
30. Opposite Drive End Lubrication Type	(Grease) Grease Lubricated	
31. Opposite Drive End Bearing Insulation or Grounding Device?	none	
32. Opposite Drive End Wavy Washer/Snap-Ring Other Retention Device?	yes	P56

2 each

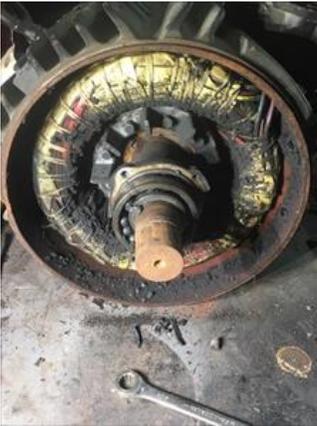
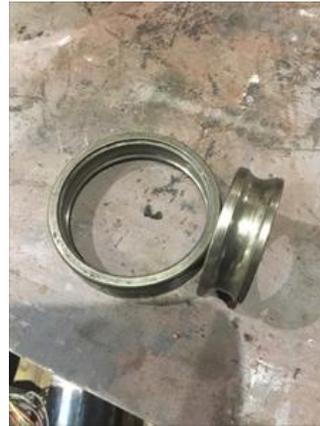
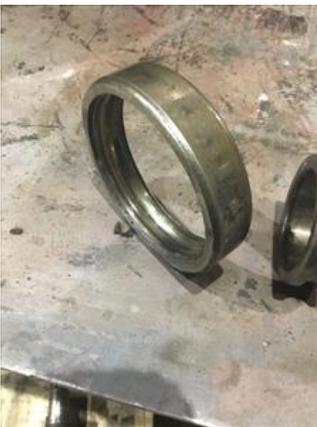
P57

33. Opposite Drive End Bearing Condition

cage failure

59.	Failure locations			
	<i>Grease contaminated with water. ODE bearing cage failed.</i>

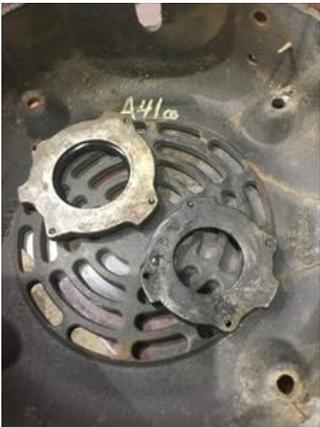
55.	Bearing Cap Condition			P30
	Drive End Bearing Cap	Opposite Drive End Bearing Cap		
	<b>pass</b>	<b>pass</b>

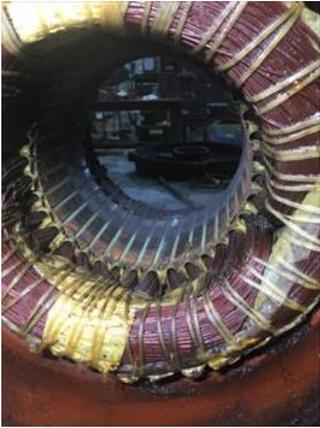
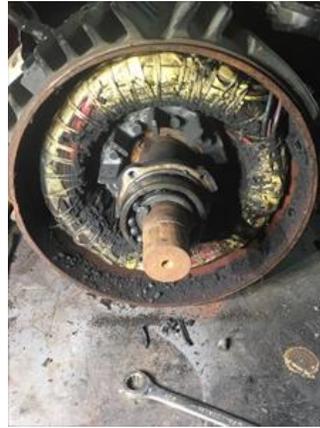
*Moisture inside stator. Contaminated grease in both bearings. Cage failure on ODE bearing.*
