AC Recondition As Found

Remington (10243)

AC Recondition - Rev. 2

Description: 15HP BALDOR 3600RPM 254TCZ

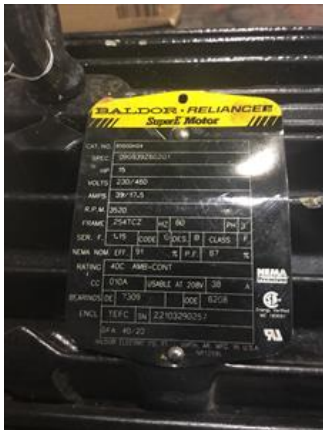
P20

- Report Date
- Nameplate Picture

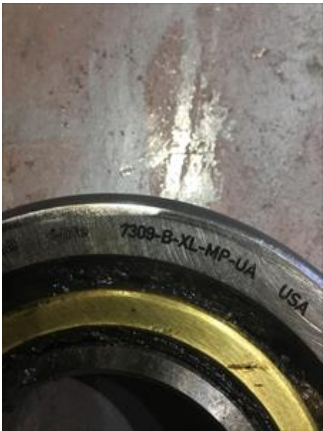
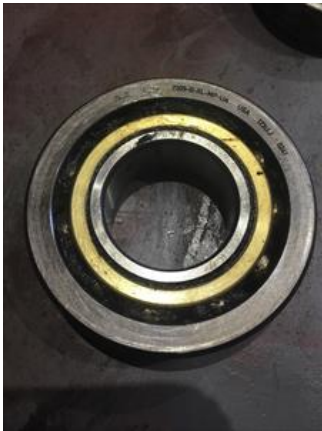
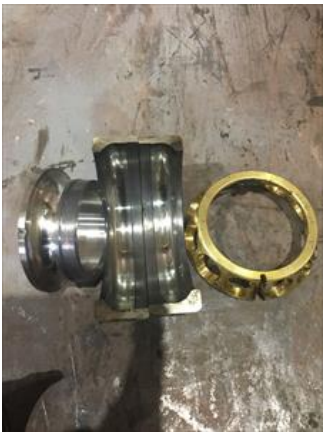
P8

20. Drive End Bearing Number-

7309

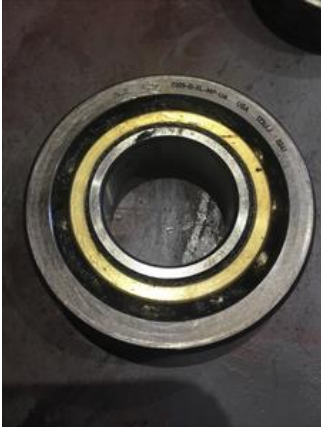
26. Drive End Bearing Condition

contaminated grease

7306 & 6208 bearings. Re-sleeve ODE housing fit

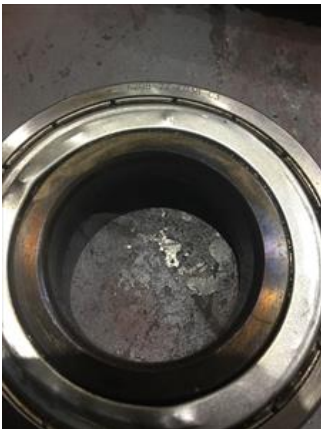
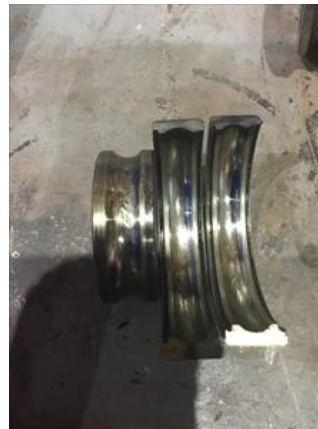
P47

27. Opposite Drive End Bearing Number-

6208

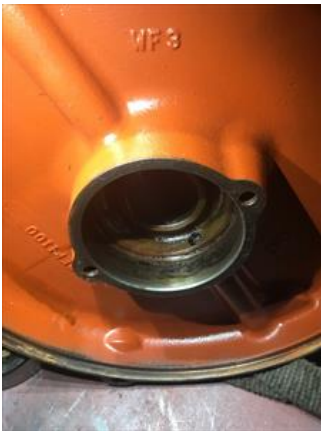
48.	Opposite Drive End Bearing Shaft Fit		
	0 Degrees	60 Degrees	120 Degrees
	1.575	1.5752	1.575
49.	Opposite Drive End Bearing Shaft Fit Condition		(P) Pass
50.	Shaft Air Seal Fits		
	Drive End Air Seal	Opposite Drive End Air Seal	
Mechanical Fits- Bearing Housings			
51.	Drive End - Endbell Bearing Fit		
	0 Degrees	60 Degrees	120 Degrees
	3.9377	3.9378	3.9377
52.	Drive End - Endbell Bearing Fit Condition		(P) Pass
53.	Opposite Drive End - Endbell Bearing Fit		
	0 Degrees	60 Degrees	120 Degrees
	Pitted		
54.	Opposite Drive End - Endbell Bearing Fit Condition		(F) Fail

ODE housing fit pitted

ODE bearing cage failure.

ODE housing fit pitted.

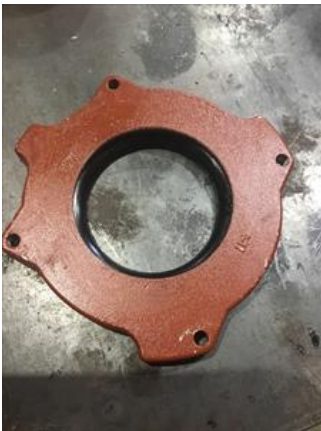
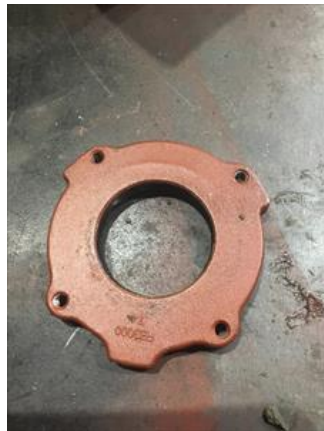
55.	Bearing Cap Condition		P30
	Drive End Bearing Cap	Opposite Drive End Bearing Cap	
	pass	pass	
<div>
