AC Recondition As Found

Hiland Dairy (10126)

AC Recondition - Rev. 2

Location: MOTOR SHOP LR
Serial Number: W08 473295F
Description: 30KW ATB 1800RPM 200L

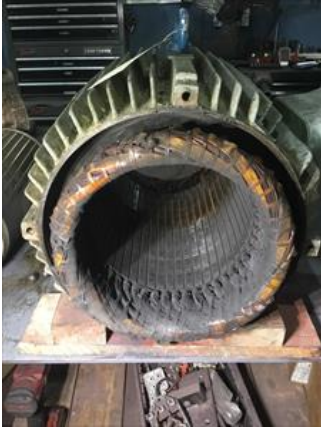
14.	Broken or Missing Components		
	<div> <div></div> <div>Fan cover mount bolts. One connection block lead wire mount bolt.</div> </div>		
Initial Electrical Inspection			<div> <div></div> </div>
15.	Insulation Resistance/Megger		
16.	Winding Resistance		
	1-2	1-3	2-3

19. Stator Condition

rewind stator

Root Cause of Failure		
59.	Failure locations <i>Windings shorted on drive end. Both housing fits bad. Both shaft fits bad.</i>	
60.	Root cause of failure

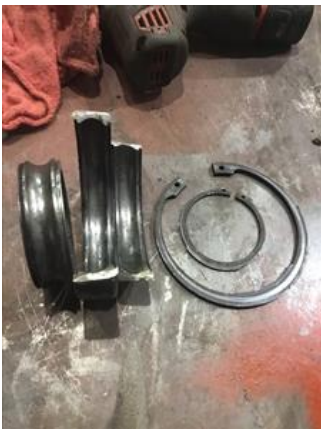
P39

26. Drive End Bearing Condition

total cage and bearing failure.

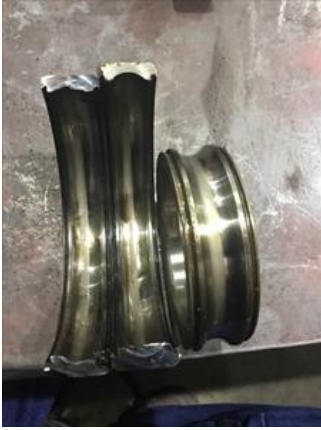
29. Opposite Drive End Bearing Type	(Ball) Ball Bearing
30. Opposite Drive End Lubrication Type	(Grease) Grease Lubricated
31. Opposite Drive End Bearing Insulation or Grounding Device?	none
32. Opposite Drive End Wavy Washer/Snap-Ring Other Retention Device?	none
33. Opposite Drive End Bearing Condition	replace
34. Drive End Seal	none
35. Opposite Drive End Seal	none

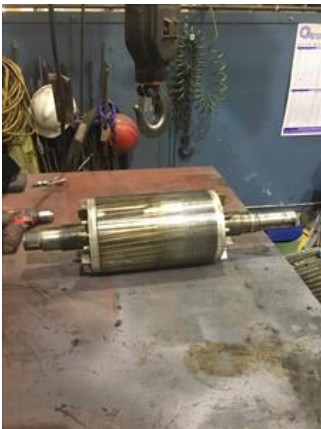
P3

36. Rotor Type/Material	(Squirrel Aluminum) Squirrel Cage Aluminum Die Cast
-------------------------	--------------------------------------------------------

37. Growler Test	(Pass) Pass
38. Number of Rotor Bars	
39. Rotor Condition	pass
40. List the Parts needed for the Repair Below <i>Re-sleeve both end bell housing fits. Machine both shaft bearing journals. Rewind Stator.</i>	
41. Signature of Technician that Disassembled Motor	Terrence Holland

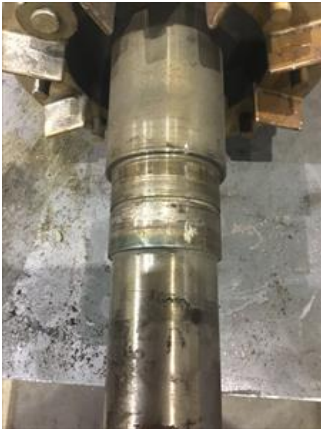
P40

Excessive wear.

47. Drive End Bearing Shaft Fit Condition (F) Fail P45

55.	Bearing Cap Condition	
	Drive End Bearing Cap	Opposite Drive End Bearing Cap
	none	none
56.	End Bell Air Seal Fits	
	Drive End Air Seal	Opposite Drive End Air Seal
57.	List Machine Work Needed Below <i>Re-sleeve both housing fits. Machine both shaft bearing journals.</i>	
58.	Technician	Terrence Holland

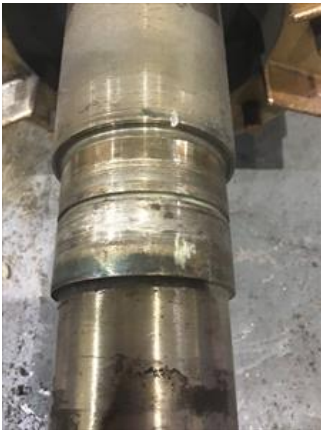
48.	Opposite Drive End Bearing Shaft Fit		
	0 Degrees	60 Degrees	120 Degrees
	2.3621	2.362	2.3622

49. Opposite Drive End Bearing Shaft Fit Condition (F) Fail

Out of tolerance.

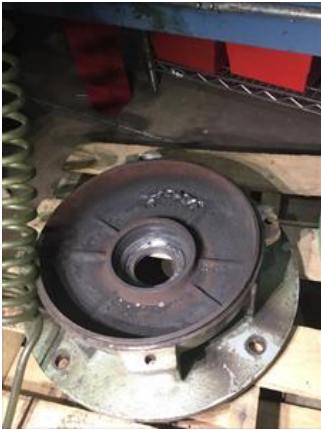
P10

Excessive wear.

52. Drive End - Endbell Bearing Fit Condition

(F) Fail

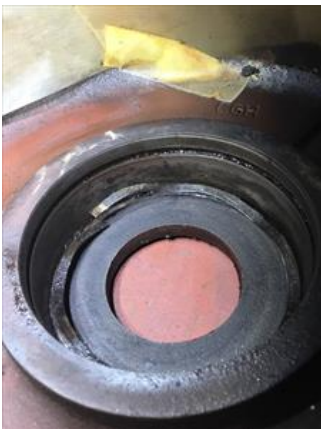
P17

Excessive wear.

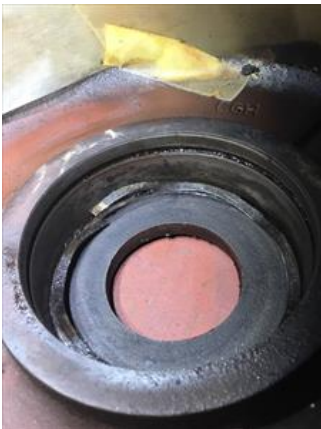
P22

54. Opposite Drive End - Endbell Bearing Fit Condition

(F) Fail
