AC Recondition As Found

Sage V Foods

AC Recondition - Rev. 2

Location: MOTOR SHOP LR
Serial Number: EF5T46663N-F4-10-01/21
Description: 0.5HP SWECO 1200RPM 143TZX

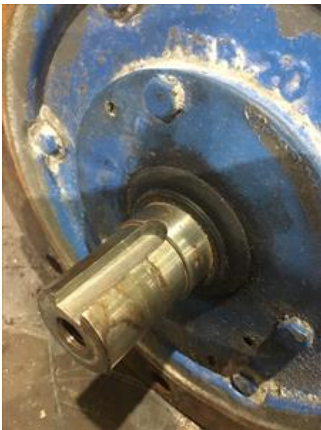
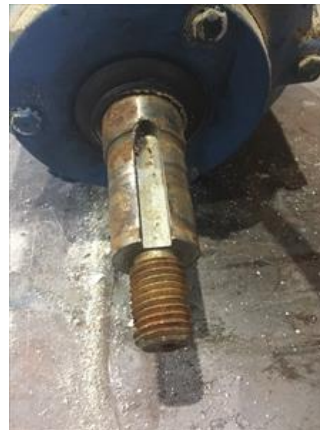
5. Does Shaft Turn Freely? (No) No
6. Does Shaft Have Visible Damage? (No) No P11
