AC Recondition As Found

Peco Foods

AC Recondition - Rev. 2

Description: 5HP BALDOR 1800RPM 184JM
MEMPHIS PUMP MPAL-300-500TEBF
184647

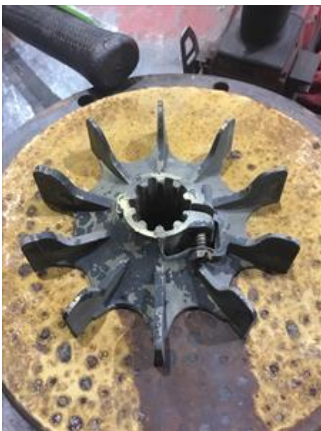
P55

6.	Does Shaft Turn Freely?	(Yes) Yes
7.	Does Shaft Have Visible Damage?	(No) No
8.	Assembled Shaft Runout	0.001 Inches
9.	Assembled Shaft End Play	inches
10.	Air Gap Variation <10%	
11.	Lead Condition	(P) Pass
12.	Lead Length	7 Inches
13.	Frame Condition	pass
14.	Fan Condition	(P) Pass

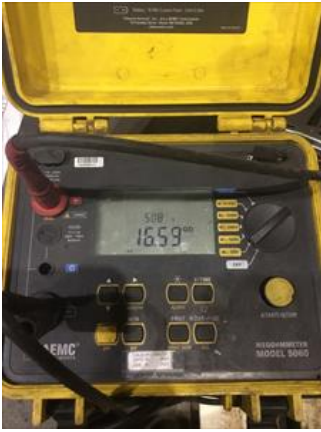
P5

16. Insulation Resistance/Megger

16000 Megohms

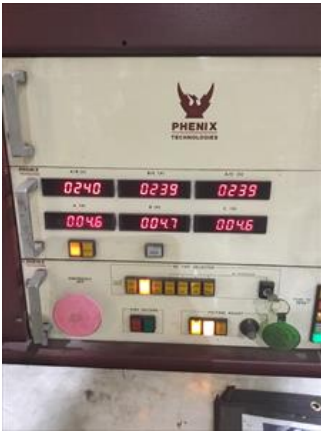
P35

18. Perform Surge Test

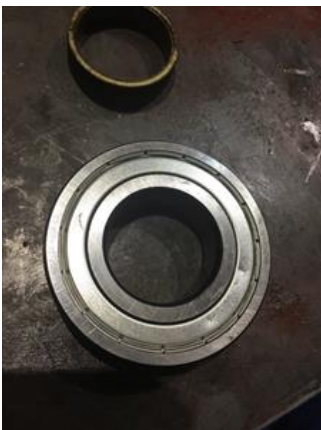
P8

21. Drive End Bearing Number-

6207 2Z/C3

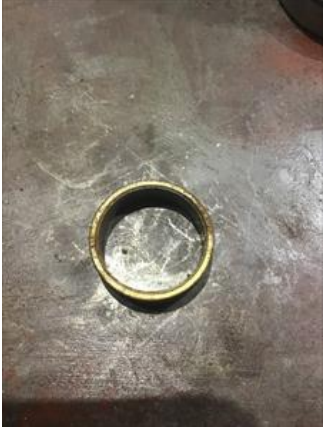
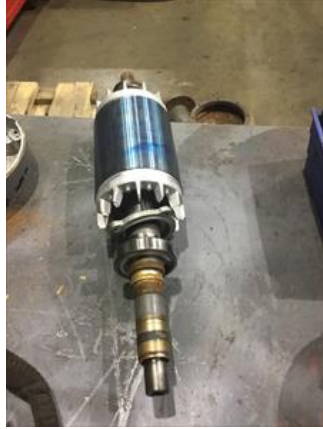
24.	Drive End Lubrication Type	(Grease) Grease Lubricated	
25.	Drive End Bearing Insulation or Grounding Device?	none	
26.	Drive End Wavy Washer/Snap-Ring Other Retention Device?	spacer goes on after bearing	P39
<div style="display: flex; justify-content: space-around;">

</div>			
27.	Drive End Bearing Condition	replace	
28.	Opposite Drive End Bearing Number-	6205 ZE C3	P48

Replace Seal, 6207 & 6205 bearings. Need new seal sleeve machined.

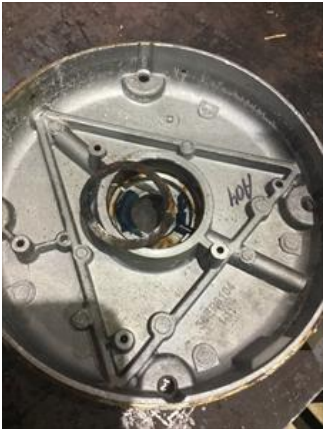
29.	Opposite Drive End Bearing Qty.	1	
30.	Opposite Drive End Bearing Type	(Ball) Ball Bearing	
31.	Opposite Drive End Lubrication Type	(Grease) Grease Lubricated	
32.	Opposite Drive End Bearing Insulation or Grounding Device?	none	
33.	Opposite Drive End Wavy Washer/Snap-Ring Other Retention Device?	yes	P57

34.	Opposite Drive End Bearing Condition	Worn

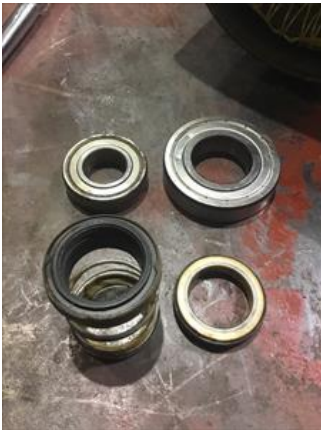
P29

41. List the Parts needed for the Repair Below

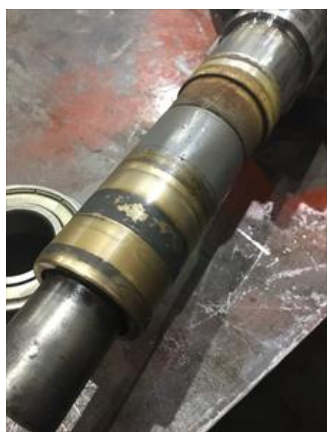
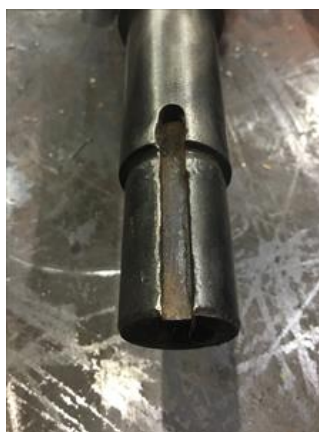
P6

60. Failure locations

D.E. Seal sleeve worn. Shaft key way wallowed.

61. Root cause of failure

Pump seal failure due to worn seal sleeve.
