AC Recondition As Found

Sage V Foods

AC Recondition - Rev. 2

Location: MOTOR SHOP LR
Serial Number: C0906200018
Description: 50HP Baldor 1800RPM 326TDZ

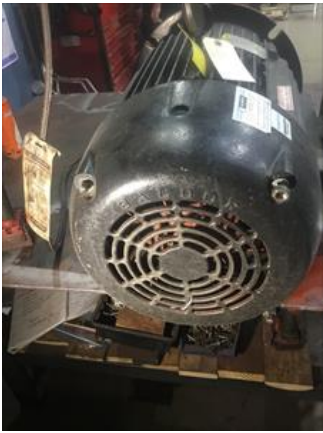
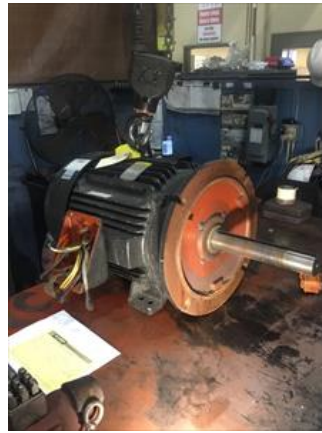
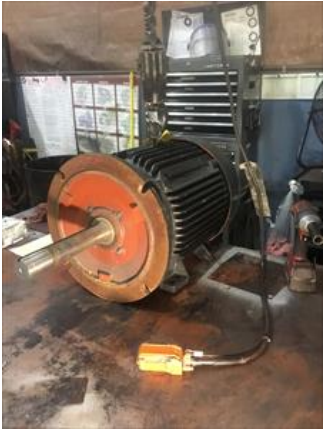
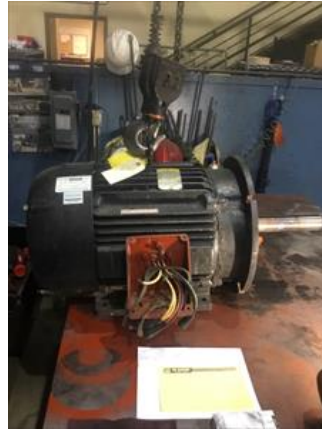
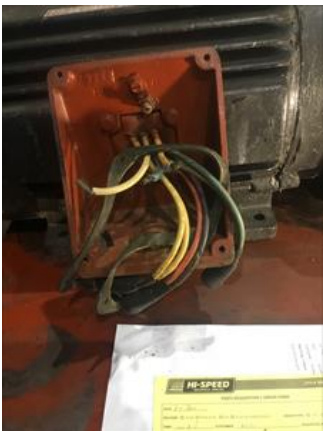
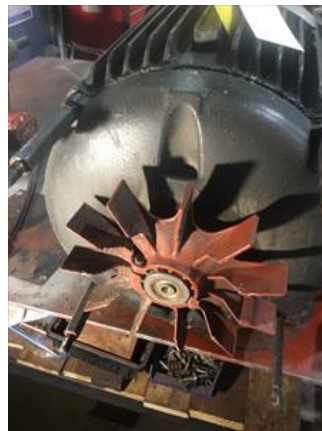
3. Photos of all six sides of the machine.

4. Describe the Overall Condition of the Equipment as Received
Serviceable

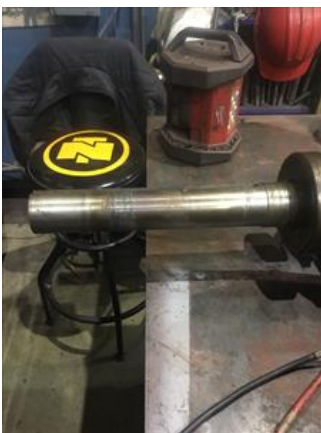
| 6. Does Shaft Have Visible Damage? | (Yes) Yes | P20 |

57.	List Machine Work Needed Below		
	<i>D.E shaft bent .022. D.E. housing fit has lip worn in. D.E. Shaft bearing journal worn out of tolerance.</i>		
58.	Technician		Terrence Holland

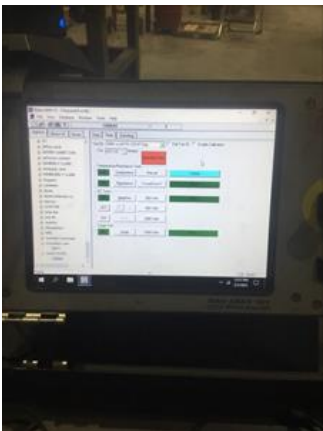
17. Perform Surge Test

(P) Pass

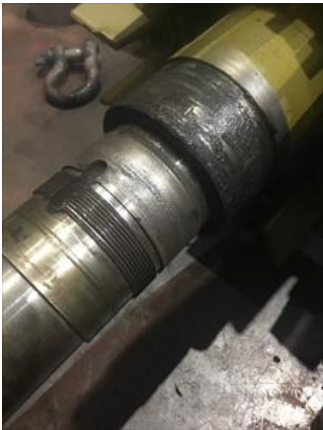
45.	Coupling Fit Closest to the end of the Shaft		
	0 Degrees	60 Degrees	120 Degrees
46.	Drive End Bearing Shaft Fit		
	0 Degrees	60 Degrees	120 Degrees
<div> <div></div> <div>Excessive wear.</div> </div>

47.	Drive End Bearing Shaft Fit Condition		(F) Fail
<div> <div></div> <div>Bearing came off by hand</div> </div>
