# QualiTest IR Radiometric Survey Report

## Harlow's Casino and Resort 2019 IR Survey Report

Job Number	140437
Survey Date	8/21/19
Report Date	8/27/19

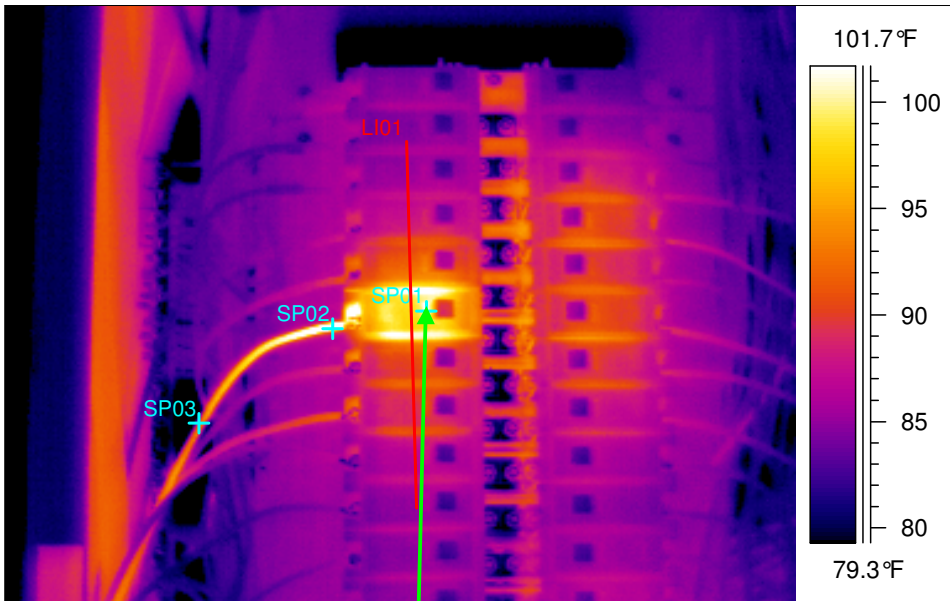
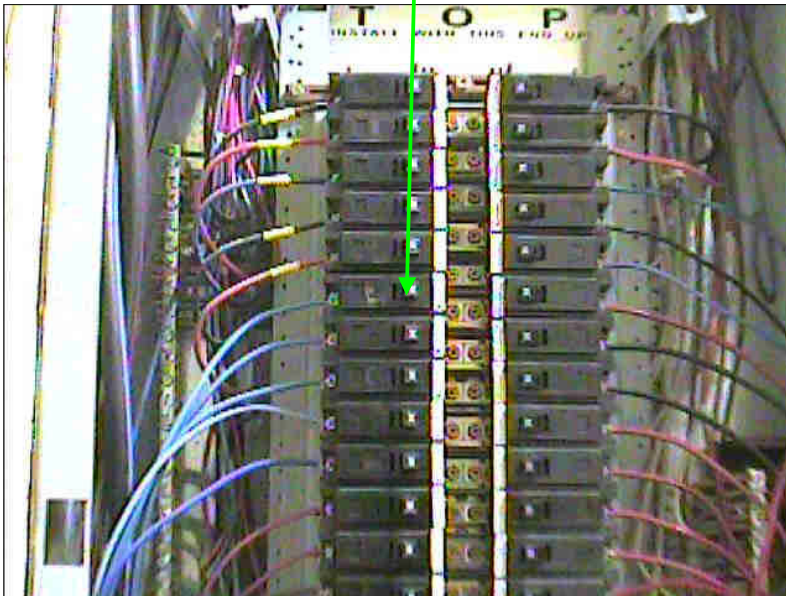
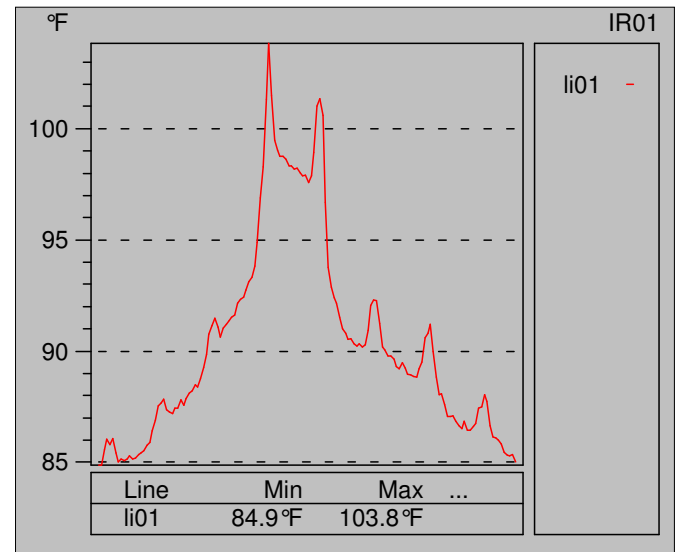
Component	Equipment/Bucket ID	Plant/Area	Date
Circuit 11	RP-1	Stage Bar Panels	8-21-19

Label	Value
IR : max	106.6°F
IR : min	72.9°F
SP01	102.7°F
SP02	105.9°F
SP03	90.4°F
LI01 : max	103.8°F
LI01 : min	84.9°F

Fault	Breaker issue
Defect Rating	<b>CLASS I</b>

Breaker appears to be heavily loaded or has possible internal issue that is causing heat. Lead connection checked to be tight. Ensure breaker isn't under excessive load. Breaker may need to be replaced.

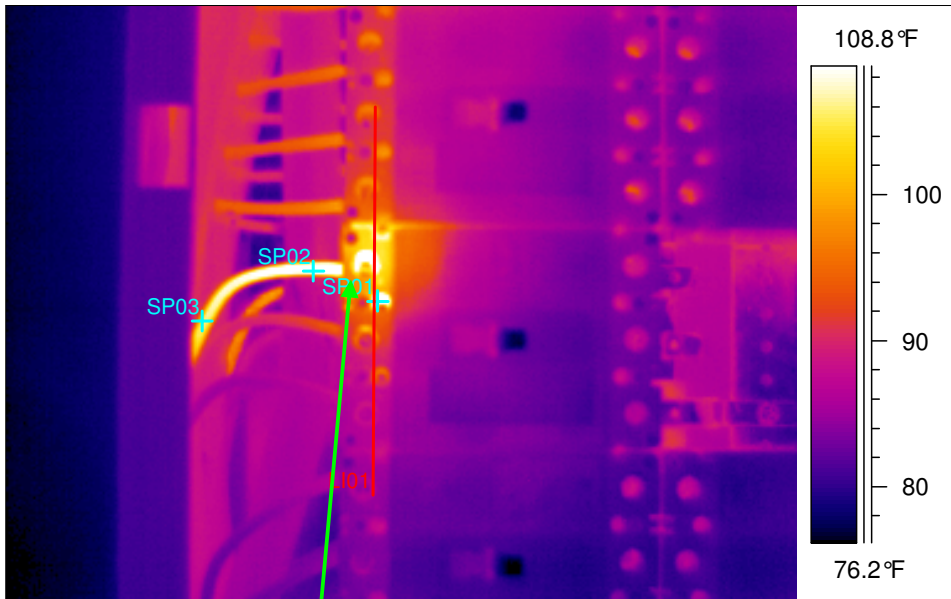
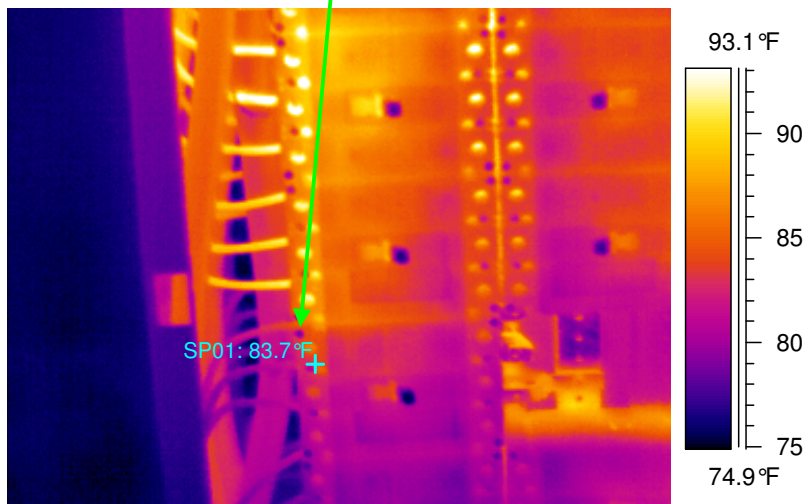
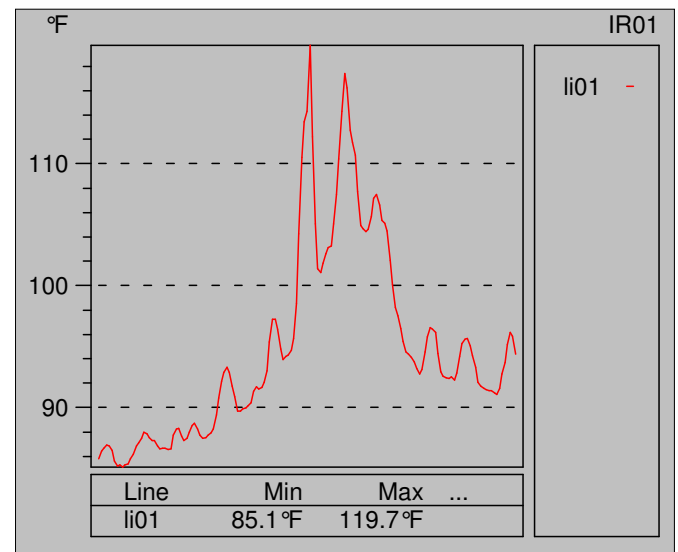
Component	Equipment/Bucket ID	Plant/Area	Date
Loose connection	Water Well Pump/HP-1	Emergency Panel Room (Bridge)	8-21-19

Label	Value
IR : max	128.8°F
IR : min	75.7°F
SP01	127.0°F
SP02	112.9°F
SP03	105.6°F
LI01 : max	119.7°F
LI01 : min	85.1°F

<b>Fault</b>	Loose connection
<b>Defect Rating</b>	<b>CLASS II</b>

IR image showed a possible loose connection. Connections were checked and found to be loose. Gephart safely tightened connection with proper PPE. Panel was rechecked and found to be OK after tightening connection. See 2nd image.

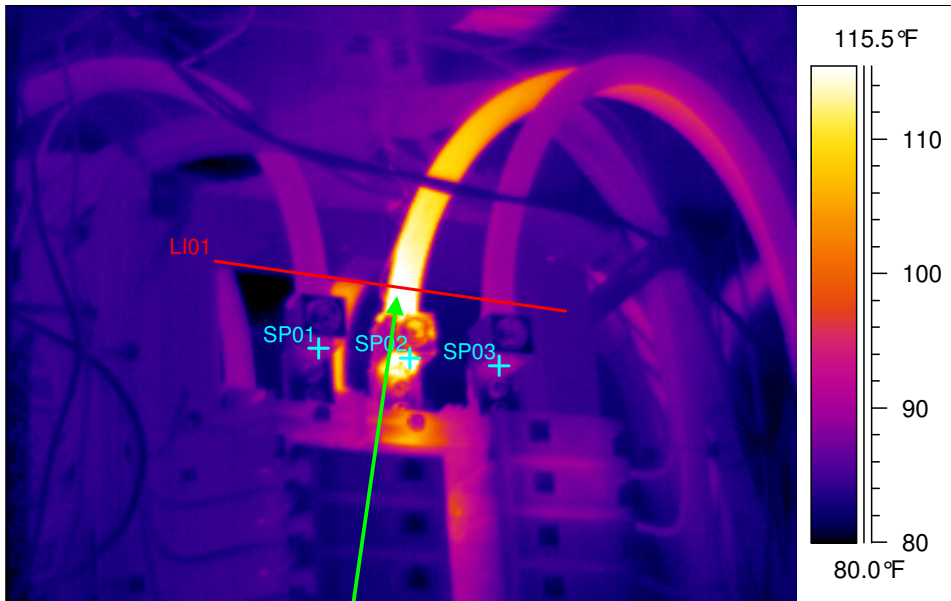
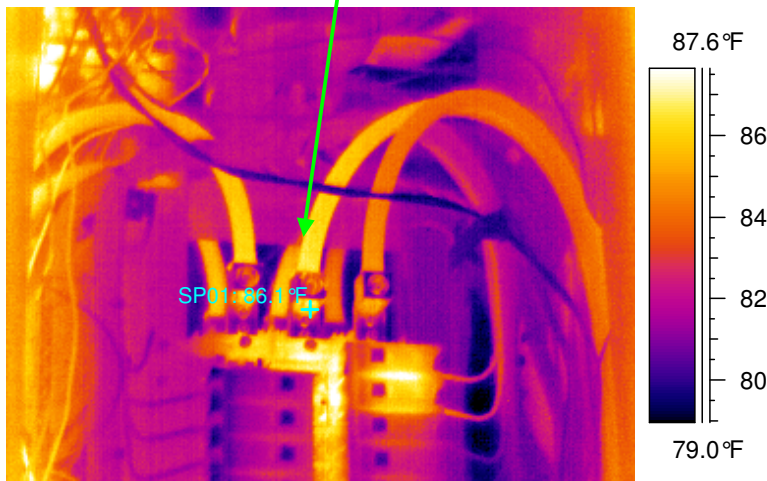
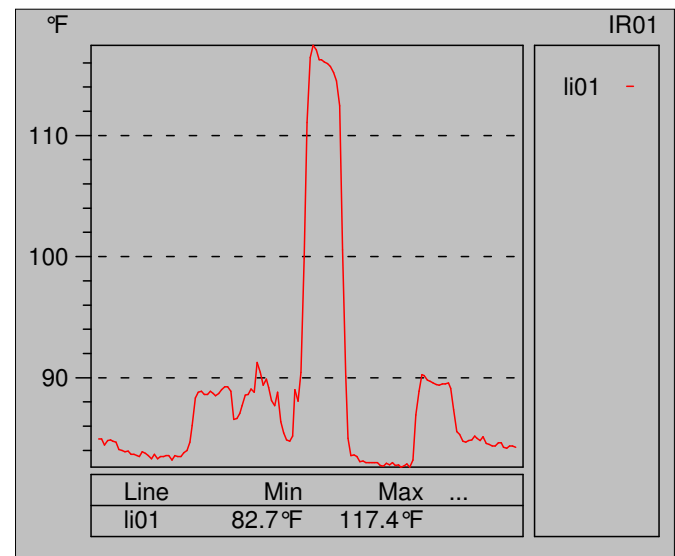
Component	Equipment/Bucket ID	Plant/Area	Date
Loose connection	Incoming B phase RP-7	Emergency Panel Room (Bridge)	8-21-19

Label	Value
IR : max	125.9°F
IR : min	79.5°F
SP01	89.8°F
SP02	125.1°F
SP03	89.9°F
LI01 : max	117.4°F
LI01 : min	82.7°F

<b>Fault</b>	Loose connection
<b>Defect Rating</b>	<b>CLASS II</b>

R image showed a possible loose connection. Connections were checked and found to be loose. Gephart safely tightened connection with proper PPE. Panel was rechecked and found to be OK after tightening connection. See 2nd image.
