Hi-Speed Industrial Service  
7030 Ryburn Dr  
Millington, Tn 38053  
901-873-5300

**AC Repair Arkansas Kraft Division**  
**004458 Green Bay Packaging**  
338 Highway 113 South  
Morrilton, AR 72110

**AC Recondition - Rev. 2**

Hi-Speed Job Number:	149327
Manufacturer:	TECO Westinghouse
Product Number:	TUDP
Spec/ID #:	77B21022
Serial Number:	7803
HP/kW:	150 (HP)
RPM:	3550 (RPM)
Frame:	405TDZ
Voltage:	460
Current:	169 (Amps)
Phase:	Three
Hz:	60 (Hz)
Service Factor:	1.25
Enclosure:	ODP
# of Leads:	6
J-box Included:	Complete
Coupling/Sheave:	Coupling
Date Received:	01/13/2023
Bearing RTDs:	No
Stator RTDs:	No
Repair Stage:	Teardown Inspection
Heaters:	No
Winding Type :	Random Wound
Bearing Type:	Rolling Element

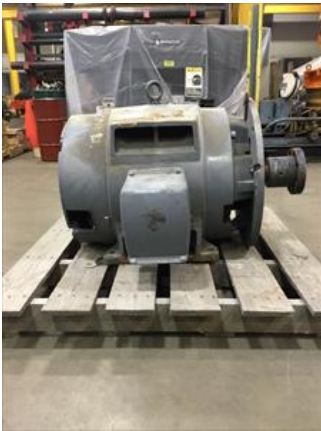
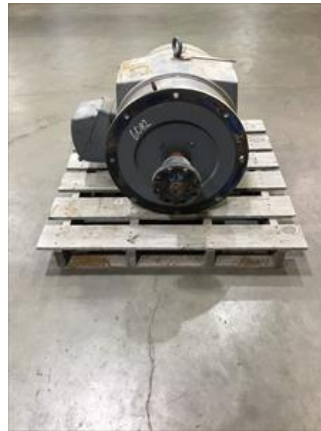
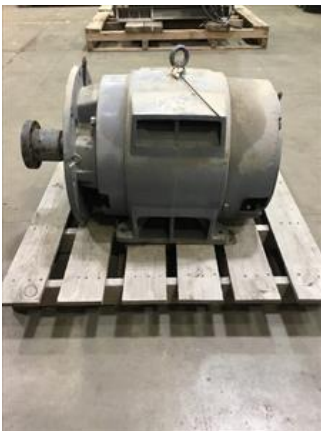
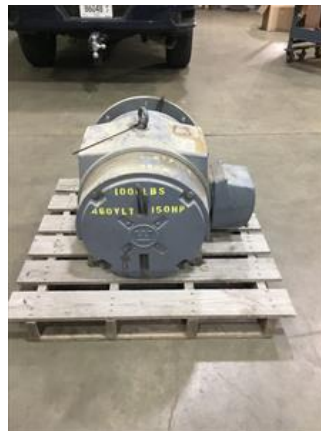
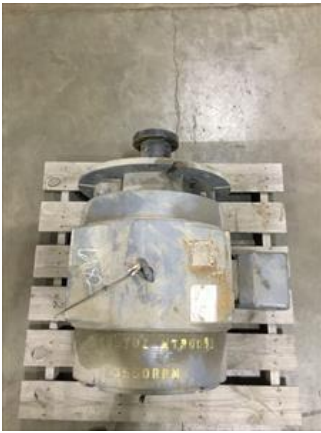
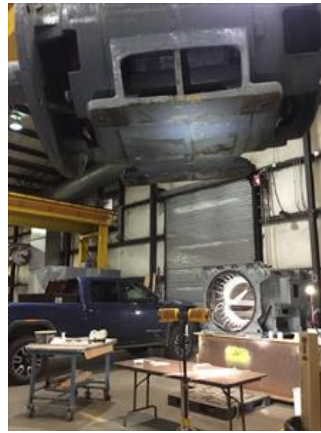
## 4. Photos of all six sides of the machine.

5. Describe the Overall Condition of the Equipment as Received

*Windings need to be steamed and baked  
Bore and Bush on both endbells  
Metallization of both ends of the shaft  
New bearings required*

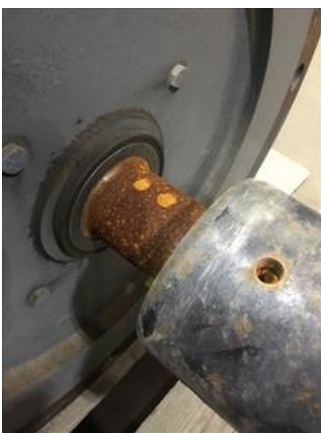
P8

8. Does Shaft Have Visible Damage? (No) No

*Rusty*

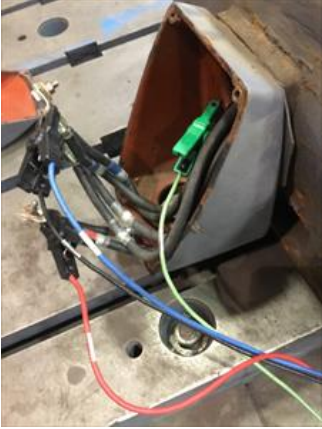
11.	Assembled Shaft End Play	0.008 inches	
● 12.	Lead Condition	(P) Pass	
13.	Lead Length	Inches	P13

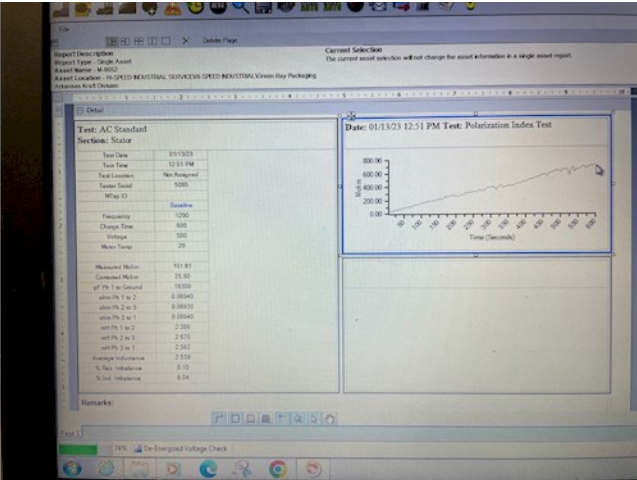
● 20.	Perform PDMA Test	(P) Pass	P23

21.	Insulation Resistance	25.5	
22.	Polarization Index	7.14	
23.	Winding Resistance		
	1-2	1-3	2-3
	.06940	.06930	.06940
24.	Number of Stator Slots	48

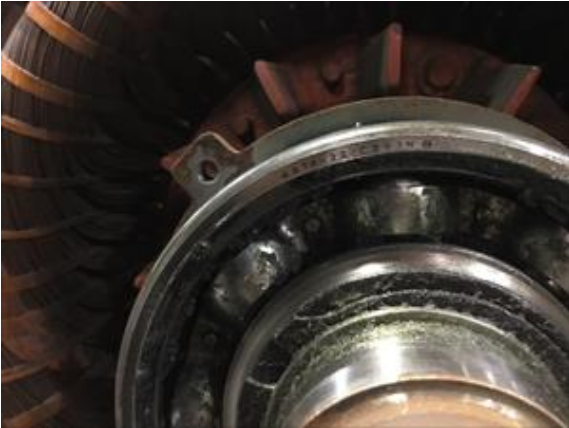
26.	Drive End Bearing Number-	6314Z C3	P29

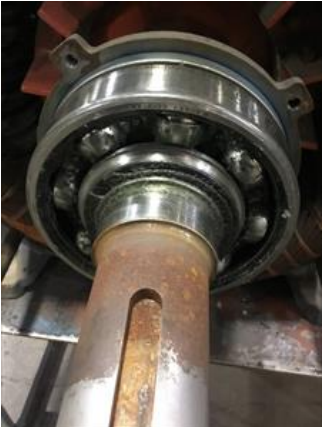
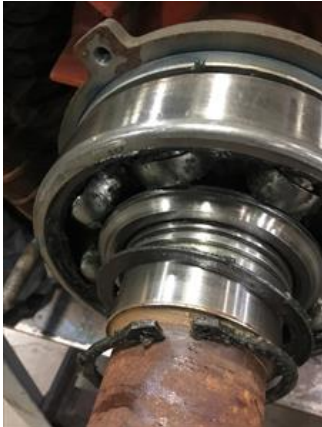
31.	Drive End Wavy Washer/Snap-Ring Other Retention Device?	Snap Ring	P34

Spacer behind snap ring

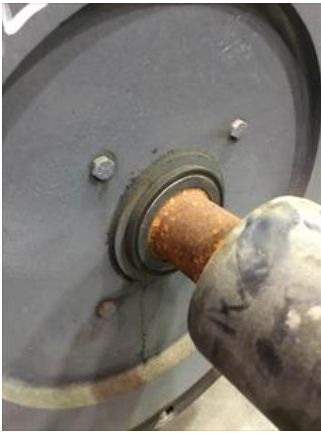
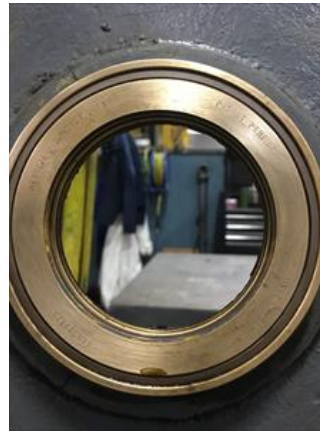
40.	Drive End Seal	Present	P43

*Grease tubes NPT  
1/8" x 4 1/2".  
1/8" x 3".  
2 1/8" x 3/4" coupling  
6314Z  
6312z  
314 bushing  
312 bushing  
Drive end inpro seal. See picture for part number.*

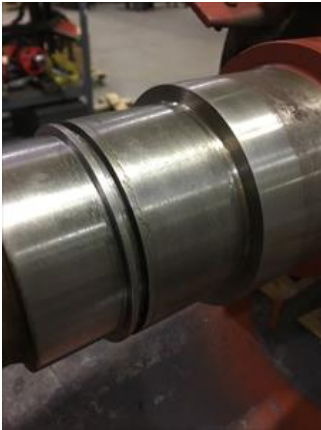
## 52. Drive End Bearing Shaft Fit

0 Degrees	60 Degrees	120 Degrees
2.7558	2.7558	2.7558

- 70mm=2.7559. Tolerance is 2.7560-2.7565. Outside of tolerance and requires machining. Shows signs of previous repair.

## 53. Drive End Bearing Shaft Fit Condition

(F) Fail

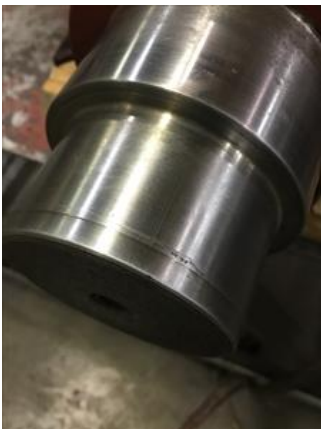
P65

## 54. Opposite Drive End Bearing Shaft Fit

0 Degrees	60 Degrees	120 Degrees
3.3621	3.3621	3.3621

- 60mm=2.3622. Tolerance is 3.3626-3.3634. Outside of tolerance and requires machining. Shows signs of previous repair.

## 55. Opposite Drive End Bearing Shaft Fit Condition

(F) Fail

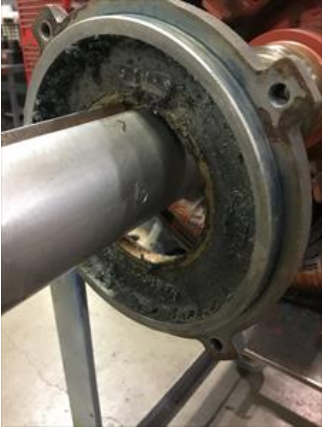
59.	Opposite Drive End - Endbell Bearing Fit		
	0 Degrees	60 Degrees	120 Degrees
	5.1121	5.112	5.112
	130mm=5.1181. Tolerance is 5.1181-5.1191. Outside of tolerance and requires bore and bush		
60.	Opposite Drive End - Endbell Bearing Fit Condition		(F) Fail
61.	Bearing Cap Condition		
	Drive End Bearing Cap	Opposite Drive End Bearing Cap	
	Good		
	DE has bushing.

Root Cause of Failure			
65.	Failure locations		
	Dry Bearings		
66.	Root cause of failure		
	Improper bearing lubrication

DE			
62.	End Bell Air Seal Fits		
	Drive End Air Seal	Opposite Drive End Air Seal	
	N/A	N/A	
63.	List Machine Work Needed Below		
	Metallize and machine both ends of rotor. Both end bells need bore and bush.		
64.	Technician		Brandon Woodard
