Hi-Speed Industrial Service
7030 Ryburn Dr
Millington, Tn 38053
901-873-5300

AC Repair Arkansas Kraft Division
004458 Green Bay Packaging
338 Highway 113 South
Morrilton, AR 72110

AC Recondition - Rev. 2

Hi-Speed Job Number:	149327
Manufacturer:	TECO Westinghouse
Product Number:	TUDP
Spec/ID #:	77B21022
Serial Number:	7803
HP/kW:	150 (HP)
RPM:	3550 (RPM)
Frame:	405TDZ
Voltage:	460
Current:	169 (Amps)
Phase:	Three
Hz:	60 (Hz)
Service Factor:	1.25
Enclosure:	ODP
# of Leads:	6
J-box Included:	Complete
Coupling/Sheave:	Coupling
Date Received:	01/13/2023
Bearing RTDs:	No
Stator RTDs:	No
Repair Stage:	Final
Rewind:	No
Shaft Machined Fit Repairs Required:	Yes
Bearing Housing Machined Fit Repairs Required:	Yes
Heaters:	No
Winding Type :	Random Wound
Bearing Type:	Rolling Element

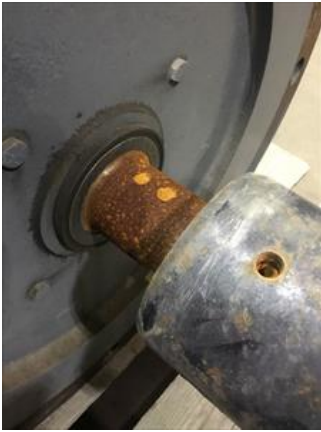
P8

Rusty

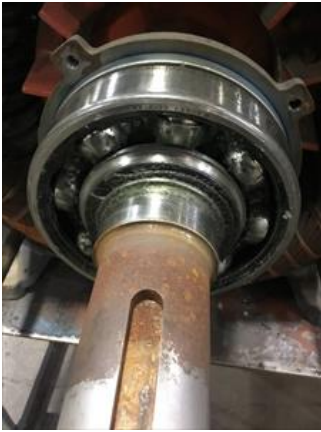
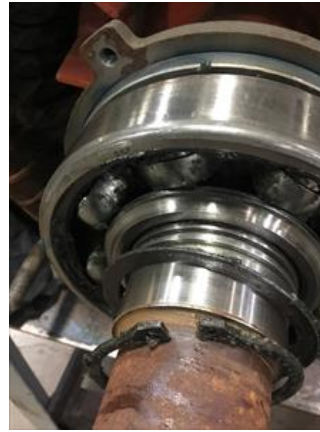
P33

Spacer behind snap ring

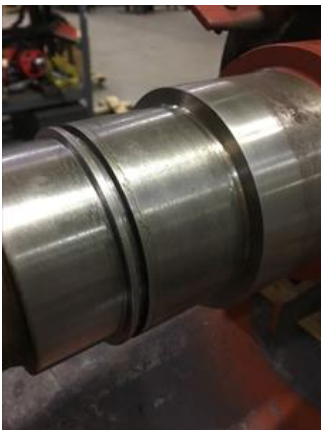
P54

70mm=2.7559. Tolerance is 2.7560-2.7565. Outside of tolerance and requires machining. Shows signs of previous repair.

(F) Fail

Metallize and machine both ends of rotor. Both end bells need bore and bush.

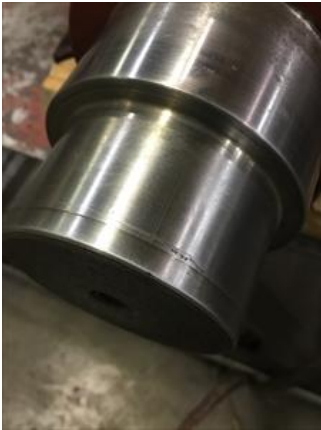
- 60mm=2.3622. Tolerance is 3.3626-3.3634. Outside of tolerance and requires machining. Shows signs of previous repair.

55. Opposite Drive End Bearing Shaft Fit Condition **(F) Fail**

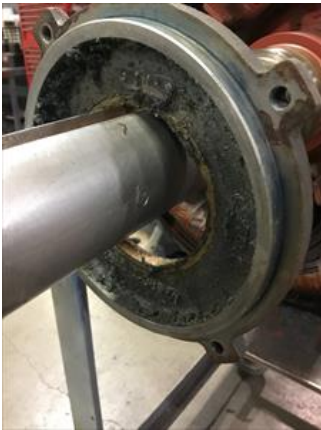
DE

*DE has bushing.*

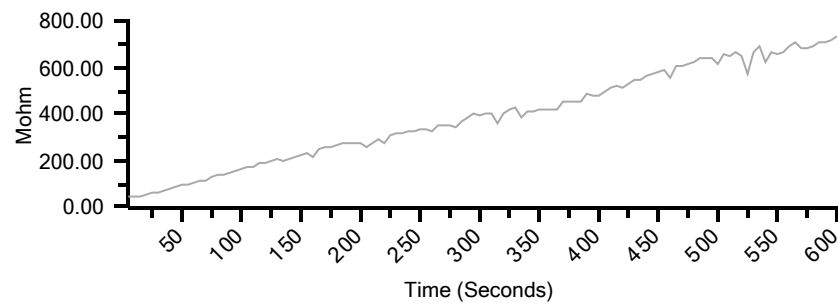
THIS TEST WAS PREFORMED PRE-RECONDITION. ALL TESTS PASS

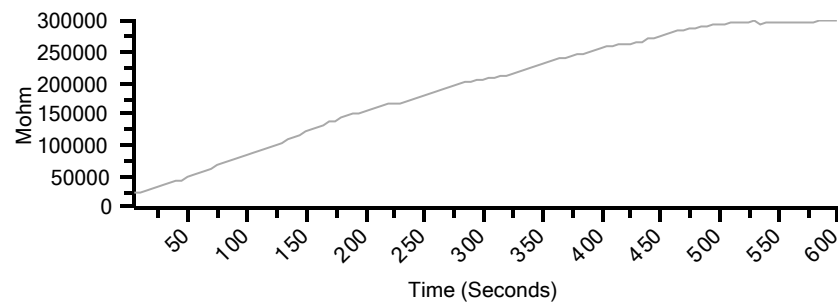
TEST WAS PREFORMED AFTER RECONDITION AND ASSEMBLY. INCREASED INDUCTIVE IMBALANCE IS DUE TO THE INFLUNCE OF THE INSTALLED ROTOR.
