AC Recondition As Found
Baptist Health Medical Center
P.O. Box 8516
Little Rock, AR 72215

AC Recondition - Rev. 2

Location: MOTOR SHOP LR
Serial Number: 0990910
Description: 50HP BALDOR 1800RPM 326T

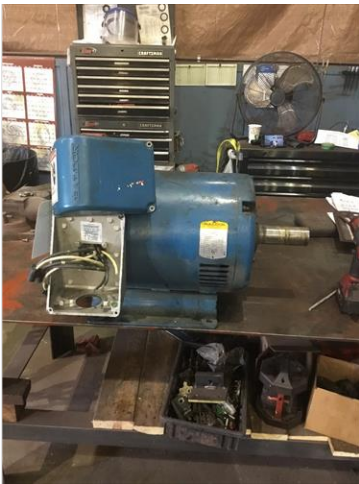
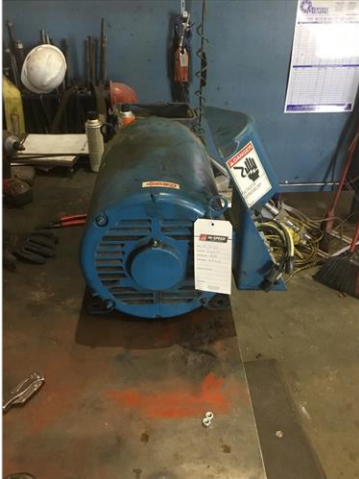
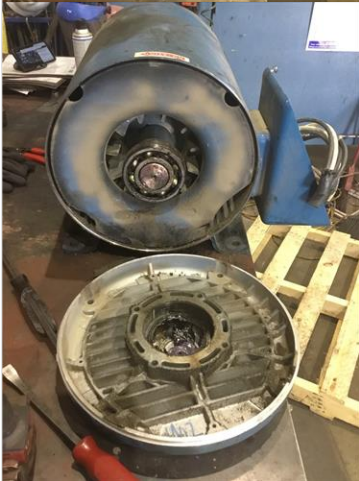
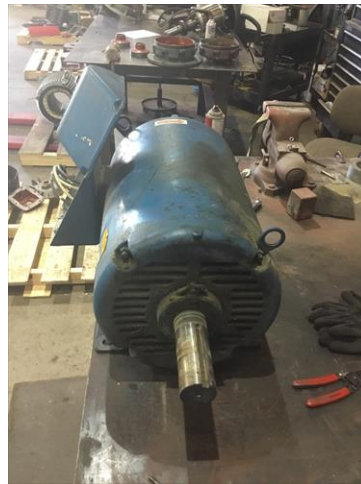
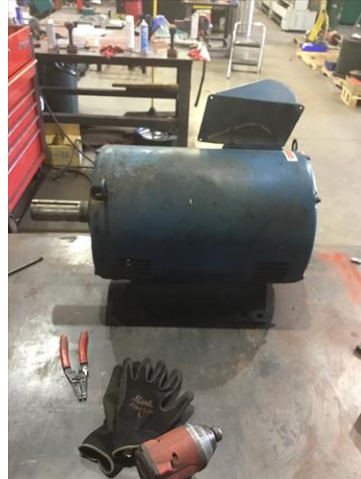
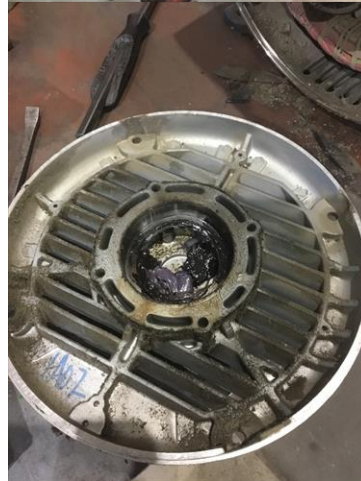
3. Photos of all six sides of the machine.

4. Describe the Overall Condition of the Equipment as Received
Serviceable but two broken baffles.

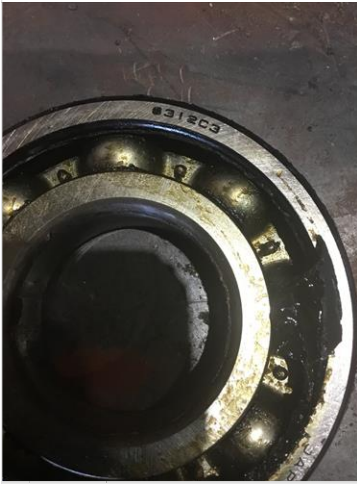
25.	Drive End Bearing Insulation or Grounding Device?	none	
26.	Drive End Wavy Washer/Snap-Ring Other Retention Device?	none	
27.	Drive End Bearing Condition	replace	
28.	Opposite Drive End Bearing Brand		
29.	Opposite Drive End Bearing Number-	6309	
30.	Opposite Drive End Bearing Qty.	1	P47

39.	Growler Test	(Pass) Pass
40.	Number of Rotor Bars	
41.	Rotor Condition	pass
42.	List the Parts needed for the Repair Below	
	<i>Replace both bearings and both end bell baffles. D.E housing fit bad.</i>	
43.	Signature of Technician that Disassembled Motor	Terrence Holland

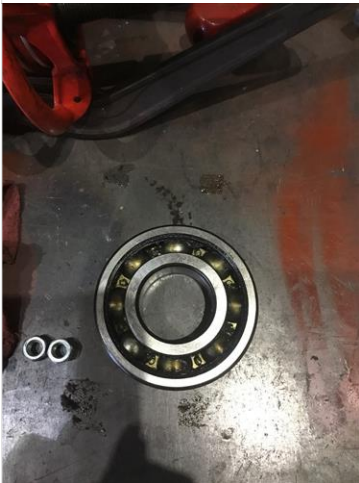
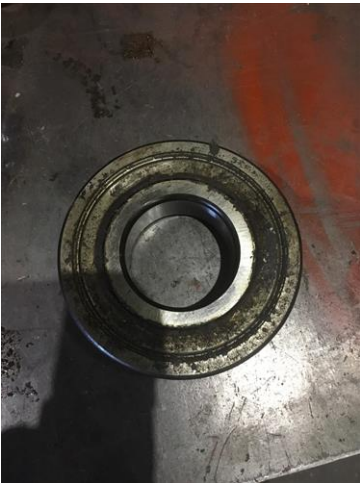
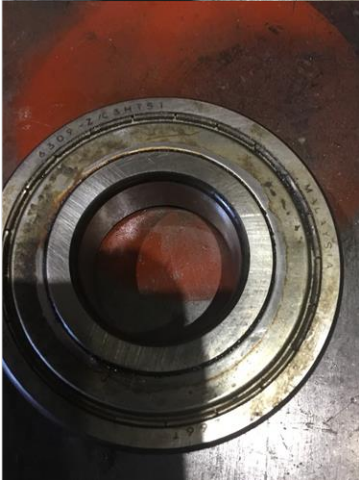
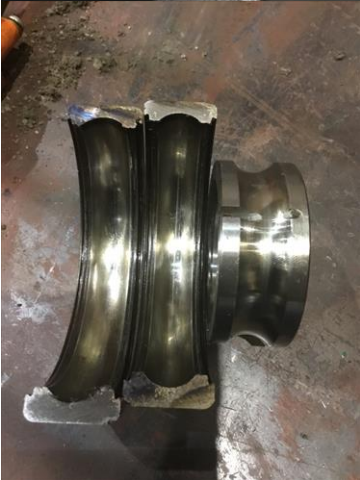
31.	Opposite Drive End Bearing Type	(Ball) Ball Bearing	
32.	Opposite Drive End Lubrication Type	(Grease) Grease Lubricated	
33.	Opposite Drive End Bearing Insulation or Grounding Device?	none	
34.	Opposite Drive End Wavy Washer/Snap-Ring Other Retention Device?	yes	
35.	Opposite Drive End Bearing Condition	replace

D.E. Housing fit out of tolerance. Replace both end bell baffles.

52.	Shaft Air Seal Fits		
	Drive End Air Seal	Opposite Drive End Air Seal	
Mechanical Fits- Bearing Housings			
53.	Drive End - Endbell Bearing Fit		
	0 Degrees	60 Degrees	120 Degrees
	5.1203	5.1202	
54.	Drive End - Endbell Bearing Fit Condition		(F) Fail
55.	Opposite Drive End - Endbell Bearing Fit		
	0 Degrees	60 Degrees	120 Degrees
	3.9379	3.9378	3.9378
56.	Opposite Drive End - Endbell Bearing Fit Condition		(P) Pass
57.	Bearing Cap Condition		
	Drive End Bearing Cap	Opposite Drive End Bearing Cap	
58.	End Bell Air Seal Fits		
	Drive End Air Seal	Opposite Drive End Air Seal	
59.	List Machine Work Needed Below <i>Sleeve D.E. Housing fit.</i>		
60.	Technician		Terrence Holland
