## AC Recondition As Found

Hiland Dairy (10126)

### AC Recondition - Rev. 2

Location: MOTOR SHOP LR  
Serial Number: W08 473295F  
Description: 30KW ATB 1800RPM 200L

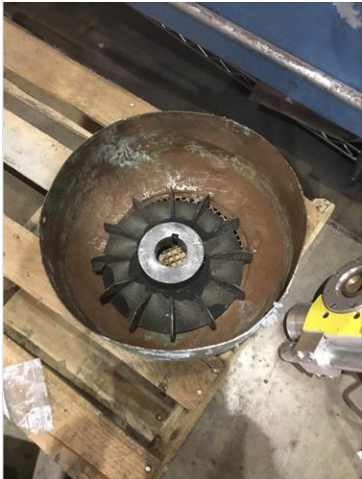
11. Lead Length
12. Frame Condition

pass

14. Broken or Missing Components
- Fan cover mount bolts. One connection block lead wire mount bolt.

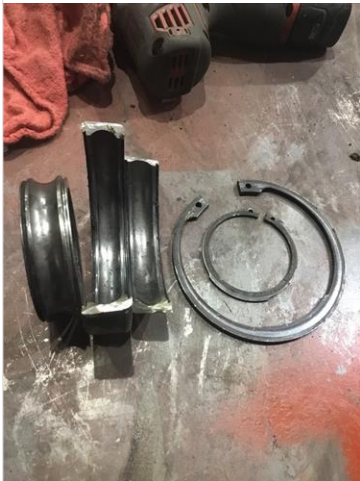
18. Number of Stator Slots		
19. Stator Condition	rewind stator	
<b>Mechanical Inspection</b>		 
20. Drive End Bearing Brand		
21. Drive End Bearing Number-	6212 2Z	
22. Drive End Bearing Qty.	1	
23. Drive End Bearing Type	(Ball) Ball Bearing	
24. Drive End Lubrication Type	(Grease) Grease Lubricated	
25. Drive End Bearing Insulation or Grounding Device?	none	
26. Drive End Wavy Washer/Snap-Ring Other Retention Device?	yes, 2ea.	P39

27. Drive End Bearing Condition	total cage and bearing failure.	
28. Opposite Drive End Bearing Brand		
29. Opposite Drive End Bearing Number-	6212 2Z

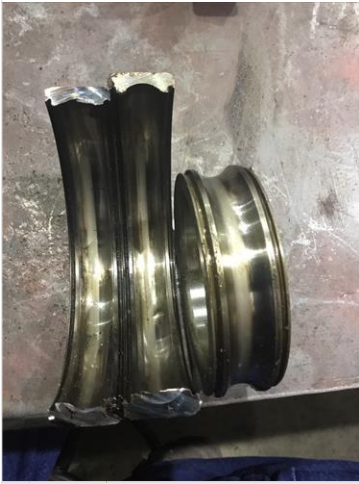
| 35. Opposite Drive End Bearing Condition | replace |

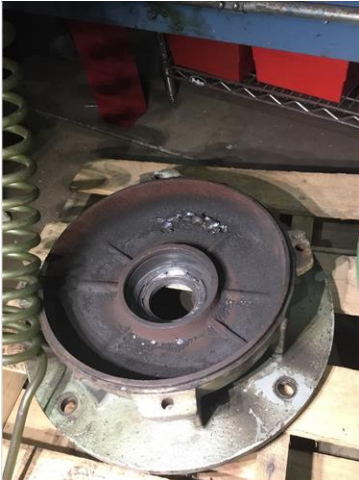
*Excessive wear.*

## 54. Drive End - Endbell Bearing Fit Condition

**(F) Fail**

*Re-sleeve both housing fits. Machine both shaft bearing journals.*

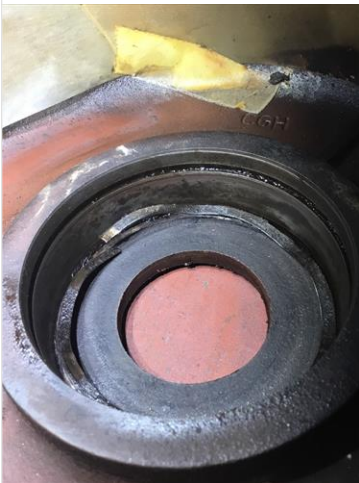
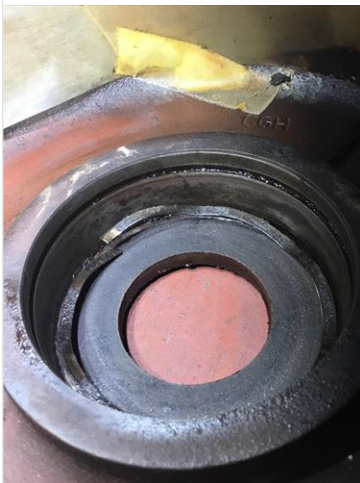
## 55. Opposite Drive End - Endbell Bearing Fit

*Excessive wear.*

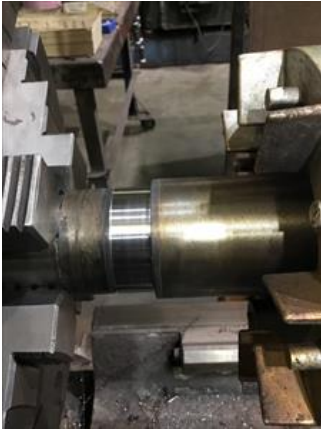
## 79. Drive End Bearing Shaft Fit Post Repair

2.3627

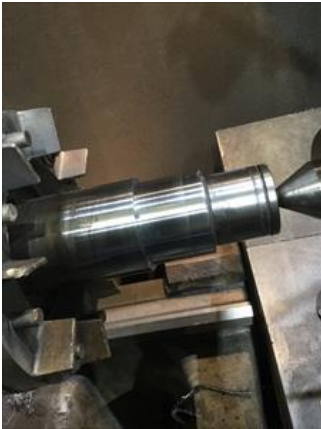
## 80. Opposite Drive End Bearing Shaft Fit Post Repair

2.3625

2.3624

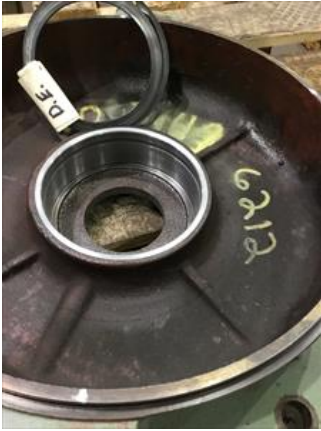
## 83. Drive End - Endbell Bearing Fit Post Repair

4.331

4.3312

4.3311

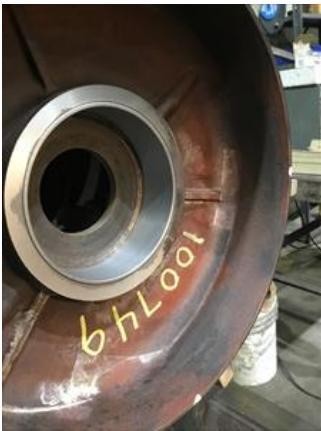
## 84. Opposite Drive End - Endbell Bearing Fit Post Repair

4.3312

4.3311
