AC Recondition As Found

Almatis Inc/RCP Bauxite (10014)

AC Recondition - Rev. 2

Description: 12.5HP IMPERIAL ELECTRIC
1200/360RPM 326T

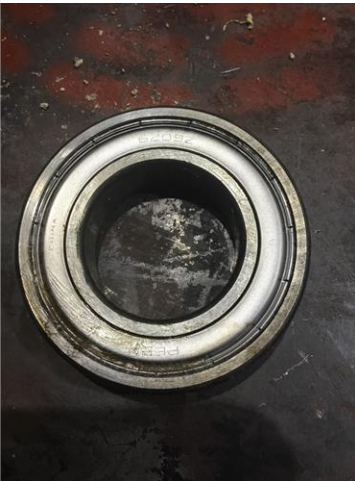
P81

27. Opposite Drive End Bearing Number-

6209Z

33. Opposite Drive End Bearing Condition

replace
