## AC Recondition As Found

### Sage V Foods

#### AC Recondition - Rev. 2

Location: MOTOR SHOP LR  
Serial Number: EF5T46663N-F4-7-8/22  
Description: 0.5HP SWECO 1200RPM 143TZX

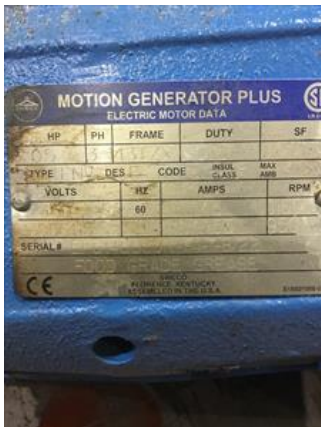
P37

- Report Date
- Nameplate Picture

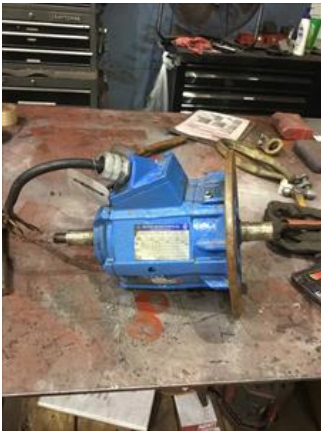
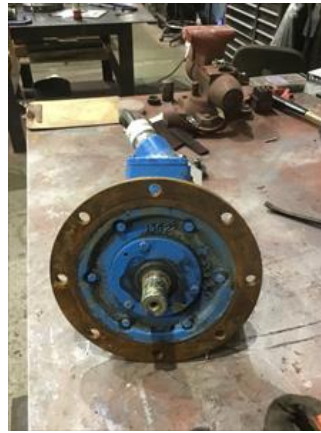
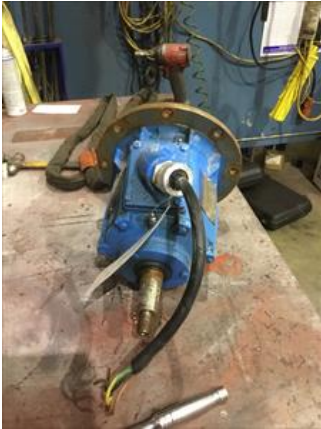
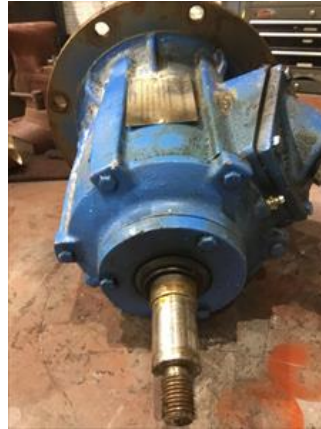
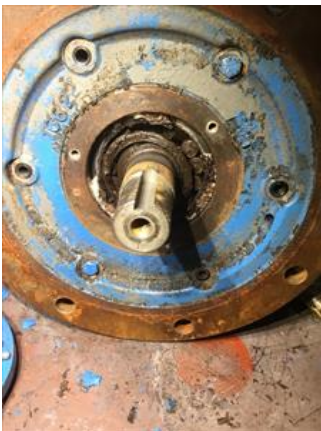
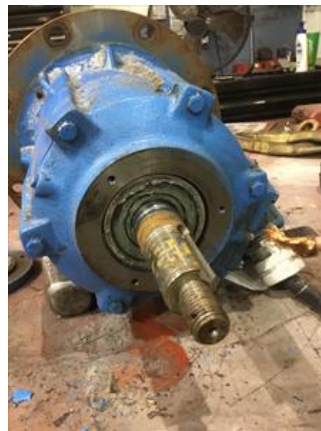
P44

- Photos of all six sides of the machine.

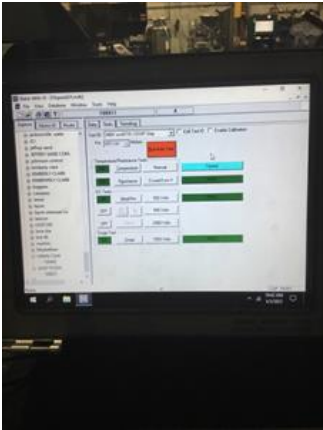
15. Insulation Resistance/Megger			
16. Winding Resistance			
1-2	1-3	2-3	
17. Perform Surge Test		(P) Pass	P56

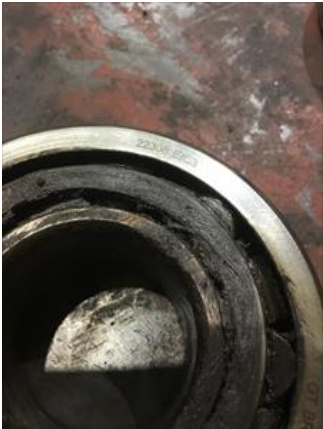
20. Drive End Bearing Brand		Skf	
21. Drive End Bearing Number-		22308/C3	P33

24. Drive End Lubrication Type	(Grease) Grease Lubricated
25. Drive End Bearing Insulation or Grounding Device?	none
26. Drive End Wavy Washer/Snap-Ring Other Retention Device?	snap ring
27. Drive End Bearing Condition	destroyed
28. Opposite Drive End Bearing Brand	SKF
29. Opposite Drive End Bearing Number-	NU 307 ECP/c3

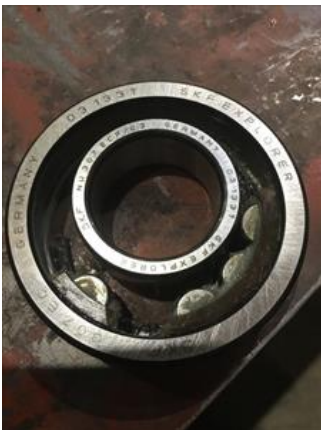
30. Opposite Drive End Bearing Qty.	1
31. Opposite Drive End Bearing Type	(Roller) Roller Bearing
32. Opposite Drive End Lubrication Type	(Grease) Grease Lubricated
33. Opposite Drive End Bearing Insulation or Grounding Device?	none
34. Opposite Drive End Wavy Washer/Snap-Ring Other Retention Device?	snap ring
35. Opposite Drive End Bearing Condition	replace
36. Drive End Seal	National 340853. S-3188

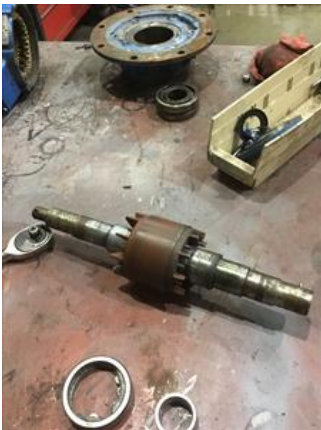
P3

(Squirrel Aluminum) Squirrel  
Cage Aluminum Die Cast

41. Rotor Condition

pass
