AC Recondition As Found

Almatis Inc/RCP Bauxite (10014)

Description: 50HP US MOTORS 1800RPM 326T

Hi-Speed Job Number: 100913

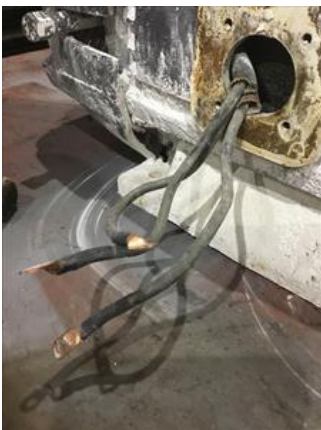
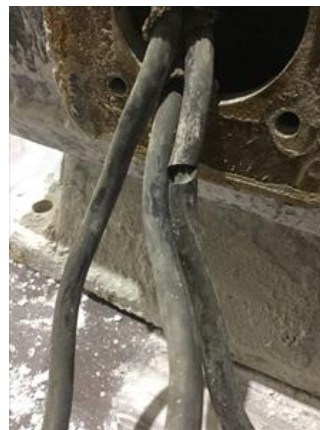
| 10. Lead Condition | (F) Fail | P53 |

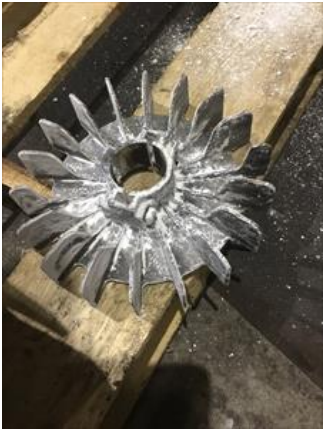
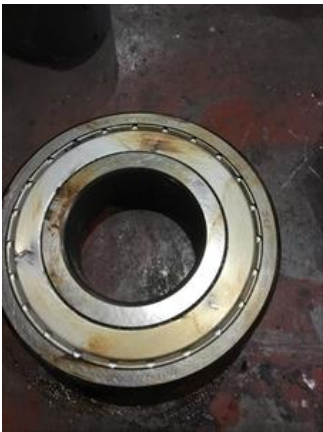
14. Broken or Missing Components		
Initial Electrical Inspection		
15. Insulation Resistance/Megger		
16. Winding Resistance		
1-2	1-3	2-3
17. Perform Surge Test (NA) Not Applicable		
18. Number of Stator Slots		
19. Stator Condition rewind		
Mechanical Inspection		
20. Drive End Bearing Brand		skf

6311 2Z & 6211 2Z bearings. 6311 & 6211 2Z sleeves. Rewind stator & core repair.

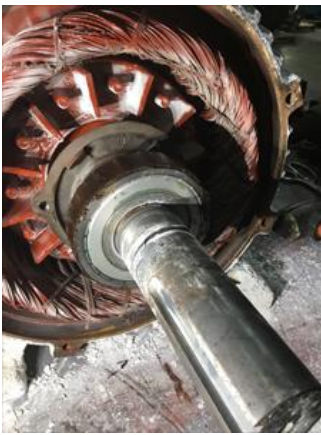
27. Drive End Bearing Condition

replace

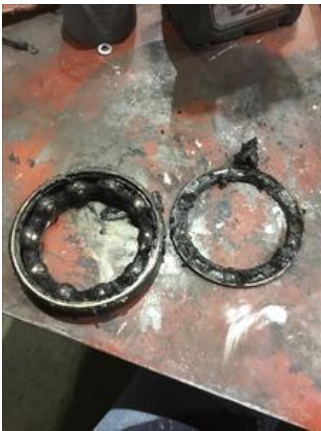
30. Opposite Drive End Bearing Qty.	1	
31. Opposite Drive End Bearing Type	(Ball) Ball Bearing	
32. Opposite Drive End Lubrication Type	(Grease) Grease Lubricated	
33. Opposite Drive End Bearing Insulation or Grounding Device?	none	
34. Opposite Drive End Wavy Washer/Snap-Ring Other Retention Device?		
35. Opposite Drive End Bearing Condition	complete bearing cage failure	P96
