AC Inspection as Found

AC Inspection - Rev. 2

Description: 8.6KW LENZE 3600RPM 132M

Hi-Speed Job Number: 100995

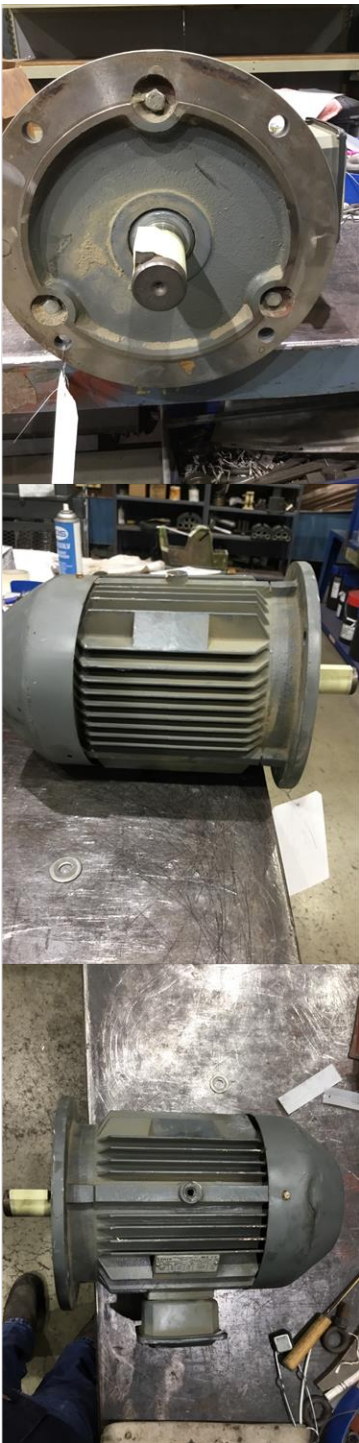
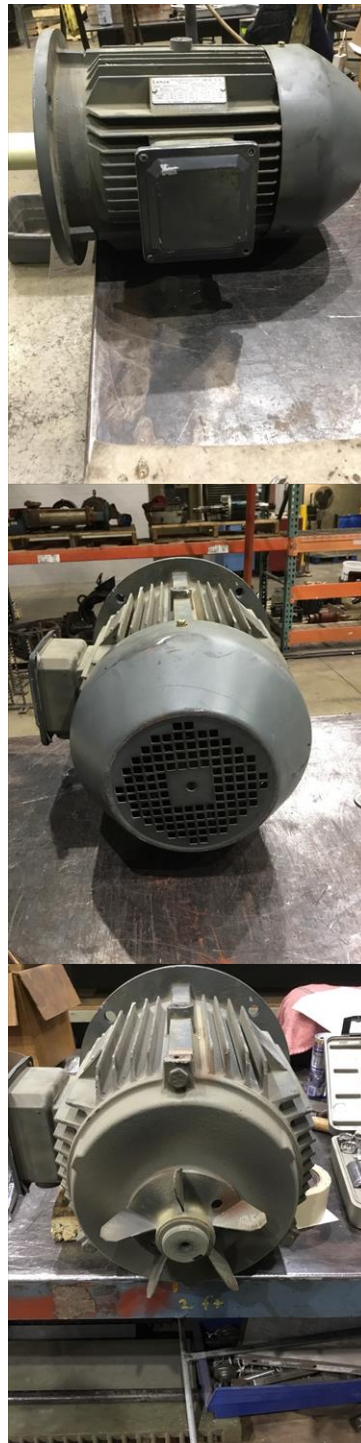
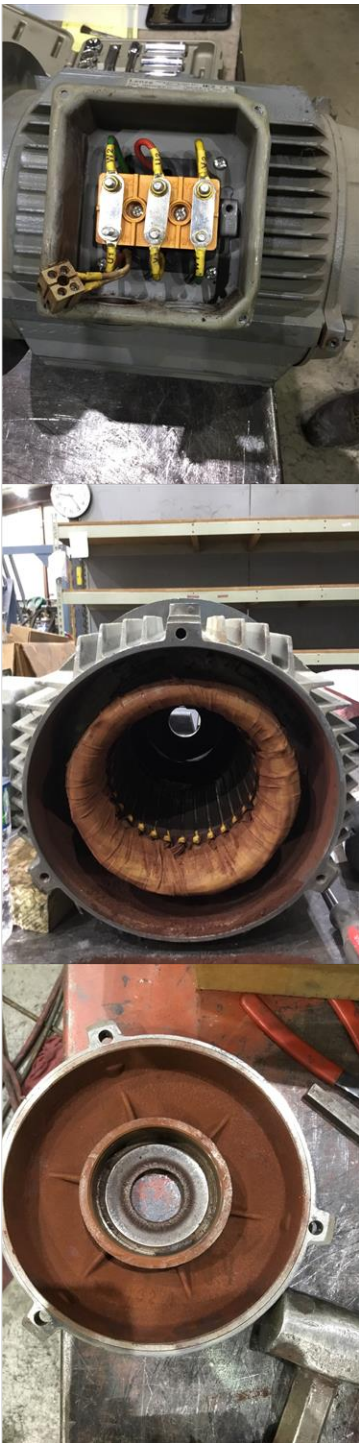
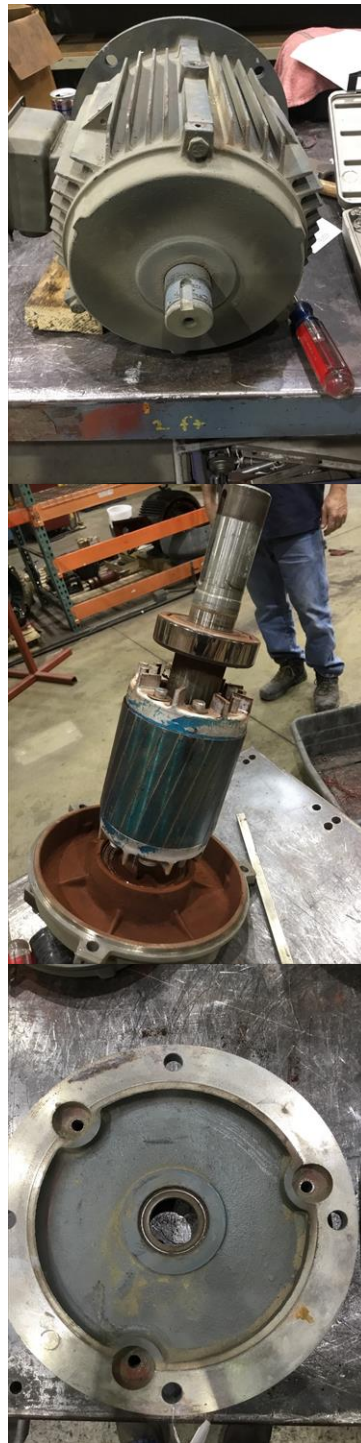
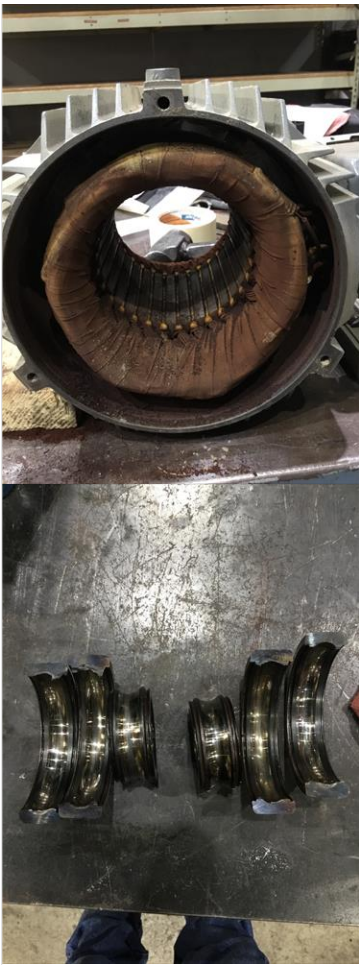
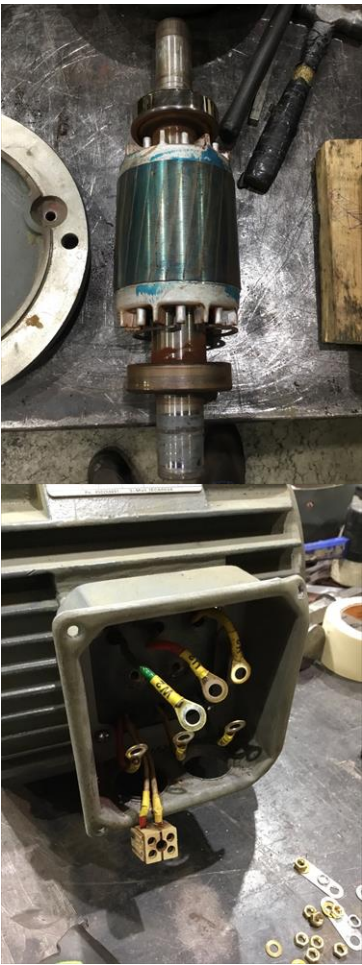
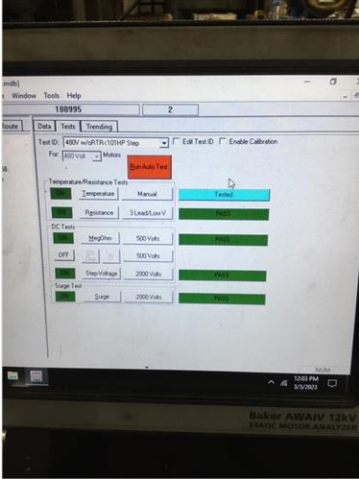
P3

4.	Describe the Overall Condition of the Equipment as Received	
	<i>Fair</i>	
5.	Distance from the end of the shaft to the Coupling/Sheave	inches
Initial Mechanical/Electrical		
6.	Does Shaft Turn Freely?	(Yes) Yes
7.	Does Shaft Have Visible Damage?	(No) No
8.	Assembled Shaft Runout	Inches
9.	Assembled Shaft End Play	inches
10.	Air Gap Variation <10%

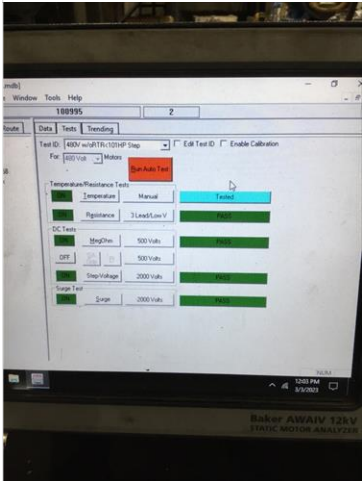
16.	Insulation Resistance/Megger	Megohms	
17.	Winding Resistance		
	1-2	1-3	2-3
18.	Perform Surge Test	(P) Pass	P18

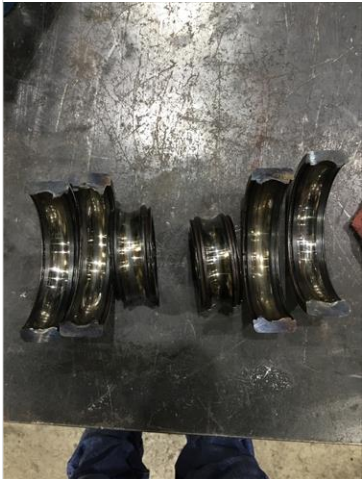
23.	Drive End Bearing Brand	FAG	P23

24.	Drive End Bearing Number-	6308zz	
25.	Drive End Bearing Qty.	1	
26.	Drive End Bearing Type	(Ball) Ball Bearing	
27.	Drive End Lubrication Type	(Grease) Grease Lubricated	
28.	Drive End Bearing Insulation or Grounding Device?		
29.	Drive End Wavy Washer/Snap-Ring Other Retention Device?

30.	Drive End Bearing Condition	replace	
31.	Opposite Drive End Bearing Brand	Korea	P31

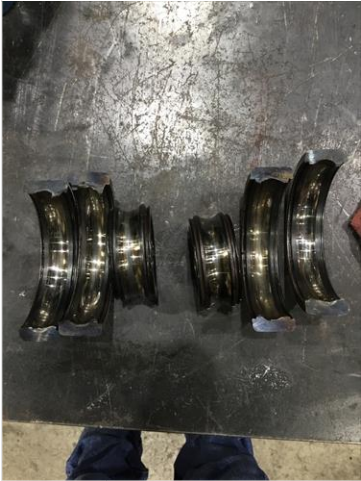
32.	Opposite Drive End Bearing Number-	6308zz	
33.	Opposite Drive End Bearing Qty.	1	
34.	Opposite Drive End Bearing Type	(Ball) Ball Bearing	
35.	Opposite Drive End Lubrication Type	(Grease) Grease Lubricated	
36.	Opposite Drive End Bearing Insulation or Grounding Device?		
37.	Opposite Drive End Wavy Washer/Snap-Ring Other Retention Device?	wavy washer	
	Needs replace		
38.	Opposite Drive End Bearing Condition		P38

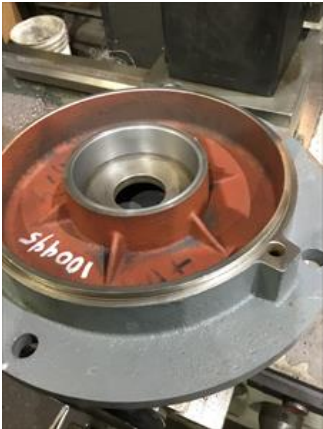
57. Drive End - Endbell Bearing Fit Condition (F) Fail

86. Drive End - Endbell Bearing Fit Post Repair			
0 Degrees	60 Degrees	120 Degrees	P86
3.5435	3.5436	3.5435

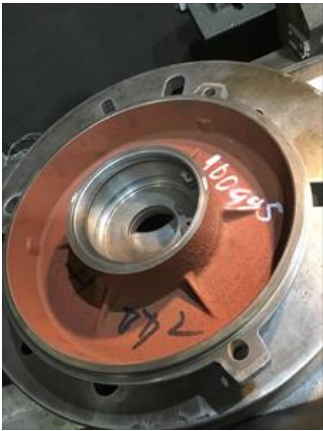
59. Opposite Drive End - Endbell Bearing Fit Condition (F) Fail

87. Opposite Drive End - Endbell Bearing Fit Post Repair			P87
0 Degrees	60 Degrees	120 Degrees	
3.5436	3.5437	3.5436
