**AC Recondition As Found**  
**Community Water System (12207)**  
299 Lakeshore Drive  
Greers Ferry, AR 72067

**AC Recondition - Rev. 2**

**Location:** LR MOTORSHOP  
**Serial Number:** 030004  
**Description:**150HP LEESON 3600RPM 405TS

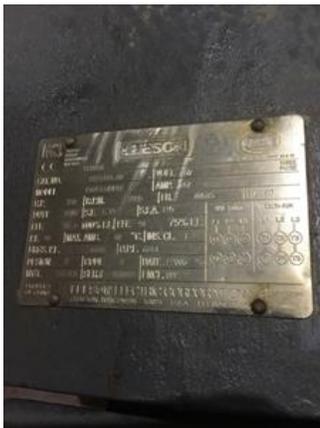
P37

1. Report Date
2. Nameplate Picture

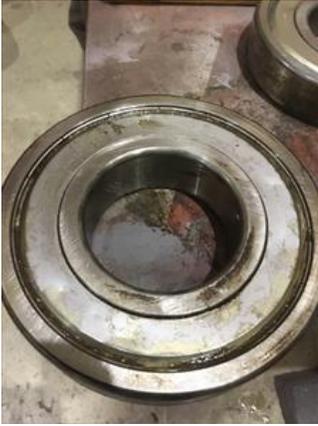
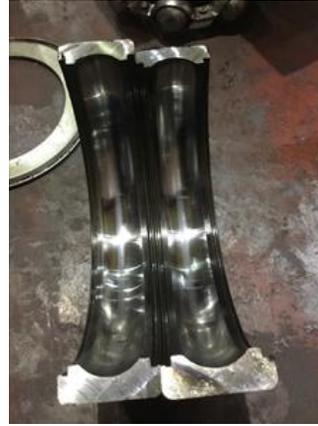
P49

24. Drive End Bearing Type

**(Ball) Ball Bearing**

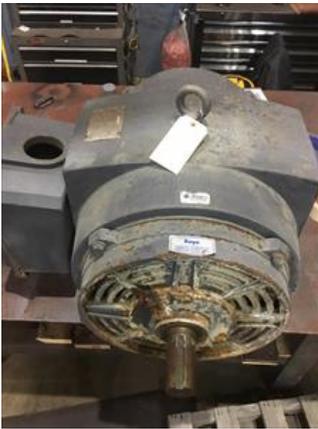
P63

26. Drive End Bearing Insulation or Grounding Device?

**aegis ring mounted on outside  
D.E. housing**

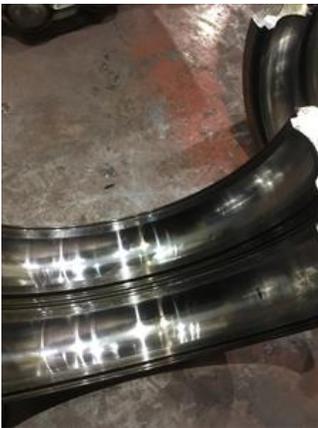
P78

28. Drive End Bearing Condition

**water contaminated with  
evidence of brinelling.**

60.	List Machine Work Needed Below		
	<i>Re-see e drive end housing fit.</i>		
61.	Technician	<b>Terrence Holland</b>

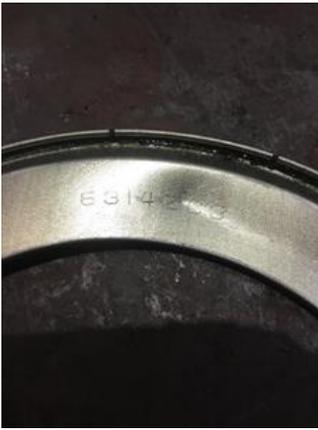
P86

29. Opposite Drive End Bearing Brand

**koyo**

30. Opposite Drive End Bearing Number-

**6314**

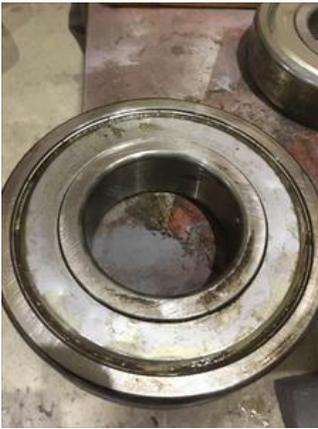
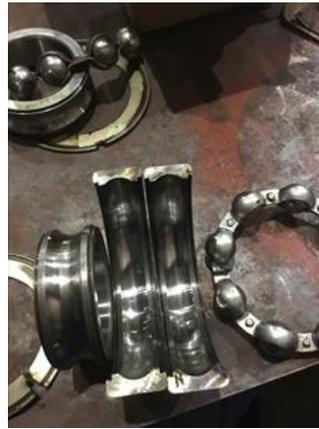
31. Opposite Drive End Bearing Qty. 1  
 32. Opposite Drive End Bearing Type (Ball) Ball Bearing P90

33. Opposite Drive End Lubrication Type (Grease) Grease Lubricated  
 34. Opposite Drive End Bearing Insulation or Grounding Device? noe  
 35. Opposite Drive End Wavy Washer/Snap-Ring Other Retention Device? wavy washer  
 36. Opposite Drive End Bearing Condition water contaminated.  
 37. Drive End Seal  
 38. Opposite Drive End Seal
