### AC Recondition As Found

Sage V Foods  
5901 SLOAN DRIVE  
LITTLE ROCK, AR 72206

#### AC Recondition - Rev. 2

Location: MOTOR SHOP LR  
Serial Number: C2002030652  
Description: 25HP Baldor 1775RPM 284T Severe Duty

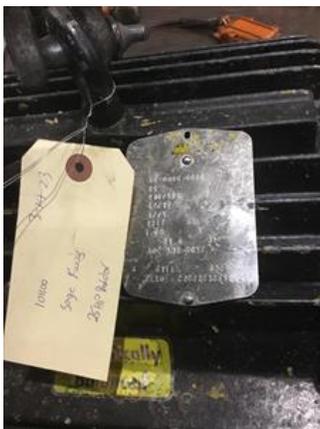
P37

1. Report Date
2. Nameplate Picture

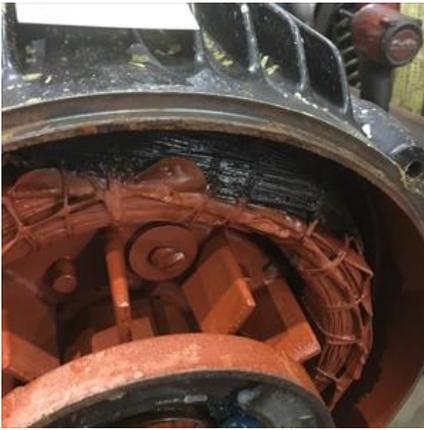
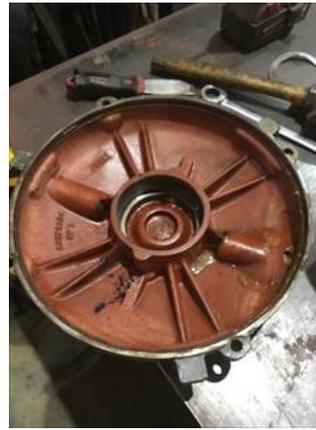
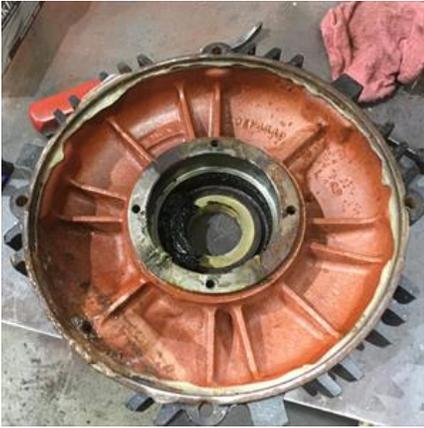
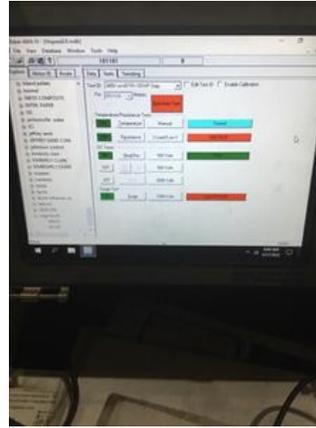
P45

3. Photos of all six sides of the machine.

4. Describe the Overall Condition of the Equipment as Received  
*Serviceable*

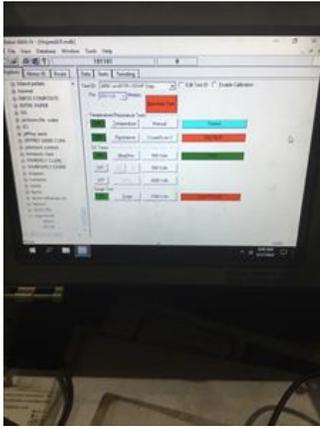
17. Perform Surge Test

(F) Fail

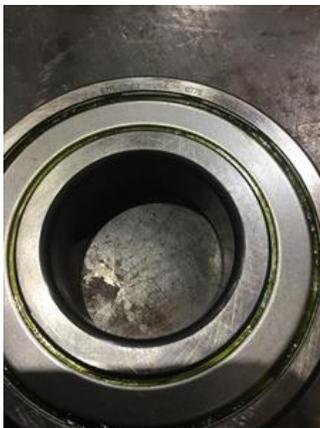
P32

20. Drive End Bearing Brand

fag

21. Drive End Bearing Number-

6311-2Z-C3

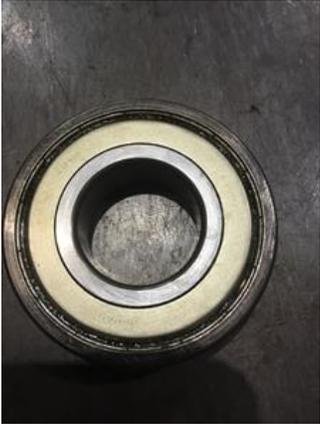
23. Drive End Bearing Type	<b>(Ball) Ball Bearing</b>	
24. Drive End Lubrication Type	<b>(Grease) Grease Lubricated</b>	
25. Drive End Bearing Insulation or Grounding Device?	<b>none</b>	
26. Drive End Wavy Washer/Snap-Ring Other Retention Device?	<b>none</b>	
27. Drive End Bearing Condition	<b>replace</b>	
28. Opposite Drive End Bearing Brand	<b>koyo</b>	P84

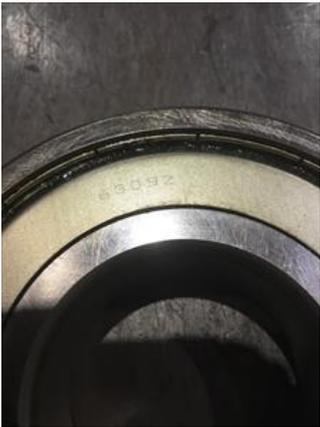
29. Opposite Drive End Bearing Number-	<b>6309Z</b>	P86
--	--------------	-----

30. Opposite Drive End Bearing Qty.	<b>1</b>	
31. Opposite Drive End Bearing Type	<b>(Ball) Ball Bearing</b>	
32. Opposite Drive End Lubrication Type	<b>(Grease) Grease Lubricated</b>	
33. Opposite Drive End Bearing Insulation or Grounding Device?	<b>none</b>	
34. Opposite Drive End Wavy Washer/Snap-Ring Other Retention Device?	<b>wavy washer</b>	
35. Opposite Drive End Bearing Condition	<b>replace</b>	
36. Drive End Seal	<b>in pro</b>	
37. Opposite Drive End Seal	<b>none</b>

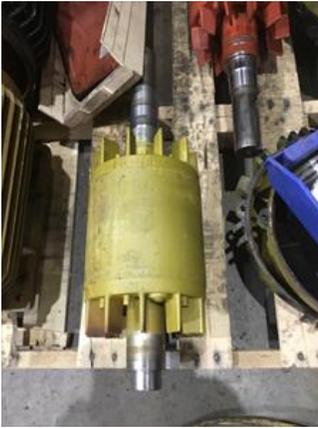
39. Growler Test (Pass) Pass

41. Rotor Condition good

42. List the Parts needed for the Repair Below  
*Rewind stator. ODE housing fitbad*
