AC Inspection as Found
City of Batesville (012100)
500 Riverbank
Batesville, AR 72501

AC Inspection - Rev. 2

Location: Shop
Serial Number: A2102222057
Description: 250HP BALDOR 3600RPM 449TS

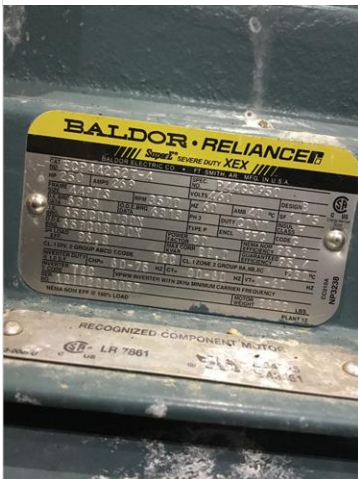
1. Report Date
2. Nameplate Picture

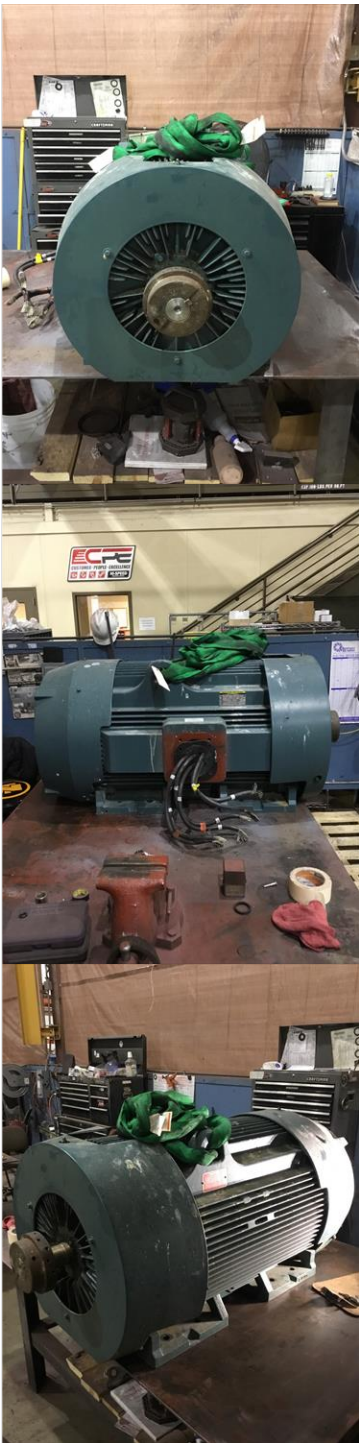
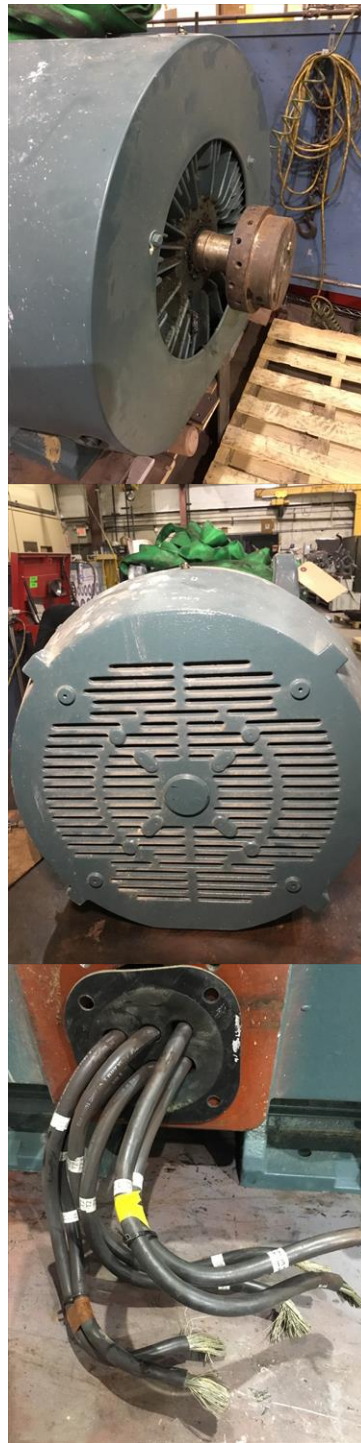
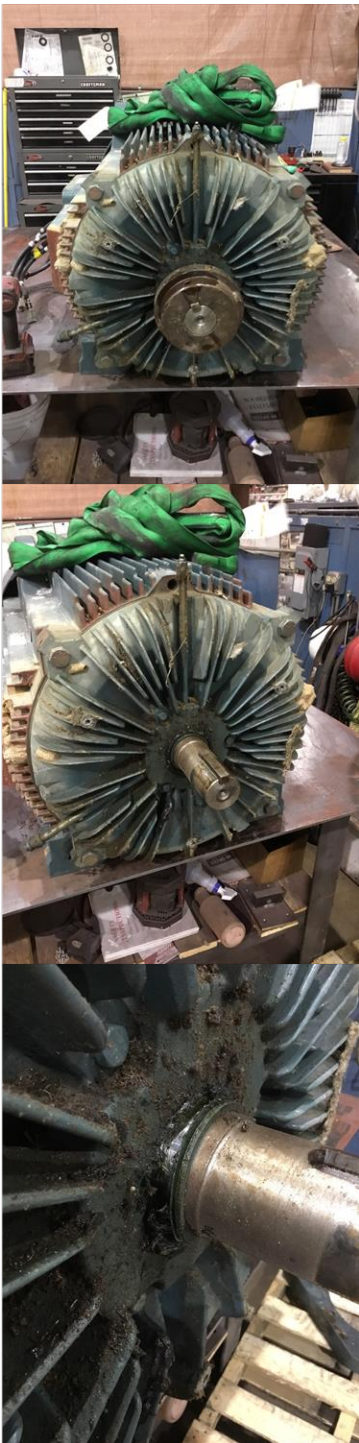
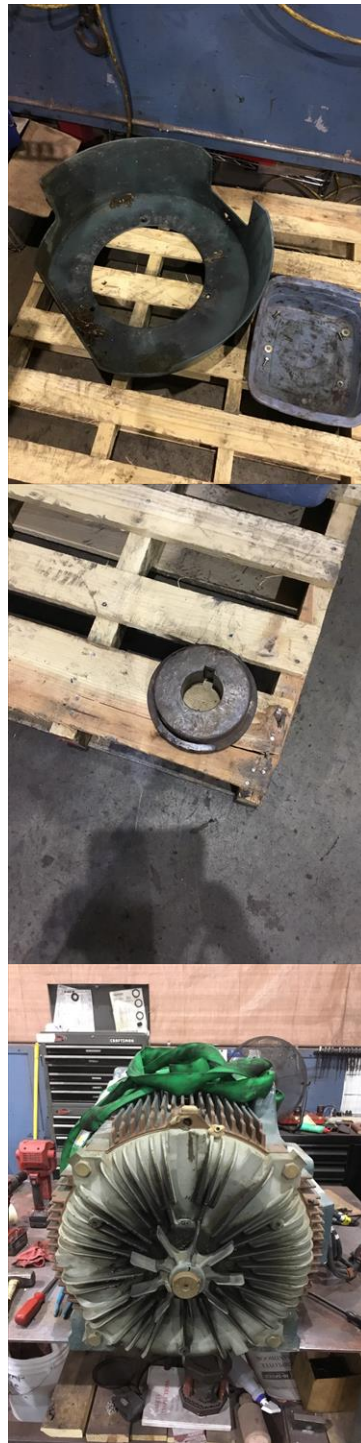
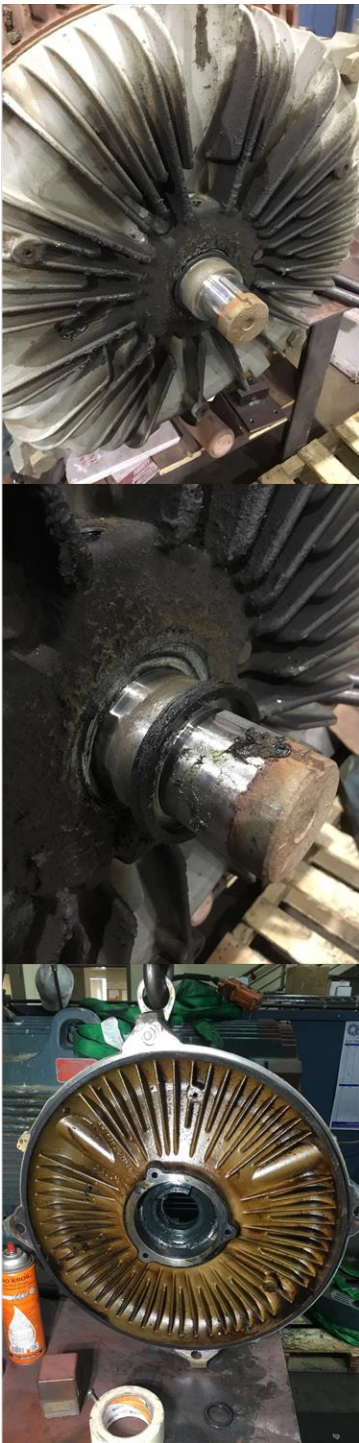
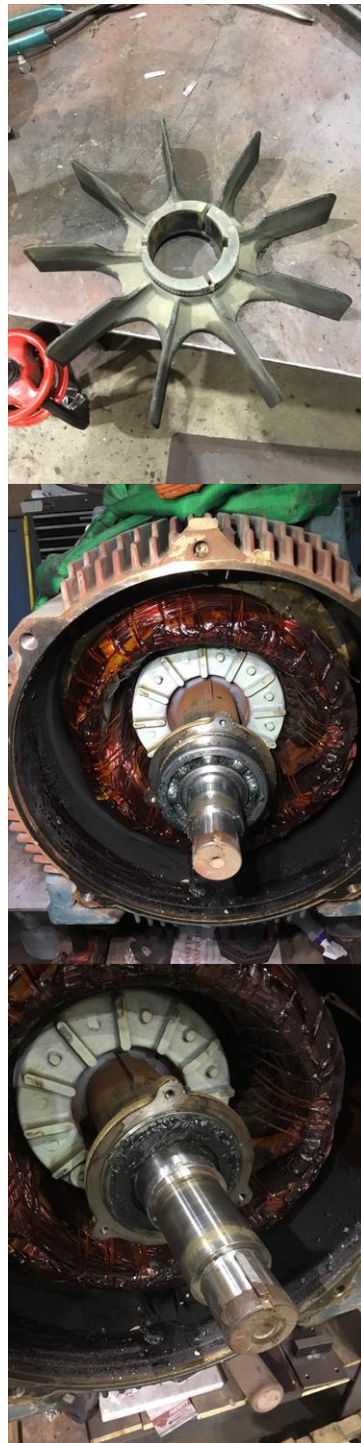
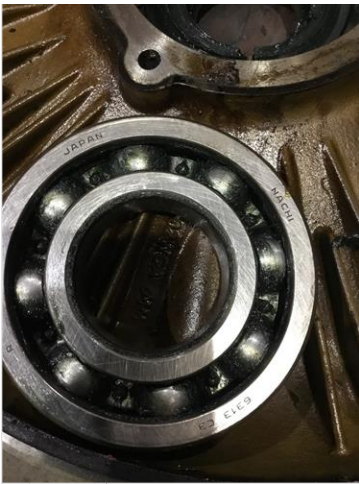
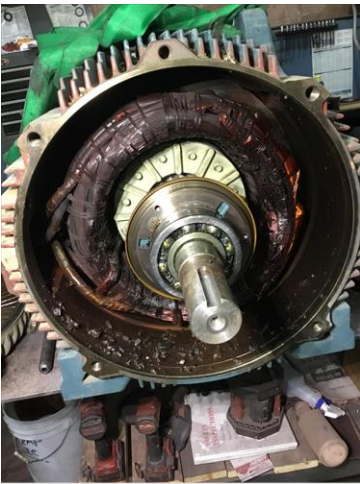
3. Photos of all six sides of the machine.

4.	Describe the Overall Condition of the Equipment as Received		
	<i>Serviceable</i>		
5.	Distance from the end of the shaft to the Coupling/Sheave	0 inches	P76
	<i>Flush</i>

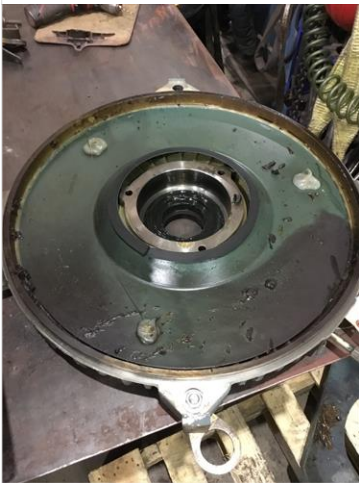
Initial Mechanical/Electrical			
6.	Does Shaft Turn Freely?	(Yes) Yes	
7.	Does Shaft Have Visible Damage?	(No) No	
8.	Assembled Shaft Runout	0.001 Inches	P26

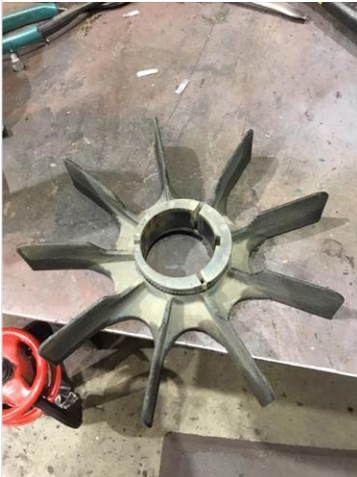
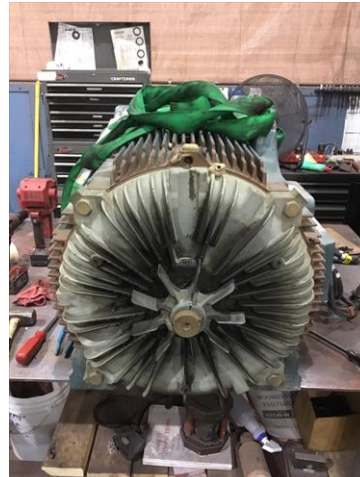
15. Frame Condition pass

16. Fan Condition

(P) Pass

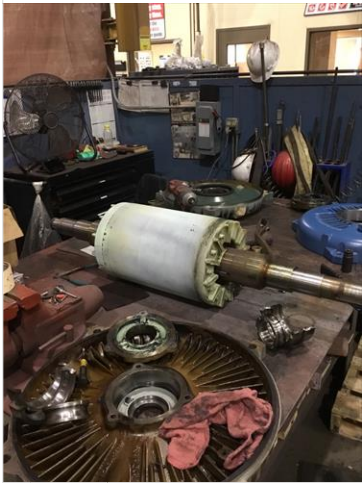
46. ODE Sleeve Bearing Inside Diameter	0 degrees	120 degrees	240 degrees
47. ODE Sleeve Bearing Outside Diameter	0 degrees	120 degrees	240 degrees
48. ODE Sleeve Bearing Housing Inside Diameter	0 degrees	120 degrees	240 degrees
49. ODE Sleeve Bearing to Housing Clearance	0 degrees	120 degrees	240 degrees
Rotor Inspection			
50. Rotor Type/Material	(Squirrel Aluminum) Squirrel Cage Aluminum Die Cast		P3

51. Growler Test			
52. Number of Rotor Bars			
53. Rotor Condition			
54. List the Parts needed for the Repair Below	2) 6313 bearings. Rewind stator.		
55. Signature of Technician that Disassembled Motor	Terrence Holland
