AC Recondition As Found

SLOAN VALVE (11763)

AC Recondition - Rev. 2

Description: 15HP BALDOR 3600RPM 254TCZ

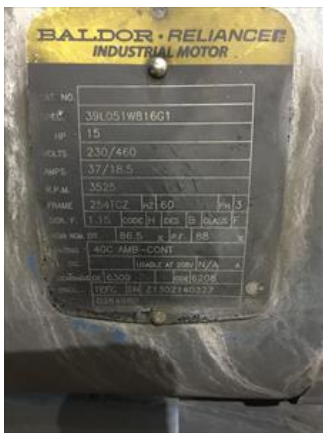
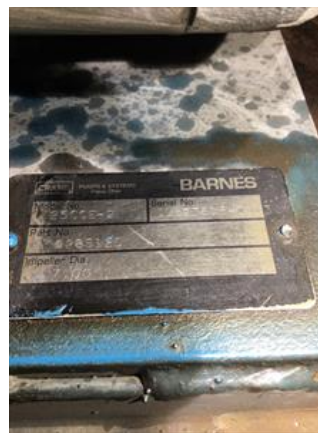
- Report Date
- Nameplate Picture

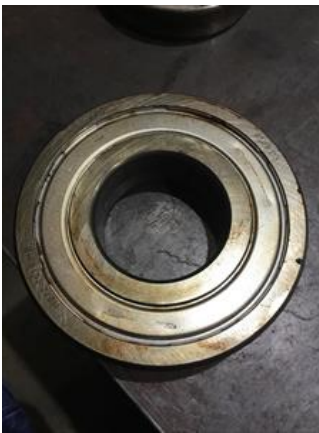
P14

22. Drive End Bearing Number-	6309
23. Drive End Bearing Qty.	1
24. Drive End Bearing Type	(Ball) Ball Bearing
25. Drive End Lubrication Type	(Grease) Grease Lubricated
26. Drive End Bearing Insulation or Grounding Device?	none
27. Drive End Wavy Washer/Snap-Ring Other Retention Device?	snap ring
28. Drive End Bearing Condition	replace
29. Opposite Drive End Bearing Brand	FAG
30. Opposite Drive End Bearing Number-	6208
31. Opposite Drive End Bearing Qty.	1
32. Opposite Drive End Bearing Type	(Ball) Ball Bearing
33. Opposite Drive End Lubrication Type	(Grease) Grease Lubricated
34. Opposite Drive End Bearing Insulation or Grounding Device?	none
35. Opposite Drive End Wavy Washer/Snap-Ring Other Retention Device?	wavy washer
36. Opposite Drive End Bearing Condition	replace
37. Drive End Seal	
38. Opposite Drive End Seal	none

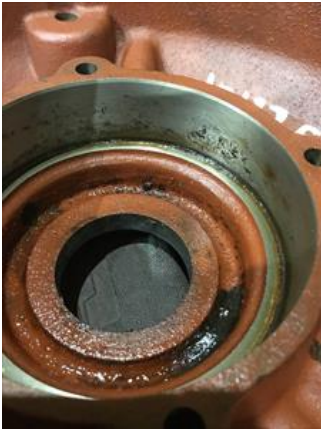
P15

Bad. Excessive wear.

55. Drive End - Endbell Bearing Fit Condition

(F) Fail

Re-sleeve both housing fits. Machine new seal sleeve.

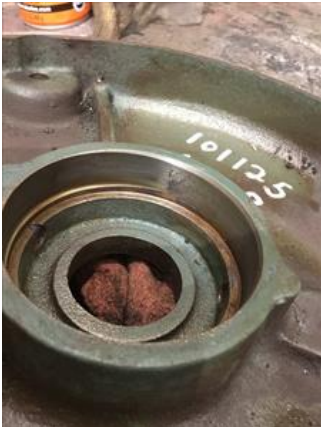
P41

Bad excessive wear.

57. Opposite Drive End - Endbell Bearing Fit Condition

(F) Fail
