AC Recondition As Found

Sage V Foods

AC Recondition - Rev. 2

Description: 30HP STERLING 1800RPM 286T

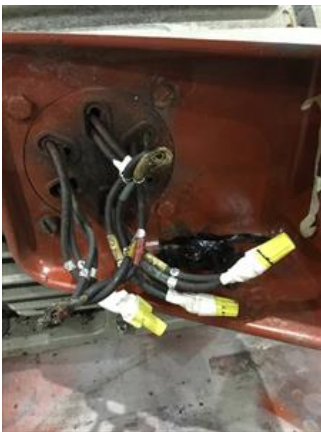
| 10. Lead Condition | (P) Pass | P54 |

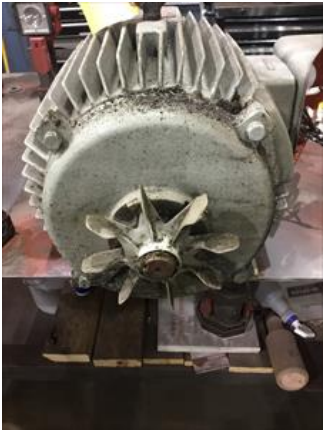
13. Fan Condition

(F) Fail

Cracked and loose on shaft.

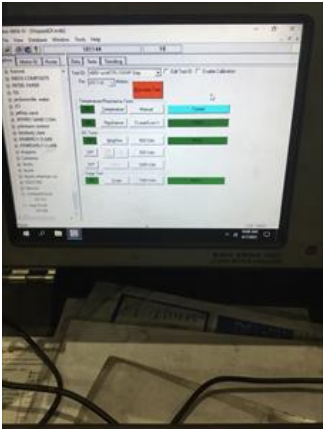
17. Perform Surge Test

(P) Pass

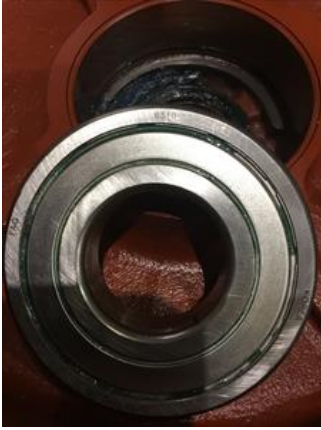
21. Drive End Bearing Number-

6310 2Z

27. Drive End Bearing Condition

replace

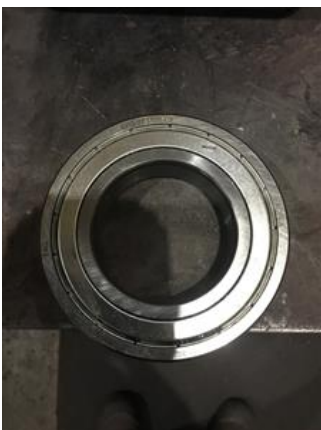
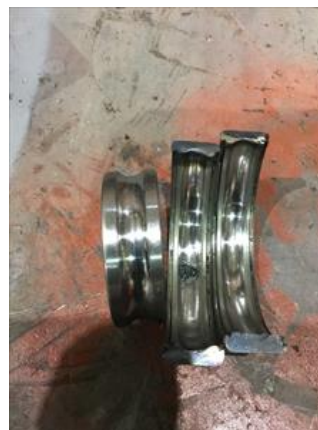
6210 2Z

35. Opposite Drive End Bearing Condition	replace	
36. Drive End Seal		
37. Opposite Drive End Seal		
Rotor Inspection

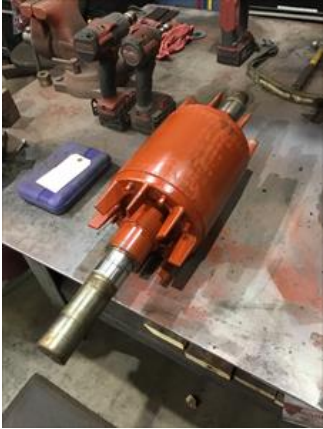
38. Rotor Type/Material	(Squirrel Aluminum) Squirrel Cage Aluminum Die Cast	P3

39. Growler Test	(Pass) Pass	
40. Number of Rotor Bars		
41. Rotor Condition	pass	
42. List the Parts needed for the Repair Below		
43. Signature of Technician that Disassembled Motor	Terrence Holland
