AC Recondition As Found
ARKANSAS SERVICE ONE
14318 EAST POLK ROAD
ALEXANDER, AR 72002

AC Recondition - Rev. 2

Location: MOTOR SHOP LR
Serial Number: 6936289A-003
Description: 15HP RELIANCE 1800RPM 254T

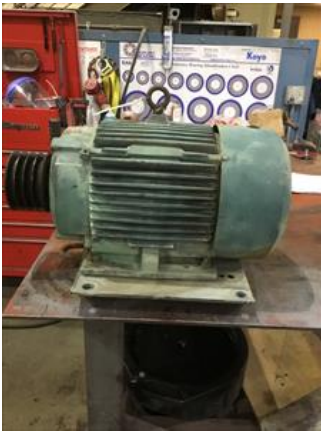
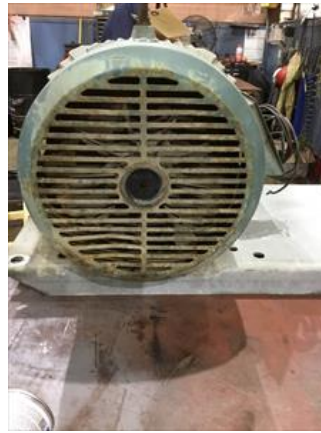
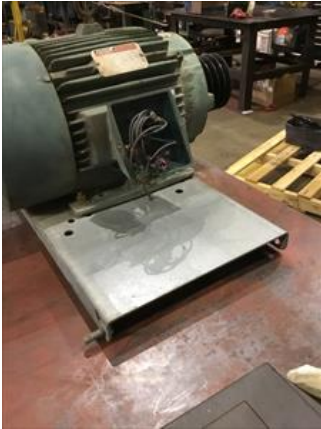
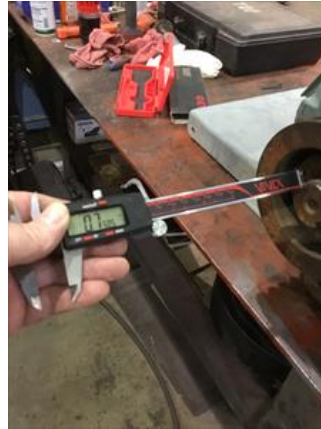
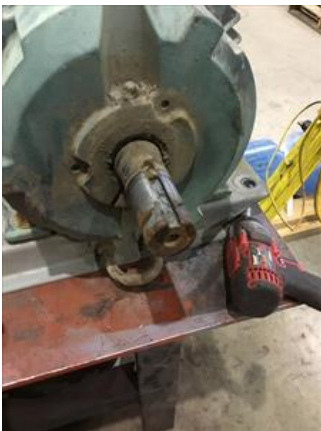
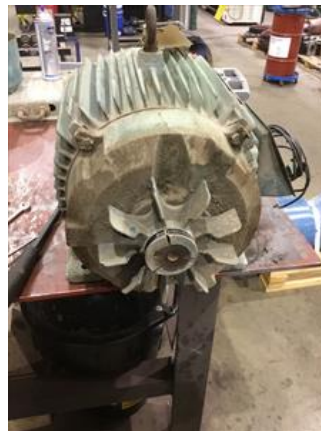
3. Photos of all six sides of the machine.
4. Describe the Overall Condition of the Equipment as Received
Ok
5. Distance from the end of the shaft to the Coupling/Sheave **0.75 inches**

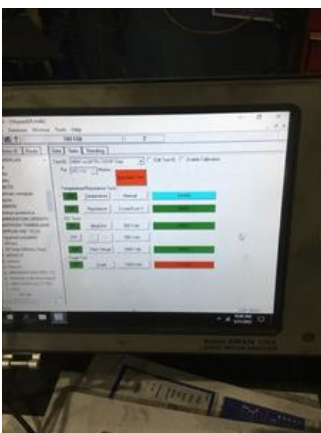
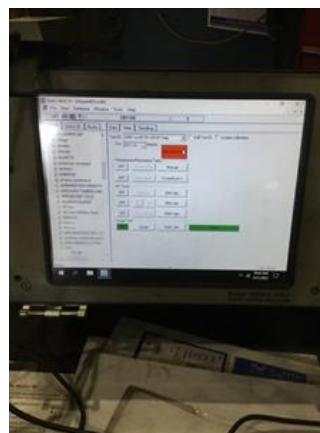
18. Perform Surge Test **(P) Pass** **P57**

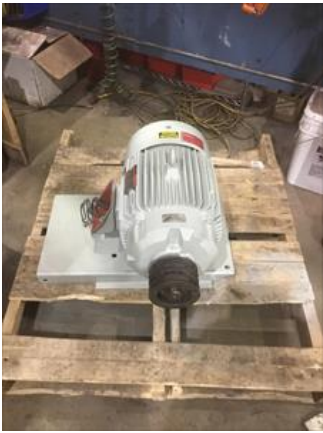
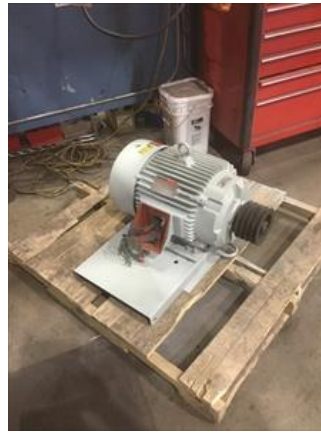
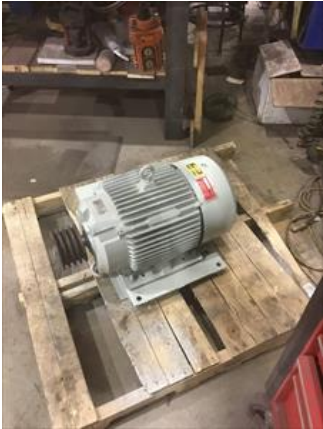
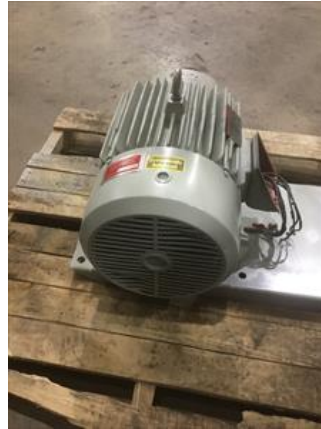
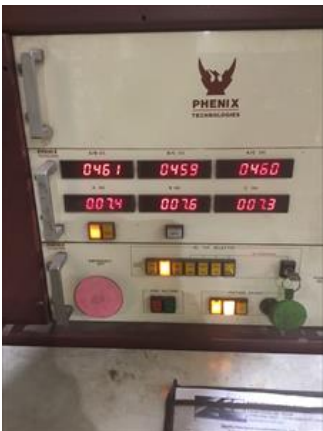
97. Opposite Drive End Vibration Readings - Inches Per Second			
Horizontal		Vertical	Axial
98. Ambient Temperature - Fahrenheit			
99. Drive End Bearing Temps - Fahrenheit			
5 Minutes		10 Minutes	15 Minutes
100. Opposite Drive End Bearing Temps - Fahrenheit			
5 Minutes		10 Minutes	15 Minutes
101. Document Final Condition with Pictures after paint			
102. Final Pics and QC Review		Terrence Holland	P102
