## AC Recondition As Found

Welspun Tubular (11685)

### AC Recondition - Rev. 2

Description: 150HP BALDOR 1800RPM 445T

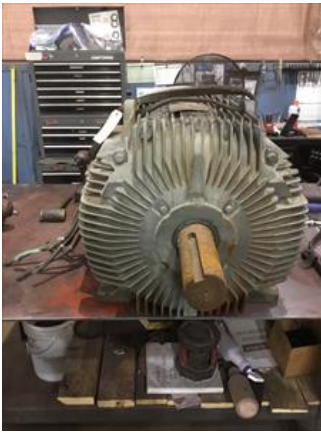
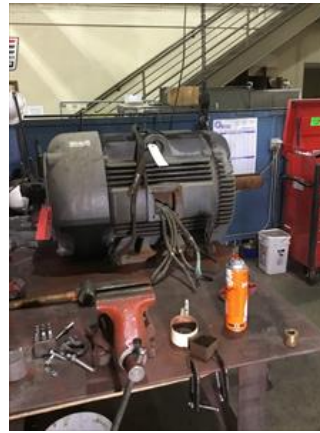
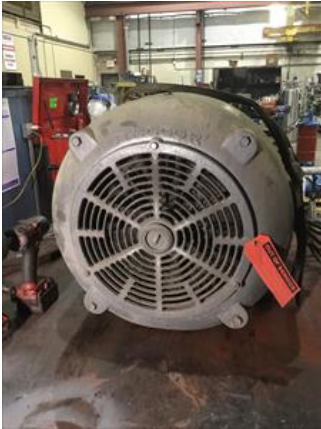
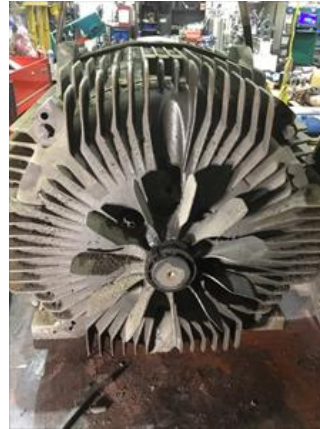
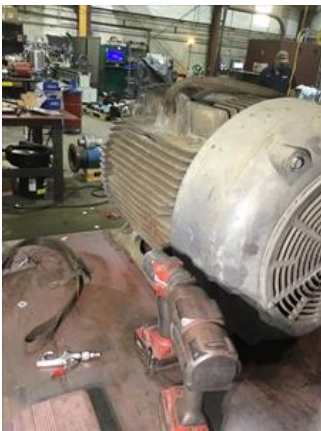
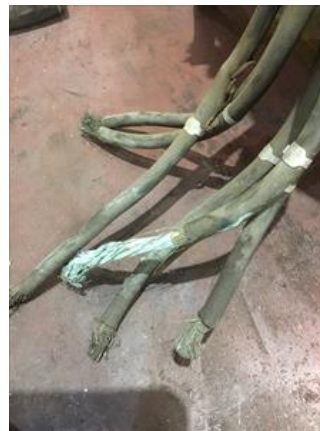
3. Photos of all six sides of the machine.

4. Describe the Overall Condition of the Equipment as Received  
*Dirty but serviceable.*

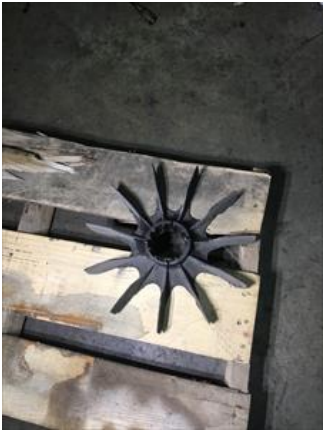
12.	Frame Condition		
13.	Fan Condition	(P) Pass	P91

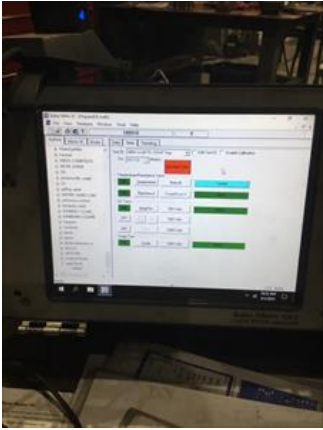
15.	Insulation Resistance/Megger		
16.	Winding Resistance		
	1-2	1-3	2-3
17.	Perform Surge Test	(P) Pass	P57

18.	Number of Stator Slots		
19.	Stator Condition	passed surge test but several leads need replacing	
20.	Stator Thermistors/Ohms		
21.	Stator Overloads/Ohms		
Mechanical Inspection

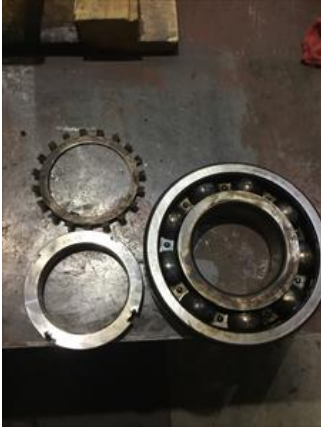
22.	Drive End Bearing Brand	fag	
23.	Drive End Bearing Number-	6319	
24.	Drive End Bearing Qty.	1	
25.	Drive End Bearing Type	(Ball) Ball Bearing	
26.	Drive End Lubrication Type	(Grease) Grease Lubricated	
27.	Drive End Bearing Insulation or Grounding Device?	none

29. Drive End Bearing Condition	replace
30. Opposite Drive End Bearing Brand	fag
31. Opposite Drive End Bearing Number-	6314
32. Opposite Drive End Bearing Qty.	1
33. Opposite Drive End Bearing Type	(Ball) Ball Bearing
34. Opposite Drive End Lubrication Type	(Grease) Grease Lubricated
35. Opposite Drive End Bearing Insulation or Grounding Device?	none
36. Opposite Drive End Wavy Washer/Snap-Ring Other Retention Device?	wavy washer
37. Opposite Drive End Bearing Condition	replace
38. Drive End Seal	
39. Opposite Drive End Seal

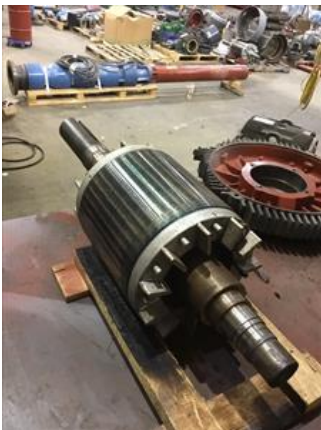
40. Rotor Type/Material	(Squirrel Aluminum) Squirrel Cage Aluminum Die Cast	P3
-------------------------	--	----

41. Growler Test	(Pass) Pass
42. Number of Rotor Bars	
43. Rotor Condition	good
44. List the Parts needed for the Repair Below

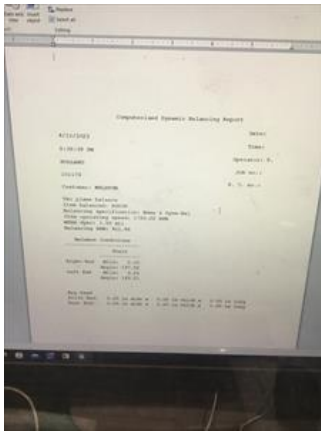
65. Final Balance Readings

.10

.26
