## AC Inspection as Found

Reynolds Metals company

### AC Inspection - Rev. 2

Description: 75HP MARATHON 1800RPM 365T

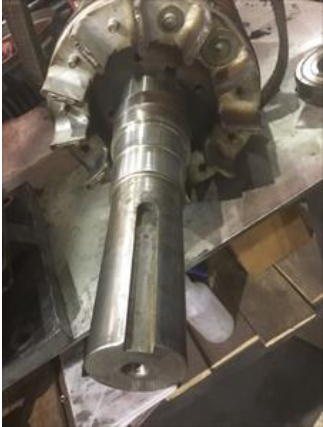
6.	Does Shaft Have Visible Damage?	(No) No	P20

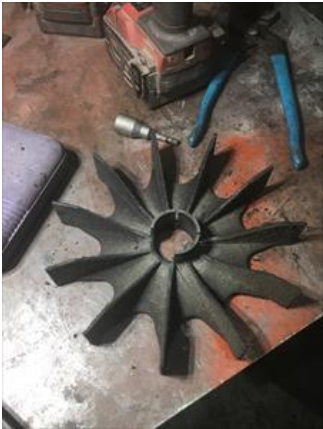
11.	Lead Length	9 Inches	
12.	Frame Condition		
13.	Fan Condition	(F) Fail	P93
	Broken

14.	Broken or Missing Components	fan assembly

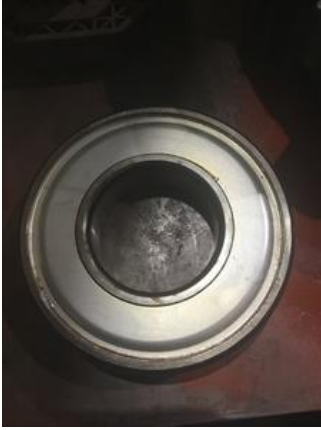
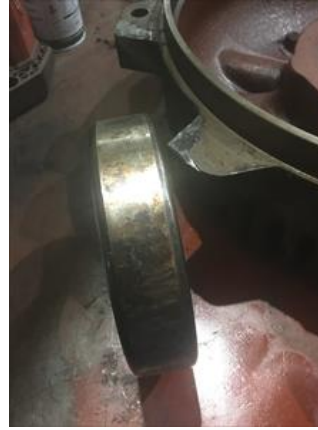
P49

29. Drive End Bearing Condition

replace

*6314 & 6312 sleeves for both housing fits*

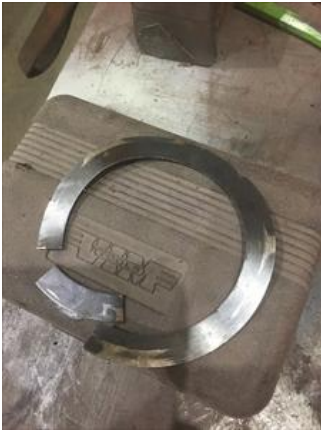
P98

36. Opposite Drive End Wavy Washer/Snap-Ring Other Retention Device?

wavy washer broken.  
replacement found

37. Opposite Drive End Bearing Condition

replace

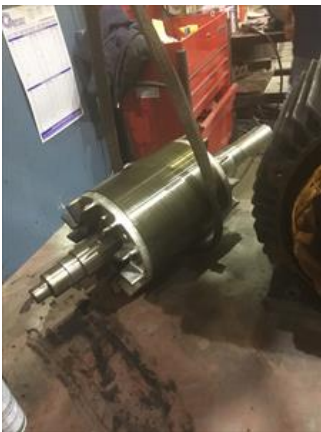
P3

40. Rotor Type/Material

(Squirrel Aluminum) Squirrel  
Cage Aluminum Die Cast

43. Rotor Condition

pass

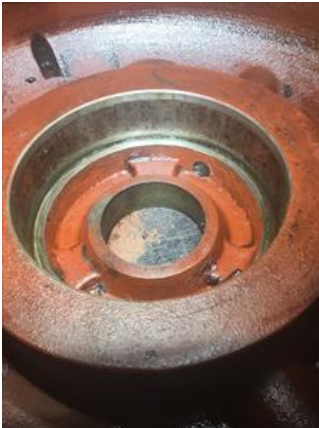
49.	Coupling Fit Closest to the end of the Shaft		
	0 Degrees	60 Degrees	120 Degrees
50.	Drive End Bearing Shaft Fit		
	0 Degrees	60 Degrees	120 Degrees
	2.7565	2.7566	2.7565
51.	Drive End Bearing Shaft Fit Condition		(P) Pass
52.	Opposite Drive End Bearing Shaft Fit		
	0 Degrees	60 Degrees	120 Degrees
53.	Opposite Drive End Bearing Shaft Fit Condition		
54.	Shaft Air Seal Fits		
	Drive End Air Seal	Opposite Drive End Air Seal	
Mechanical Fits- Bearing Housings			
55.	Drive End - Endbell Bearing Fit		
	0 Degrees	60 Degrees	120 Degrees
	<div>Fail. Excess wear.</div> <div>

</div>		
56.	Drive End - Endbell Bearing Fit Condition		(F) Fail
57.	Opposite Drive End - Endbell Bearing Fit		
	0 Degrees	60 Degrees	120 Degrees

*Sleeve both housing fits.*
